# A multidisciplinary diagnostic approach preliminary to the restoration of the country church "San Maurizio" located in Ittiri (SS), Italy

**Keyword:** Structural inspection, Stone and plaster characterization, Salt content, Microclimate

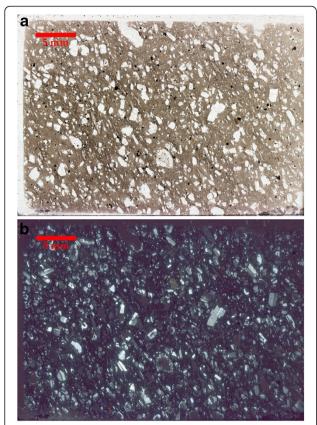
The natural stone sampled on the Church facade (see blue square in Figure 1) is a dacitic to rhyolitic welded ignimbrite, pink to violet in colour in hand specimen with white grains standing up from the matrix. The petrographic analyses (Figure 2 (a-b)) shows a porphyritic microstructure made up of fenocrystals and fenoclasts (modal volume of fenocrysts is about 35%) of dominant andesine plagioclase and subordinate biotite, pyroxene (wholly pseudomorphosed by chlorite), magnetite, lithic

Figure 2 Thin-section photomicrographs of the building stone sampled on the facade of the San Maurizio church. a) view under plain-polarized light; b) view under cross polarized light.

fragments of igneous rocks. The groundmass is vitroclastic, glassy to cryptocrystalline, showing a microtextural anisotropy defined by the parallel alignment of flames (flattened pumice and glass shards) and/or vesicles. Zircon and apatite are the main accessory phase. The petrographic features and the mineralogical composition closely match those of the welded ignimbrite deposits of the Oligo-miocene calcalkaline volcanism outcropping in the local area [33].

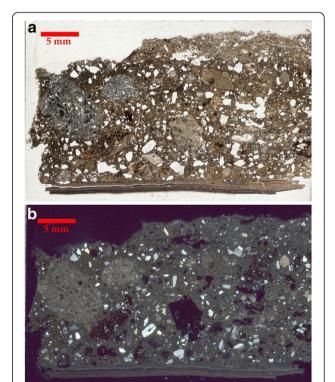
The plaster base consists of 40-45% in volume of aggregate with a grain size in the field of average-coarse sand (0.1-10 mm), moderate to scarce sorting, variable roundness (ranging from angular to sub-rounded) and average to low sphericity (Figure 4 (a-b)). The aggregate

**Figure 4 Thin-section photomicrographs of the plaster sample. a)** view under plain-polarized light; **b)** view under cross-polarized light.

is homogeneously distributed and no preferred orientation of the grain was discerned. The aggregate is composed of lithic fragments and monocrystalline grains. The prevalent lithologies are dacite to rhyolite igneous rocks showing porphyric textures and groundmass varying from microcrystalline to holoyaline, pyroclastic volcanic rocks with eutaxitic textures and holoyaline volcanic scoria; carbonate rocks (bioclastic calcarenites), quartzites. Monocrystalline grains consist mostly of oligoclase andesite plagioclase and subordinately of quartz, calcite, biotite, magnetite, iron hydroxides and microcline. Fossil fragments of echinides and bivalves were also found. The mineralogic-petrographic composition of the aggregate supports a provenance of the raw materials from the main volcanic and sedimentary lithologies outcropping in the surroundings of the San Maurizio church [33].

The binder is a lime-based (calcitic), nearly homogeneous, micritic sometime microsparitic matrix, although some sparse uncarbonated rounded lumps of lime were also observed. The volume occupying by the lime binder is about 50 vol. %, the porosity is less than 20% on the total volume of the sample and is due to voids occurring in the binder, in the lithic fragments of the aggregate and sporadically due to cracks at the grain-binder boundary. In its inner part the plaster base reveals a distinct layer, showing a lighter coloured matrix, which seem also distinguished by the finer grain size of the aggregate, a minor content of volcanic lithic fragments and a higher porosity in the binder. Such contrasting features could indicate the occurrence of an older plaster layer, different for, aggregate composition, binder concentration and porosity, which probably suffered carbonate dissolution-reprecipitation of the lime binder matrix.

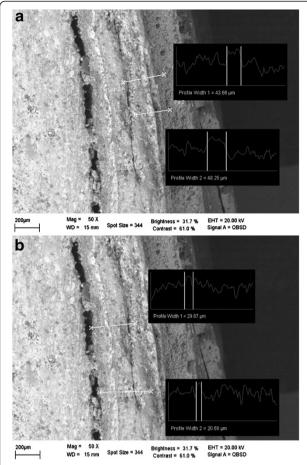
The SEM/EDS analyses (Figure 5a-b) on the outermost white finishing layer well agree with the optical microscopy observations concerning the occurrence of multiple finishing coats composed of calcium carbonate (Layer A). However, in the lower part of the layer (layer B), EDS microanalyses revealed the presence of S, Ba and Zn suggesting that was used lithopone (ZnSBaSO<sub>4</sub>) as finishing component. Such pigment is not commonly used as finishing layer; however, since no other traces of wall paintings were found on the church walls, during the restoration, it is supposed to be employed for its high covering power. Since lithopone started to be used from the second half of 1800 and the room was built in XVII century (see Church description), we can have a rough dating of a previous restoring intervention.

**Figure 5** Scanning electron microscopy (SEM) images of the outermost layers of the plaster sample. a) detail of the limebased finishing layer; b) detail of the lithopone-based finishing layer.

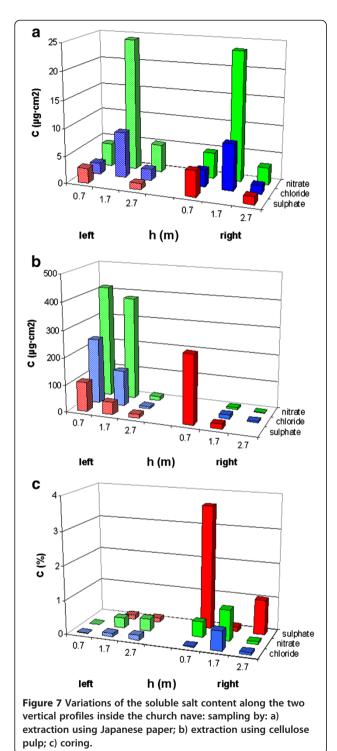
Figure 7 (a-c) shows that data obtained by the three sampling methods are significantly different. Indeed, the UNI method reveals a higher salt content on the right side of the nave; on the other hand, the amount of salts extracted by cellulose pulp is higher for the sampling points located on the left side of the nave whereas the salt content obtained using Japanese paper is similar for the two sides.

Such data are also in agreement with the conductivity measurements on the solutions obtained by the three methods (Additional file 1: Figure S17). The overall results suggest that, in the three procedures, salts were extracted from different depths within the wall. Actually, the maximum sampling depth is known for the UNI method (5 mm) but there is no information for the other two procedures. Anyway, a much higher efficiency of the extraction using the cellulose pulp compared with that obtained with Japanese paper is evident and it could be correlated to an extraction from deeper levels. Probably, Japanese paper, due to the low water content and the short time period of contact with the substratum, extracts salts only from a very thin superficial layer; the data obtained by this method evidence the same salts content on both the two sampled surfaces with a maximum in the central part of the profiles. If we consider the exposition of the walls from which the sampling profiles were chosen, data obtained by the UNI11087/2003 procedure could be justified even if not completely explained. The left side wall, being an exterior wall, is subject to direct sunlight which entails wide thermohygrometric variations along the wall thickness, due to the larger variation of outside temperature than to inside (compare Hobo D and Hobo 12 in Figure 8 (a-b)). On the other hand the right-side wall, being an interior wall separating the nave from the room monitored by data-logger H, bears a lower thermohygrometric change between its opposite sides, since the temperature variations inside the two environments are almost similar (compare HoboB with HoboH data-loggers in Figure 8 (a-b)). Such climatic condition leads to a scarce movement of salts inside the right wall and salts preferentially concentrate near the warmer side (inside the nave) where water evaporation is favoured. On the left side wall, salts move toward outside during insulation (maximum external temperature) and in the opposite direction during the night (minimum external temperature) and probably concentrate at a level

deeper than the sampled one (5 mm). On such basis, it could be also hypothesized that the cellulose pulp can extract salts at a depth higher than 5 mm.

However, data obtained by the UNI method, that surely must be considered the more accurate, indicate a

worrying sulphate concentration in the colder right wall, (i.e. higher than 3% w/w for the lower sampling point (see Additional file 1: Table S3).

content was revealed also in the lower sampling point of the vertical profile inside the niche. Further analyses after restoration are suggested in order to assess the need for desalination treatment.

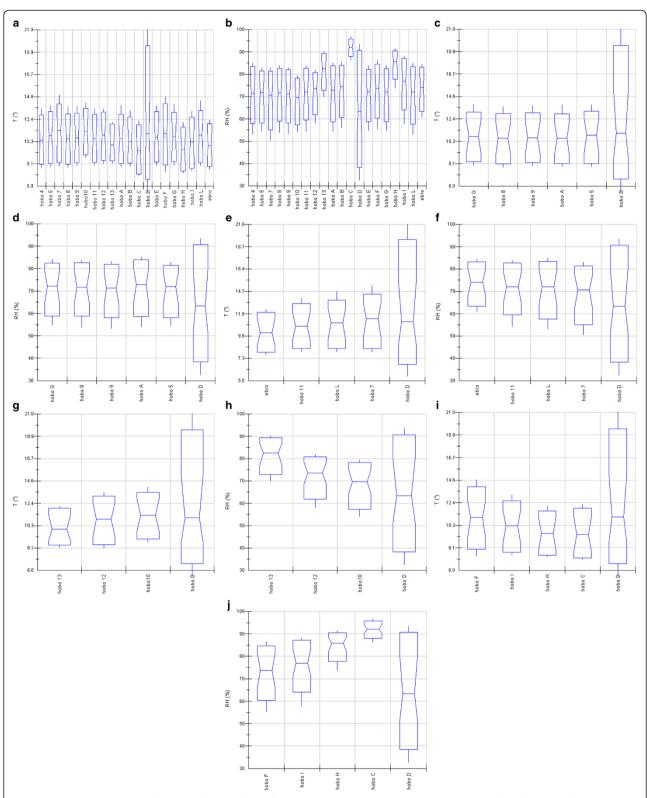
The highest RH values and the lowest RH spread were recorded inside the room monitored by HoboC (Figure 8b), in agreement with its north-facing position. Slightly lower RH values were registered in the room monitored by HoboH (also north-facing), and in the point monitored by Hobo13 (in south-facing position but at the minimum sampled quote, i.e. about 0.2 m). No enough significant variations result for the horizontal profile along the nave (Figure 8c and d), while small but significant changes are evidenced along the vertical profile in the middle of the church (about 1°C of T and 3% of RH, Figure 8 (e-f)). The largest thermohygrometric variability is observed along the vertical profile inside the niche containing the wall painting (more than 1°C of T and about 14% of RH, Figure 8 (g-h)) and among the four rooms around the church nave (about 2°C of T and about 19% of RH, Figure 8 (i-l)). The decreasing RH trend from bottom to top observed inside the niche suggests that water enters by rising damp (being the exterior wall directly in contact with the ground) rather than by infiltration through the roof. As regards the four rooms around the nave, data are congruent with their orientation and sun exposure.

Figure 8 Box-Whiskers graphs for: a) and b) data from all data-loggers (T and RH in the order); c) and d) data from data-loggers located on the E-W horizontal profile along the Church nave (T and RH in the order); e) and f) data from data-loggers along the vertical profile located in the middle of the Church nave (T and RH in the order); g) and h) data from data-loggers along the vertical profile located in the niche hosting the wall painting (T and RH in the order); i) and j) data from data-loggers placed in the rooms around the Church (T and RH in the order).

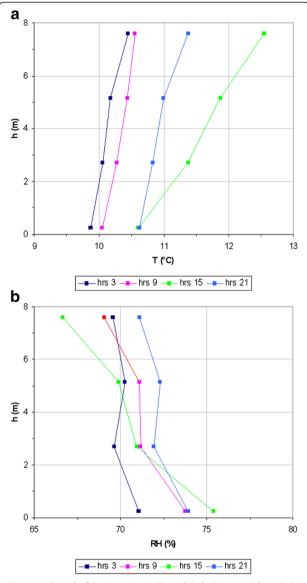
As an example, Figure 9 (a-b) shows such average values obtained from the data-loggers positioned at different heights along the vertical profile in the middle of the nave. It is obvious that the real maximum average T, as well as the maximum and minimum average RH, may not correspond (either as values that as times), to those inferred from Figure 9 (a-b). The T trends along the vertical profile (Figure 9a), at all the established times, are those expected for a not-conditioned environment. The T changes observed during the day at each different height are consistent with a circadian cycle and, as expected, with an increasing extent at increasing height. Actually maximum Temperature variations between the floor and the ceiling in the middle of the Church occurs at 3 pm (15.00); at this time, the maximum temperature is also observed except for the sensors near the floor for which the T value is comparable to those measured at 9 pm. A decreasing RH trend, fully coherent with the T increase, is observed only at 3 pm (Figure 9b); on the contrary, at 5 m of height, the 3-am, 9-am and 9-pm trends show an anomaly (RH increase instead of a decrease) that could be reasonably due to the outdoor humidity entering through two windows located at about the same quote and left always opened during all the monitoring period (Additional file 1: Figure S4 (a-b)). Indeed, the anomalous RH increase is higher during the night. Contrarily to those observed for Temperature, the RH trends along the profile cross each other, thus the RH daily trends are different at the various quotes and never follow circadian cycle. This is probably due to the presence of two humidity sources: the capillary rise of water (almost constant) and the humidity coming from outside, greatly varying during the day at the higher quotes. However, T and RH fluctuations, either along the profile than during the day, are quite small so confirming a good insulation of the church nave.

Figure 9 Trend of Temperature (T) and Relative Humidity (RH) averages calculated from data recorded by each sensor, daily, throughout the monitoring period, at the same times as a function of the height along the vertical profile located in the middle of the Church. a) T; b) RH.
