Study on the causes of secondary cracks of the eave wall mural of Daxiong Hall at Fengguo Temple in Yixian, Liaoning, China

Cheng Liu¹, Yuan He^{1*}

Keywords: Fengguo Temple, Mural, Eave wall structure, Secondary disease, Crack

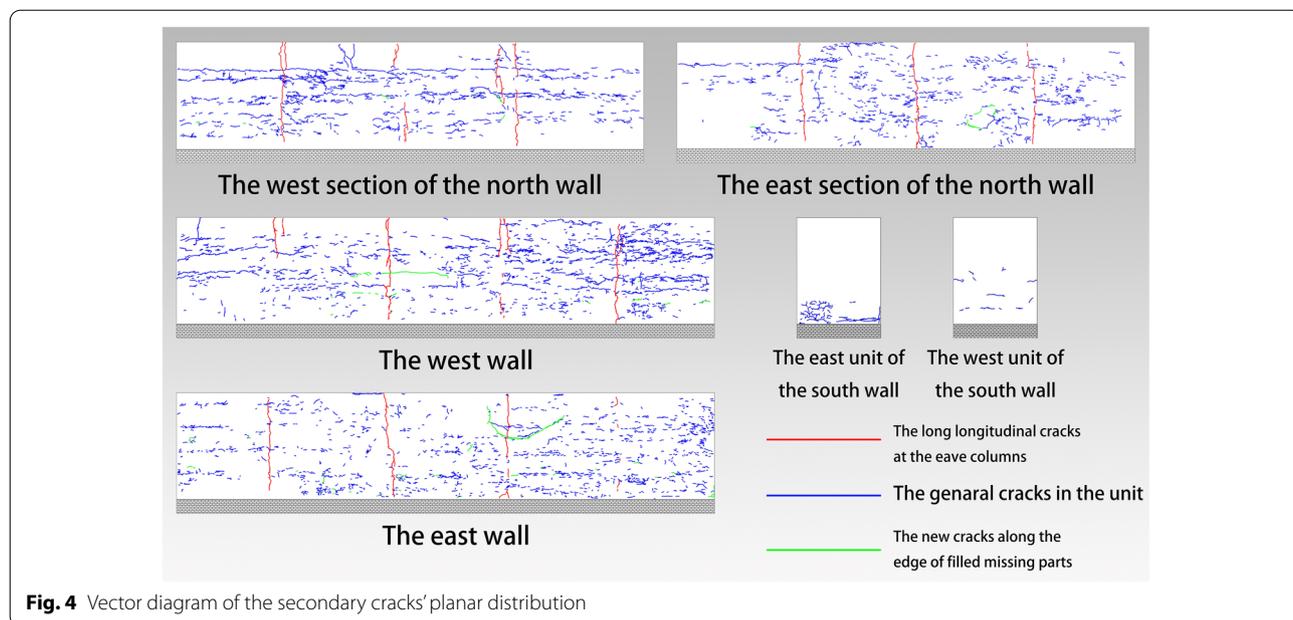
Fig. 4 Vector diagram of the secondary cracks' planar distribution

The secondary cracks on the eave wall's surface can be divided into three categories according to their nature. The first category contains the long longitudinal cracks at the eave column positions, which developed vertically and generally run through the entire wall from top to bottom, dividing the mural into units. Some developed into several segments, yet these remain independent from one another. Most of these cracks have caused the tear of added backing layers, and the adjacent walls are often dislocated due to shear failure. In terms of orientation, the cracks on the north wall are clearly more serious than those on the east and west walls. This is most noticeable in the crack at the junction of N1 and N2, whose widest point reaches a staggering 5 cm. The second category includes the general cracks in the unit, which is less serious than the first category. In addition to some long transverse cracks that intersect with the longitudinal ones at the eave columns, other cracks mostly

form transverse development trends in the form of short crack groups. Several rows of parallel distribution formed among different short crack groups in the same unit. There are also clear deformations near some cracks. The third category comprises the new cracks along the edge of the filled missing parts. There are few cracks within this category, and those that are developed in irregular directions, which is mainly the result of internal stress releasing along the weak edge of the filled parts.

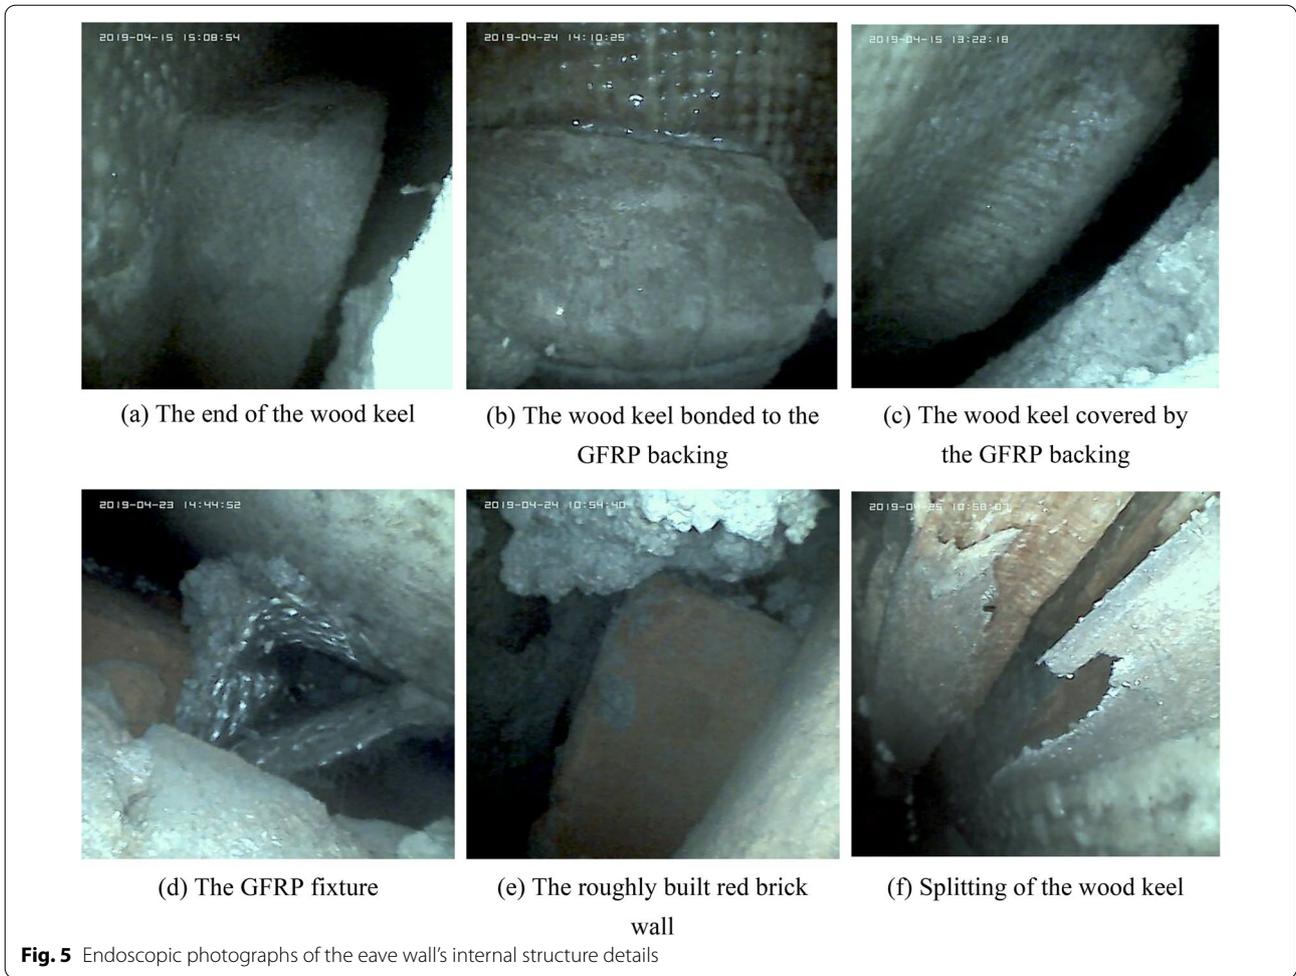
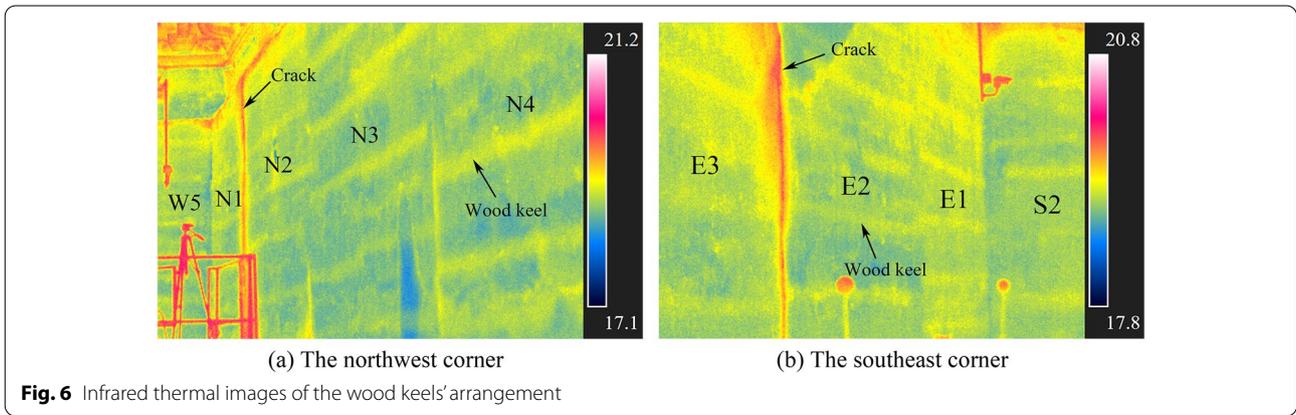
The filed investigation results (see Figs. 5 and 6) revealed a cavity 2–10 cm thick between the GFRP backing and the red brick wall, in addition to the structure mentioned in the engineering report. We can infer highly important information from this cavity regarding the mural's structure, something which has been ignored in previous investigations [12]. The red brick wall was built roughly and with little precision, and the gaps between the bricks are relatively large. Furthermore, there are 5–6 parallel rows of horizontal wood keels adhered to the GFRP backing. They are roughly 3 cm thick, 10 cm in height, and their length is approximately equal to the width of a unit. However, there is no physical connection between the wood keels and the red brick wall, and certain keels have split near the bonding surface due to the deformation of the materials. The wood keels of two adjacent units are discontinuous, and their upper and lower positions are relatively staggered. Moreover, their transverse extension does not cross the longitudinal cracks without exception. The tips of some of the wood keels are covered by the upturned fiberglass cloth of adjacent units, which is consistent with the engineering report's description that the reinforcement was conducted unit by unit. The combination of wood keels and GFRP backing was a routinely used support method for detached murals in China in the 1970s and 80s [17]. The wood keels were generally arranged into a grid frame to strengthen the level of support and enhance the mural's integrity.

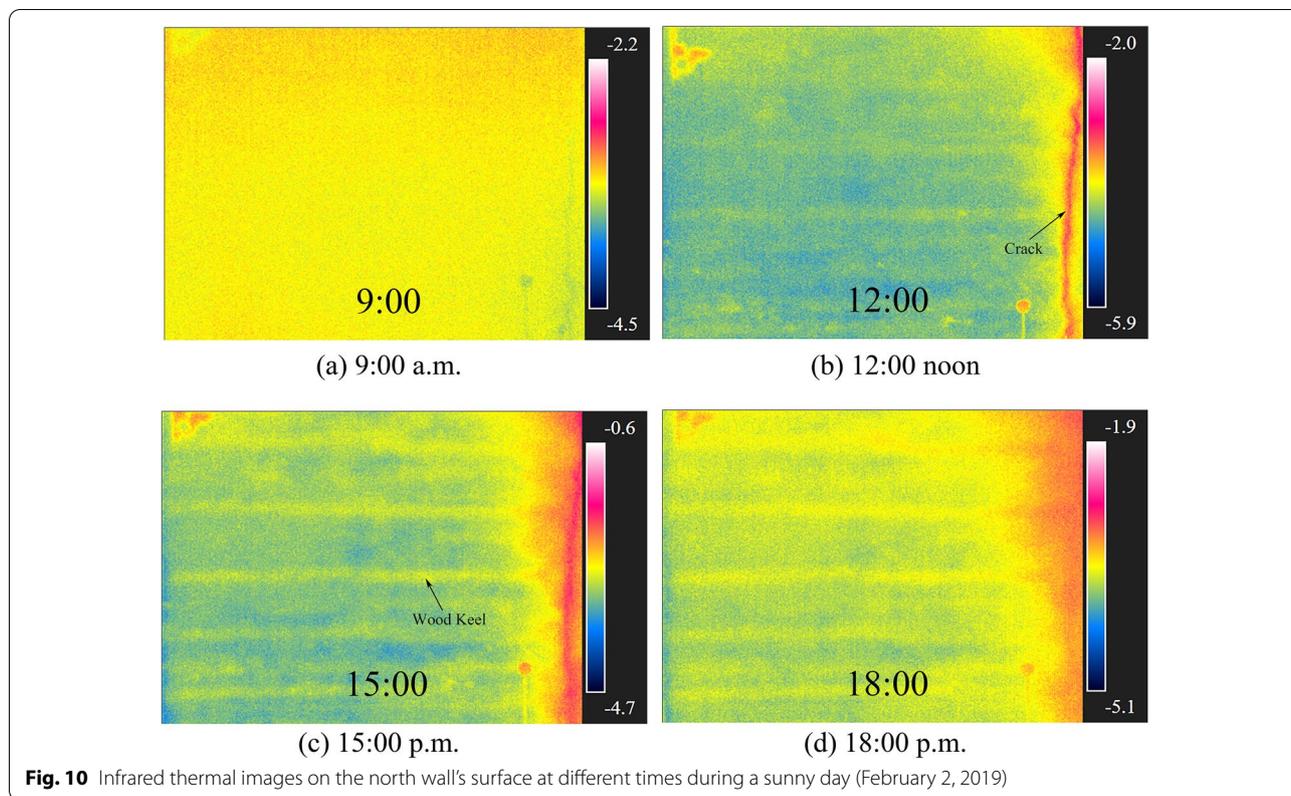
Fig. 10 Infrared thermal images on the north wall's surface at different times during a sunny day (February 2, 2019)

Figure 10 shows the infrared thermal images of the north wall (N1) surface during the course of a sunny day (February 2, 2019, sunrise at 7:06 a.m. and sunset at 17:11 p.m.), which visually reflects the external environment's impact on the mural body from the perspective of heat transfer theory. The vertical line near the right edge of the image is the long longitudinal crack at the eave column, and the horizontal parallel stripes are the wood keels behind the GFRP backing. At 9:00 a.m., the mural's surface temperature was relatively uniform, and the temperature at the long longitudinal crack was slightly lower than that displayed in other parts. At 12:00 noon, the surface temperature of the mural increased as a whole, the temperature at the long longitudinal crack was significantly higher than elsewhere, and the stripes of the wood

keels initially emerged. At 15:00 p.m., the mural's surface temperature further increased, and a high-temperature divergence zone centered on the long longitudinal crack began to form. Moreover, the stripes of the wood keels became clearly visible. At 18:00 p.m., the surface temperature of the mural fell as a whole. The center of the high-temperature divergence zone—namely the long longitudinal crack—became less obvious due to the disappearance of the external heat source (sunset), and the stripes of the wood keels also began to fade.

There are clear and observable correlations between the variation of infrared thermal images of the mural's surface and the diurnal variation of atmospheric temperature on sunny days. Firstly, compared with other parts, the

temperature changes at the long longitudinal cracks are more responsive to the diurnal variation of atmospheric temperature, which proves that the long longitudinal cracks are well-connected to the outside atmosphere, and the heated or cooled outside air can penetrate to the crack sites through the vents and air channels, causing lasting damage to the mural. Secondly, with the passage of time, a high-temperature divergence zone centered on the long longitudinal cracks gradually formed. Simply put, the mural body and wood keels located close to the eave columns would also significantly increase in heat with the long longitudinal cracks. This is partly the result of heat conduction via solid materials and partly the direct influence of outside air, which enters through the cavity between the GFRP backing and the red brick wall. Due to the temperature fluctuation in the divergence zone being far more dramatic than in other parts, the long transverse cracks (the most serious among the second category of secondary cracks) only appear near the eave columns and cross with the long longitudinal cracks. Moreover, the wood keel stripes gradually appeared only after noon, and began to fade away after sunset. This change seems to be synchronous on each part of the stripes, which suggests that the influence of the external environment on the mural is realized not only through the air channel at the eave column, but also the heat conduction via the eave wall. The influence of this heat conduction pathway is both milder and slower than it should be due to the effective buffering of the 1.2 m-thick eave wall.

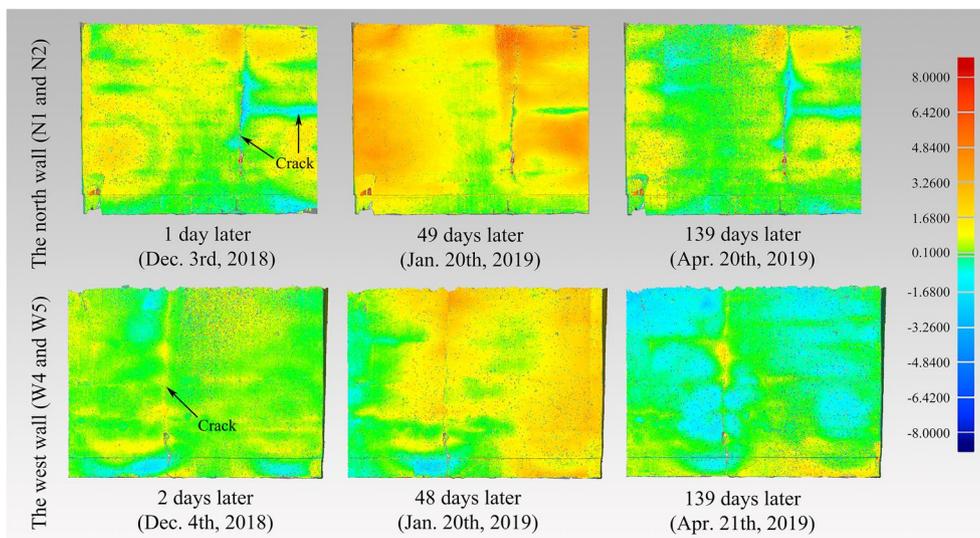
Fig. 11 Deviation chromatogram of the eave wall mural's surface deformation

The 3D scanning point cloud data of the north wall (N1–2) at 11:00 a.m. on December 2, 2018, and the west wall (W4–5) at 14:00 p.m. on December 2, 2018, were respectively packed into a grid model as a reference, and the other three 3D scanning point cloud data of the corresponding walls from December 2018 to April 2019 were compared with it (the deviation chromatogram was made as shown in Fig. 11). The different tonalities and color temperatures in the figure represent the direction and degree of deformation. We can see that the eave wall mural's surface deformation can be characterized by both integrity and locality. Among them, the deformation of the area near the longitudinal and transverse long cracks differs from the adjacent area, while the deformation of

the transverse short cracks groups in the unit are not immediately obvious. There are stripe areas parallel to each other in the unit, which seems to be consistent with the position of the horizontal wood keels. The deformation degree in the stripe areas is clearly smaller than in other areas, which could well be explained by the restriction of the horizontal wood keels and the GFRP fixture. The figure also depicts that the deformation phenomenon of block areas is by no means consistent, which can be interpreted as the non-uniform deformation restriction conditions inside the eave wall.

Generally speaking, the surface deformation of the mural in the two stages before and after January 2019 has a reverse trend, which corresponds to the changing atmospheric temperature (which first decreases, then rises) during this period, indicating that the deformation may be a cyclical process tied to temperature fluctuations. In addition to the chromatograms, this was also reflected in the 3D deviation values (see Table 2). Among them, the maximum deviations were all above 100 mm, which could be explained by cobwebs and hanging floccule in some positions on the surface of the mural being disturbed and displaced by external forces (a both random and accidental phenomenon). We cannot exclude the possibility that some other large deviation values are the result of this situation. The mean deviation values of the north and west walls are small, and both

rise before falling, indicating that small absolute deviation values may be related to the deformation caused by temperature changes. The standard deviation in the table is the error of mean squares calculated from the absolute deviation, and represents the dispersion of the absolute deviation values. We can see that the standard deviation of the north and west walls increases before remaining essentially unchanged. Combined with the change of the mean deviation, this could be due to the differentiation of the absolute deviation values in the second stage, which is to say that the smaller absolute deviation decreased while the larger absolute deviation further increased. The former corresponds to the cyclical process of the thermal stress deformation, while the latter seems congruous with the entropy increase process of the random displacement.

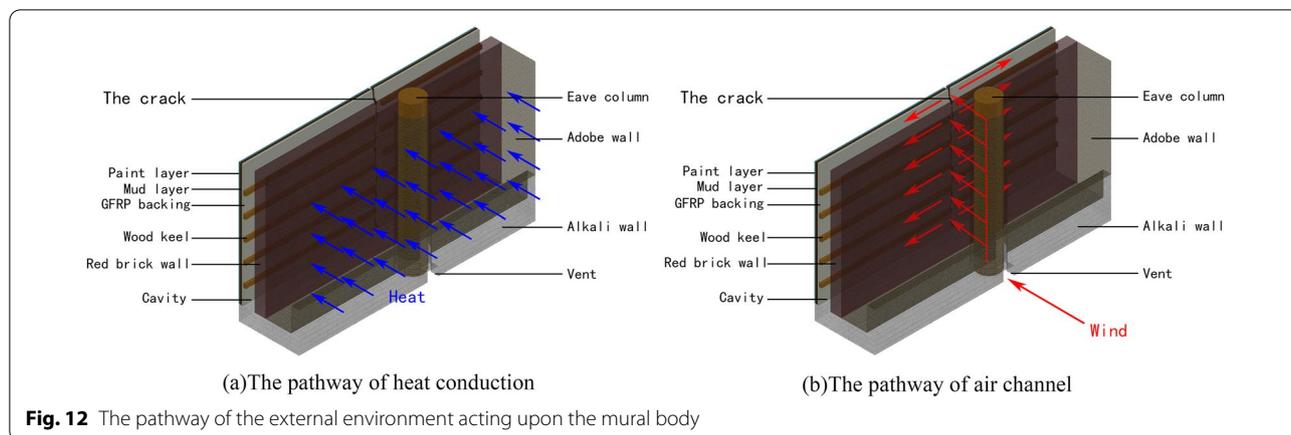
Fig. 12 The pathway of the external environment acting upon the mural body

cracks on the eave wall mural through its structural defects (Fig. 12):

- (1) The effects of the atmospheric temperature and relative humidity levels—as well as their dramatic fluctuations—can penetrate to the GFRP backing layer through the air channel at the eave column with the help of good air fluidity. This results in the GFRP deteriorating and deformation, making the stress release directionally along the end and edge of the wood keel under its restriction, thereby generating transverse and longitudinal long cracks near the eave column.
- (2) The external environment takes the eave wall as the medium to exchange heat with the mural body, generating both overall temperature stress inside the unit as well as local temperature stress at the edge of the wood keel. The former further promotes the shear failure at the eave column position, while the latter induces the formation of the parallel short crack groups between the horizontal wood keels.

The results clearly show that the deep influence of external environment and the non-uniformity of material reinforcement are the two major causes of the secondary cracks. Consequently, we can strongly recommend that these factors should be protected against in subsequent protective or restorative measures. Air channels should either be blocked or changed, and an insulation layer should be added to reduce the impact of the external environment on the mural body. Moreover, the backing and supporting materials should be removed in favor of those which have smaller rates of expansion and contraction. Lastly, the connection

between layers should be strengthened to offset the stress caused by differing restriction conditions.
