Typology, current state and non-destructive testing of timber roof trusses of historic churches in the West Vistula Delta, Poland

Tomasz Zybała^{1*}, Monika Zielińska¹, Magdalena Rucka^{2,3}, Jarosław Przewłócki¹ and Karol Grębowski¹

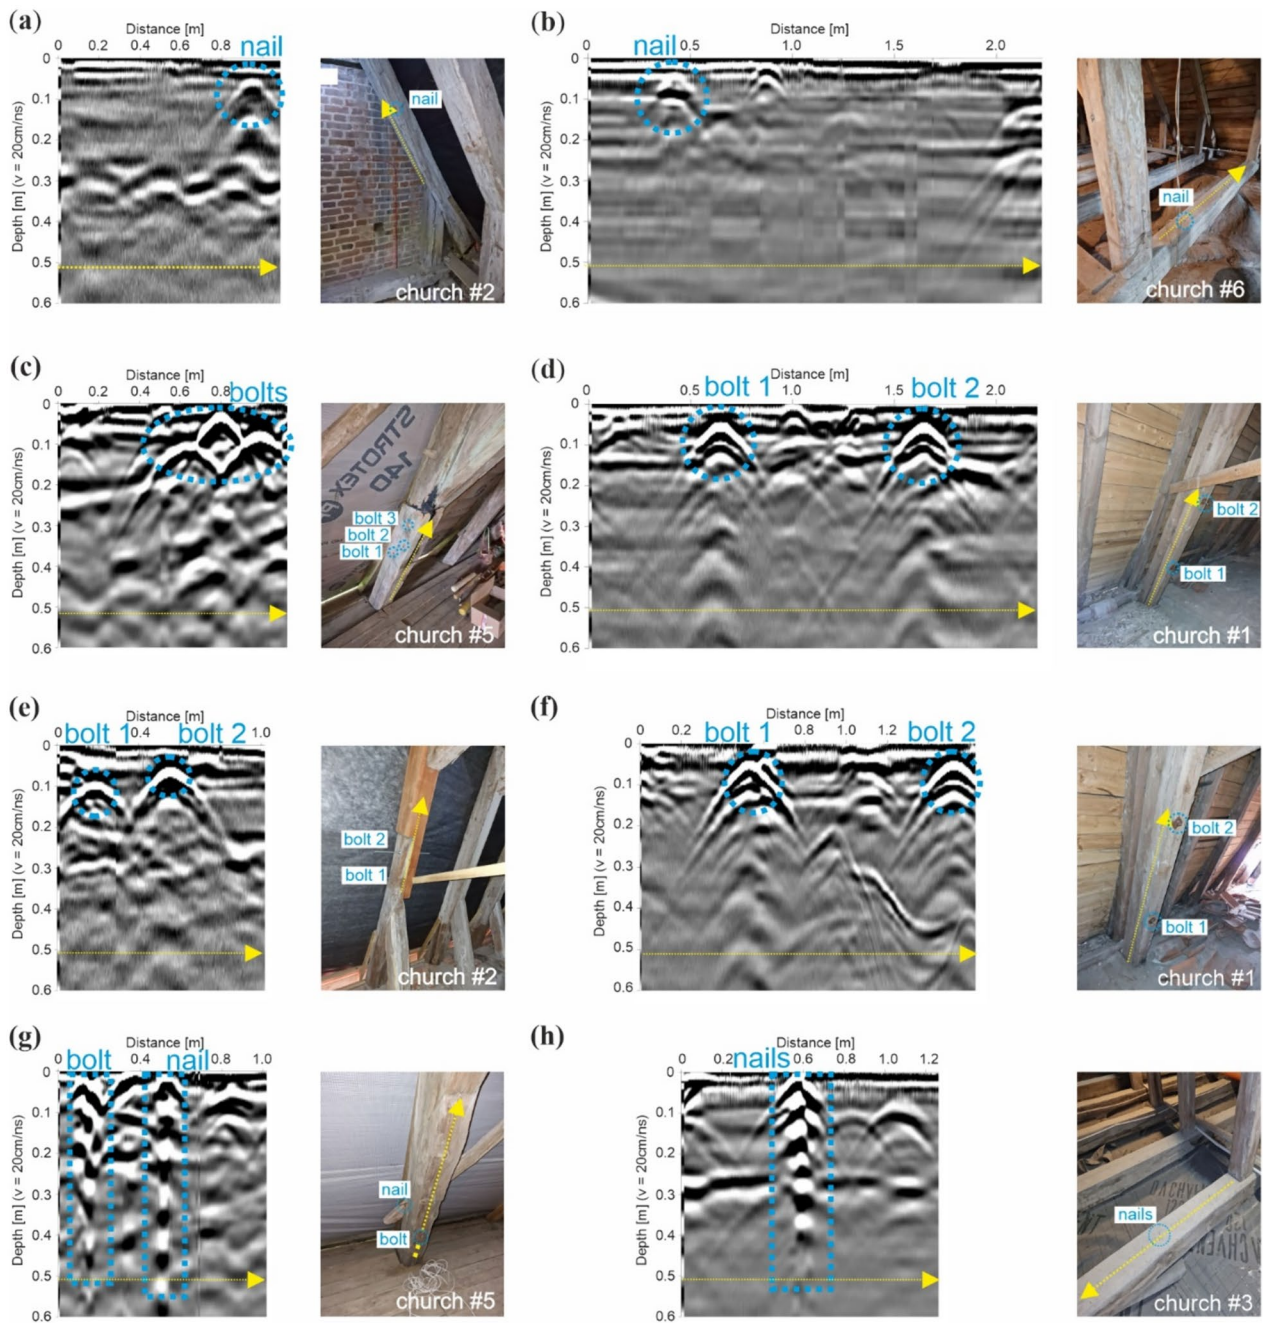
Fig. 8 GPR radagrams locating bolts and nails in timber beams a plane parallel (a–f) and perpendicular (g, h) to the moving GPR antenna

In the case of screws and nails, where the main axis is perpendicular to the direction of GPR movement, their location is marked on the B-scan in the form of several hyperbolas located one above the other (Fig. 8g, h). GPR

can therefore be used not only to locate a metal element but also to assess its orientation.

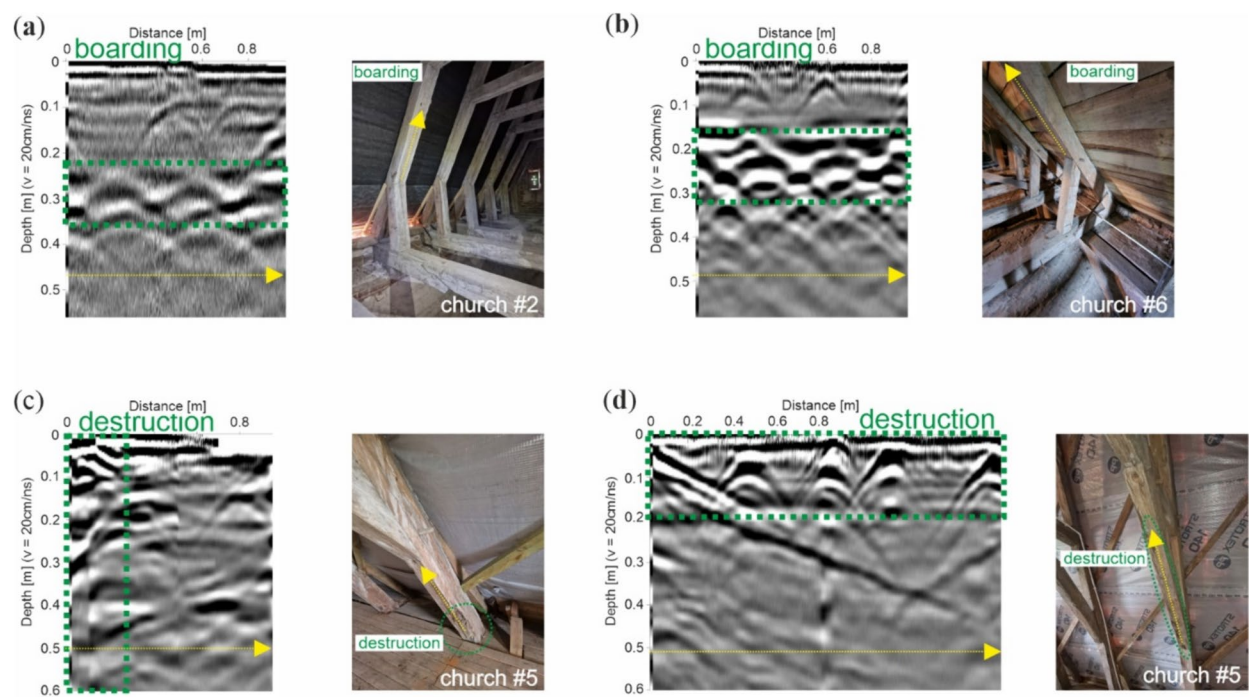
Fig. 10 GPR radagrams locating the boarding of the roof truss and decay of timber beams: **a**) Pruszcz Gdański I (#2); **b**) Trutnowy (#6); **c**) and **d**) Koźliny (#5)

The reflections from the boarding are also characteristic and they form a sequence of evenly spaced hyperbolas on the radargrams, indicating the locations of board joints (Fig. 10a, b). Damage to timber elements causes disturbances in GPR radargrams. Figure 10c shows a local failure on the lower part of the beam. The beam shown in Fig. 10d is completely and shallowly damaged, causing numerous reflections. Figure 11 shows beams from three different girders from the churches in Trutnowy, Pruszcz Gdański I, Kiezmark, and Koźliny, respectively which show varying degrees of destruction. The scans prepared for undamaged beams can be considered as reference. The reflections from the bottom of these beams are visible here, which allows the thickness of the element to be assessed. The scans prepared for the damaged beams indicate a significant disturbance in the propagation of electromagnetic waves. This demonstrates high sensitivity of the GPR method to any defect in a timber element. The reference scan is not always feasible, but it makes the interpretation of the results much easier.

- Damage and air voids in the timber beams affected the path of electromagnetic waves in the wood, causing severe distortions.
- Comparing the results for several beams made of the same material, being the same age, shape, dimensions and location allowed for a more accurate analysis of the technical condition of the tested beams. With the undamaged reference element, it was possible to

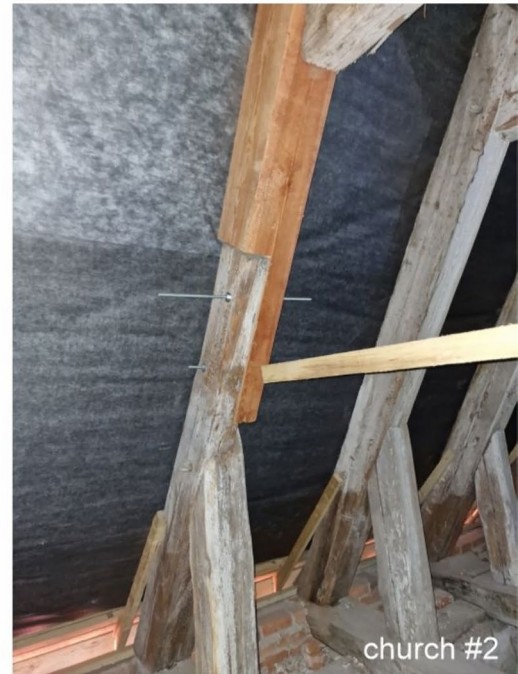
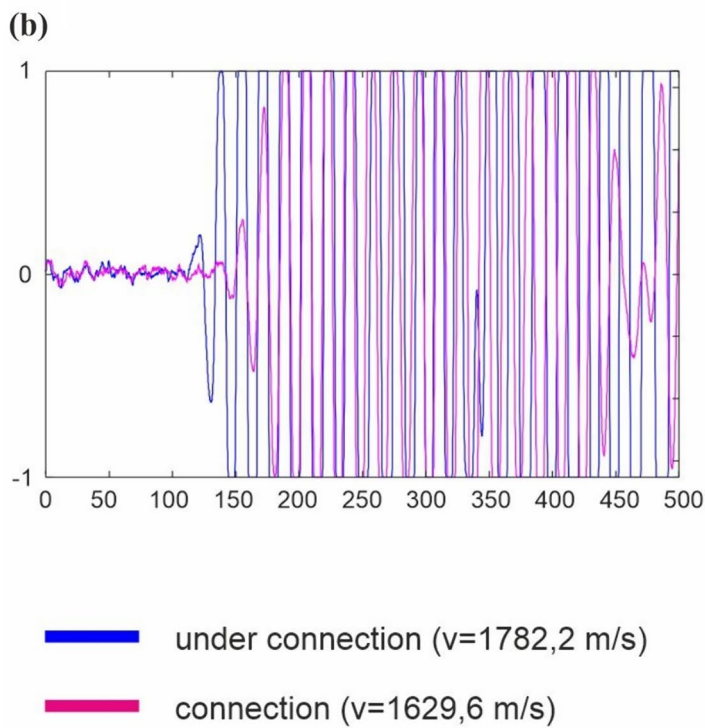
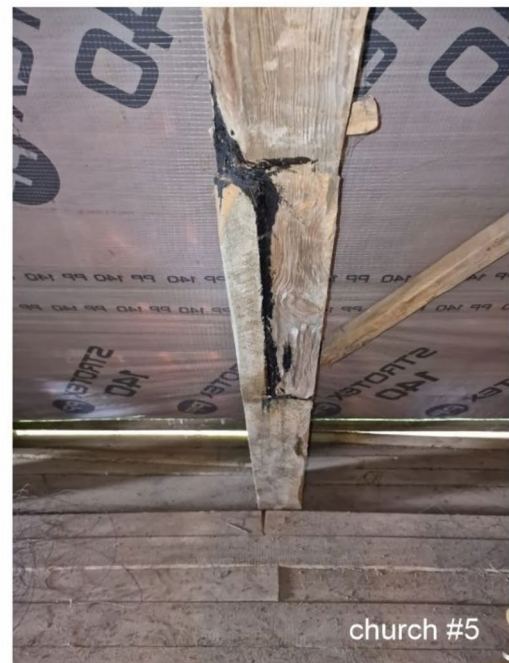
Fig. 13 Ultrasonic wave signals in wooden beam connections: **a)** Pruszcz Gdański I (#2); **b)** Koźliny (#5)

The ultrasonic wave signals propagating through the connections of the elements were analyzed. The measurements were made for straight overlap joints (Fig. 13). The first joint analyzed was in the church #2 and the second in the church #5. Both connections were bolted, and the second was additionally sealed with some adhesive. For the first analyzed joint, the measurements were taken at three levels: above the joint of the new beam, below the joint of the old beam, and at the level of the joint. The propagation velocities were 1589.4 m/s, 1632.7 m/s and 750 m/s, respectively. The signals obtained for the new

and old beams were similar. At the level of the connection, the signal weakened significantly and the propagation velocity decreased more than twofold. In the case of the second joint, where a sealing adhesive was used, the velocity of wave propagation decreased slightly from 1782.2 m/s for a full beam to 1629.6 m/s at the level of the connection. The results obtained prove high sensitivity of the ultrasonic method in the case of joints with air
