Conservation issues and chemical study of the causes of alteration of a part of the Stave Church in Hopperstad (Norway)

Marit Lehne^{1*}, Sara Mantellato², Asel Maria Aguilar Sanchez² and Francesco Caruso^{1,3}

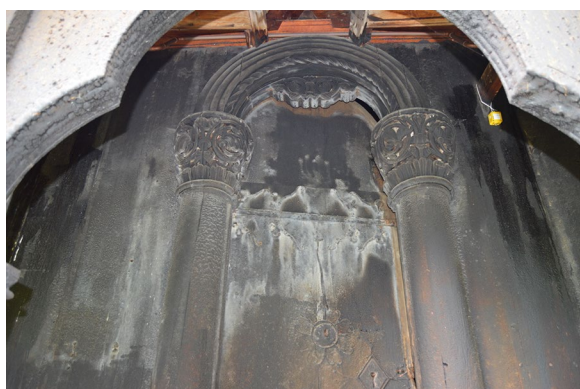
Hopperstad Stave Church suffers from several alteration and degradation problems, such as rot, leakage and distortion of the building construction and foundation, which have been documented over the past century. The most recent reports are authored by the Norwegian Directorate for Cultural Heritage (RA, *Riksantikvaren*) [3, 4]. Among the above-mentioned issues, one of the most peculiar is the formation of a white substance on the surface of localized areas of the church, both indoors and outdoors. The most affected area is the top part of the external southern door and portal of the church (both on the wood and metal) (Fig. 2).

This layer seems to be quite thick and to have a white crust-like appearance on the tarred surface. Besides, there are also some areas inside the church, on untarred wood, which are covered by a thin and powdery white

Fig. 2 The southern door and portal of Hopperstad Stave Church, partly covered by a white layer. A data logger, to monitor the temperature and RH, is visible in the upper right part of the picture

Based on this and due to the confined location of the substance on the southern side of the church, some potential causes and sources for the phenomenon could be excluded: microbiological growth, precipitation of pesticides, degradation products of tar, fertilizers and animal origin (bird droppings). It is believed that the source for the white substance is atmospheric. The white substance is harmful for neither visitors nor the environment. Although the layer has been present for several years on the church's surfaces, especially on the exterior, there were no signs of critical degradation of the church's materials, either on the wood or metal, which could be directly linked to the presence of the white layer. It is not believed that the substance poses an immediate threat to the building materials, but concerns are raised for how it can potentially change in the future and possibly inflict damage on the materials in the long term. The layer has an aesthetical displeasing appearance on the exterior door and portal, and for that reason, removal of the layer should be considered.

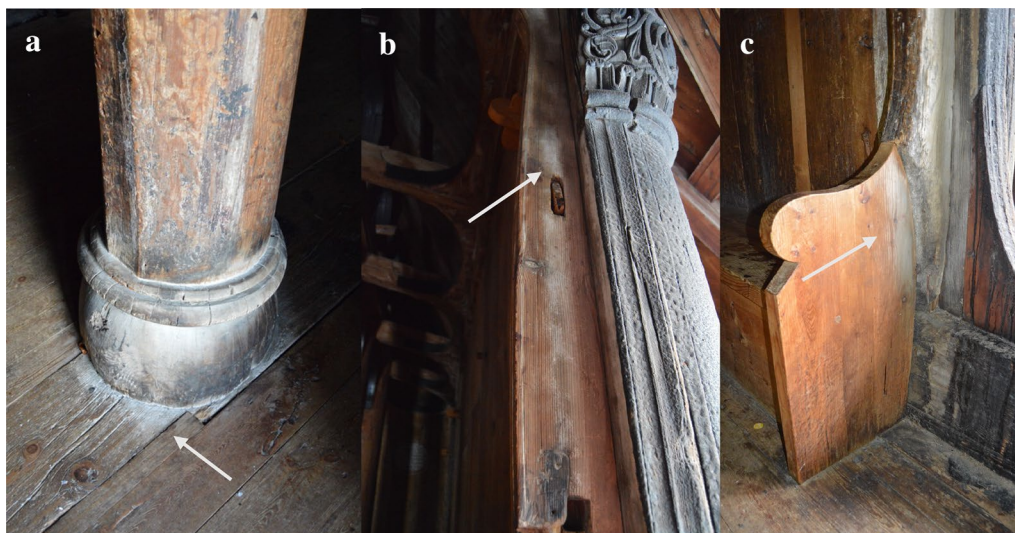
layer (Fig. 3), showing a different appearance in texture, spread and amount of substance with respect to the layer on the tarred surface.

Fig. 3 The stave base and floor of Hopperstad Stave Church with a white layer (image a), indicated by a white arrow. The white layers on the crossbar and bench in images b and c are also indicated by white arrows

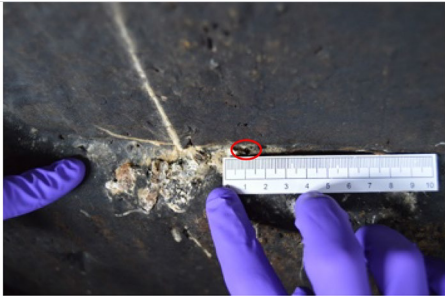
Name of sample	Description	Picture
M1 Bird droppings, outside	Taken from accumulation of bird droppings on an edge on the outside wall, left of the southern entrance

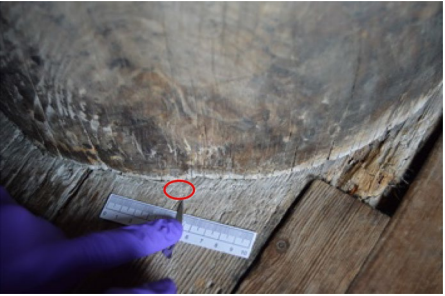
M2 Floor, inside	Taken from the floor close to the stave base, in the nearby of the southern entrance

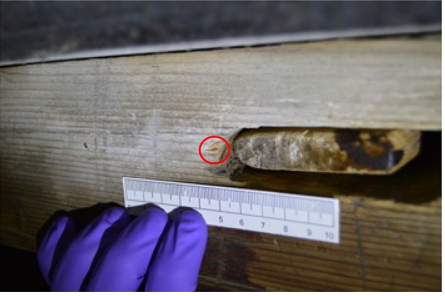
M3 Crossbar, inside	Taken from above the crossbar

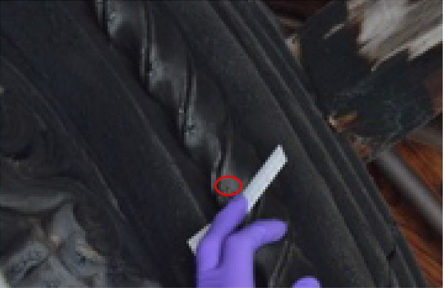
M4 Portal, outside	Taken from the southern portal, on the right side, above the entrance on the carvings (spiral decoration)

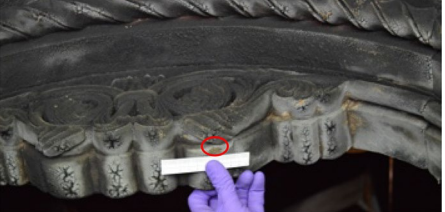
M5 Portal, outside	Taken from the middle of the southern portal, above the entrance

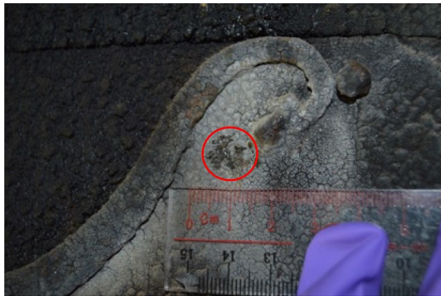
Name of sample	Description	Picture
M6 Door, outside	Taken from the southern door, below a wrought iron decoration

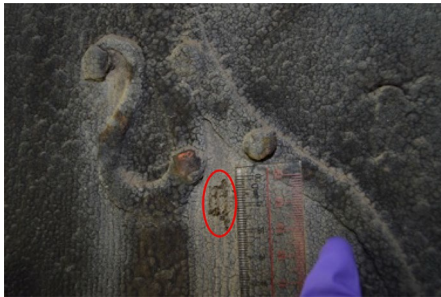
M7 Door, outside	Taken from the southern door, below a wrought iron decoration

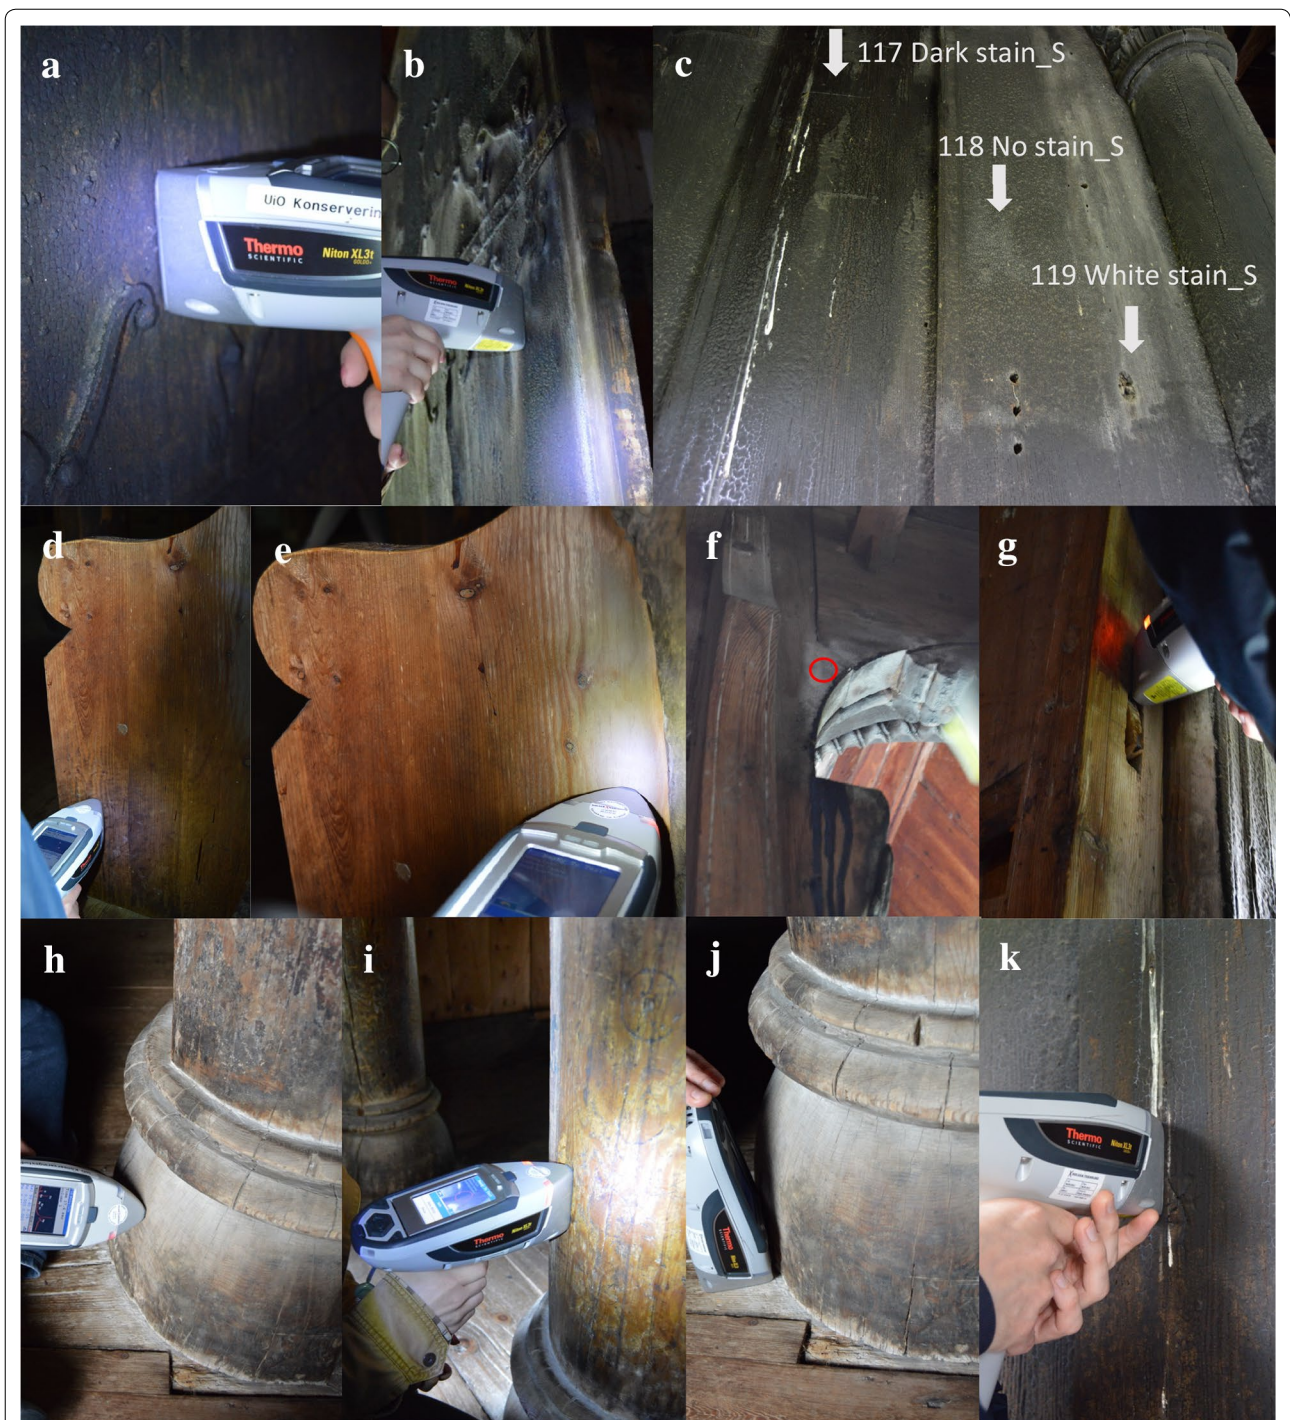
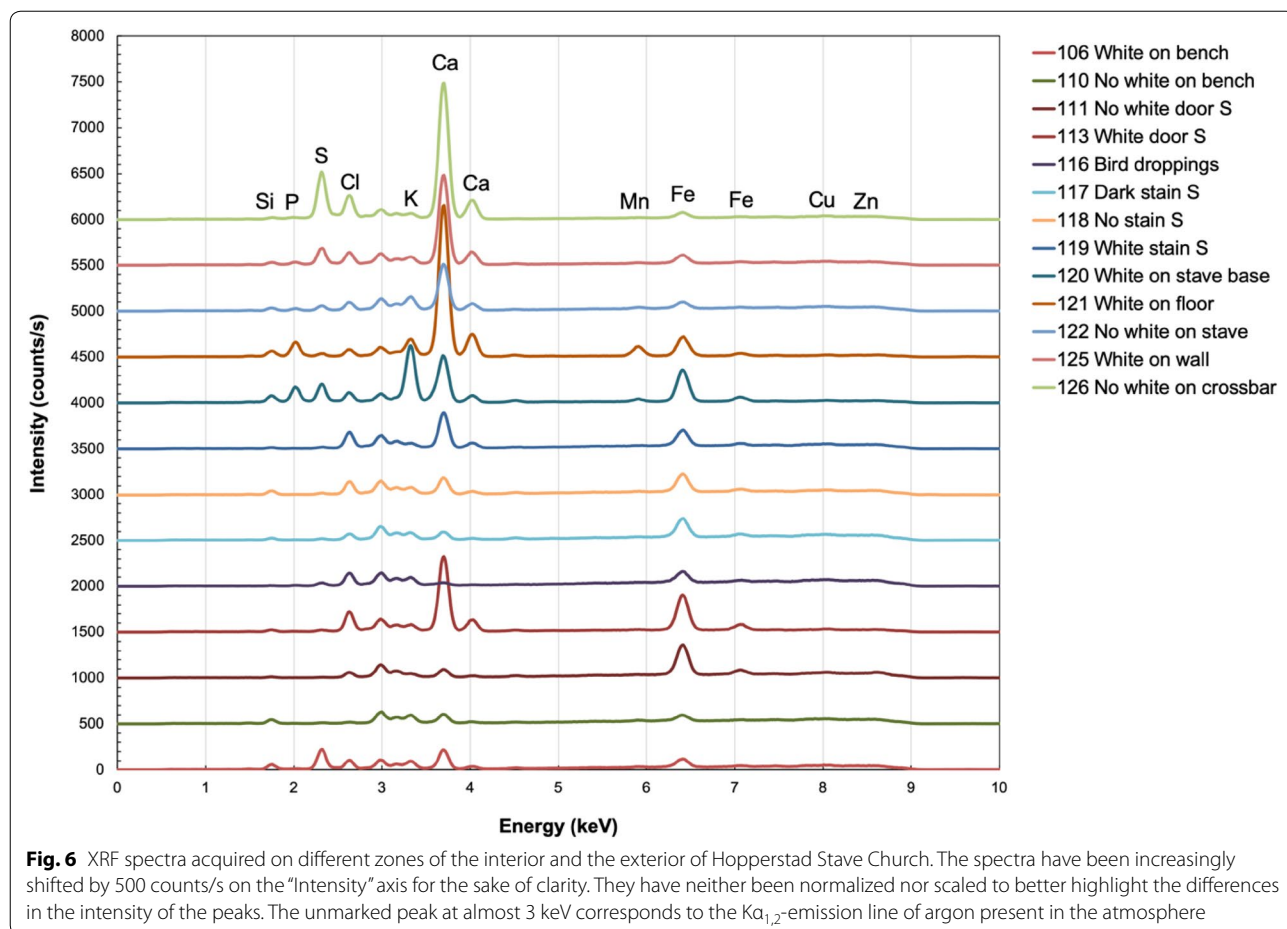
Particular attention should be given to the presence of chlorine in the spectra of the white surfaces acquired on the southern exterior side of the church (i.e., measurements 113 and 119). The intensity of chlorine peaks decreased similarly to the calcium ones. This could indicate the presence of calcium chloride, CaCl_2 . However, calcium chloride is also very water soluble and is not likely the origin of the white layer, since the salt would have been dissolved at the high recorded RH values (deliquescence humidity of CaCl_2 at 0 °C: 44.3%) [12].

Intense sulfur peaks were observed in the spectra from measurements 106, 120, 125 and 126. The peaks in these spectra are correlated with strong calcium ones, thus pointing to the possible presence of calcium sulfate (CaSO_4). This is also a white powdery material, commonly known as gypsum ($\text{CaSO}_4 \cdot 2\text{H}_2\text{O}$) when hydrated. However, gypsum has a relatively low

Fig. 5 Locations of the XRF measurements. **a** Measurement 111 with no white substance and **b** measurement 113 with white substance were taken on the southern exterior door. **c** Measurements 117, 118 and 119 (marked with white arrows) on the exterior wall left of the southern entrance with staining. **d** Measurement 110 with no white substance and **e** measurement 106 with white substance were taken on the bench inside the church. **f** Measurement 125 was taken on the white substance on the wall by the entrance (marked with a red circle). **g** Measurement 126 was taken on the white substance on the crossbar. **h** Measurement 120 was taken on the stave base with a white substance. **i** Measurement 122 was taken on the stave without a white substance and **j** Measurement 121 was taken on the floor with a white substance. **k** Measurement 116 was taken on the bird droppings

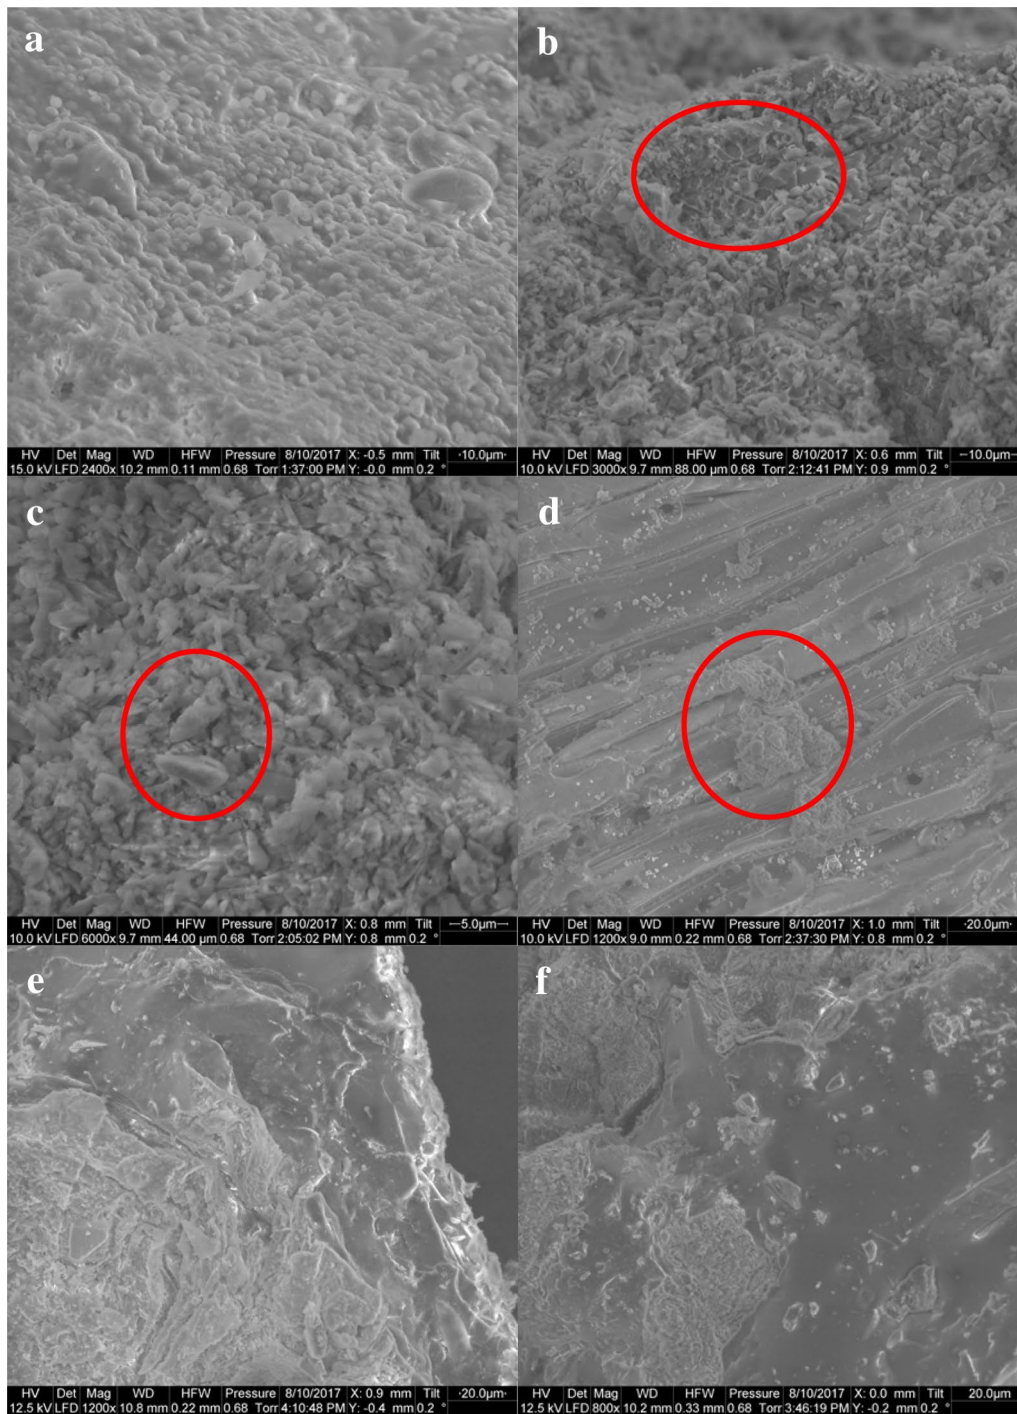
It was possible to observe some crystalline structures in the SEM images of the sample fragments with a white layer from Hopperstad Stave Church. The shapes of the crystals in some of the micrographs could correspond to those of calcite, for instance, the crystals on the samples from the floor and crossbar (Fig. 7b–d) inside the church. The micrographs of the samples with a white layer were substantially different from the ones of the bird dropping sample (Fig. 7a). The whole surface of the studied bird dropping sample had rounded formations, which indicate organic material. Similar rounded formations were only

Fig. 7 SEM micrograph of the bird dropping sample (a), from the floor (b, c), crossbar (d), the southern exterior door (e) and the portal above the southern entrance (f). The flake-like structures are marked in b and the triangular crystals are marked in c. A cluster that could be a mixture of organic and inorganic particles is marked in d

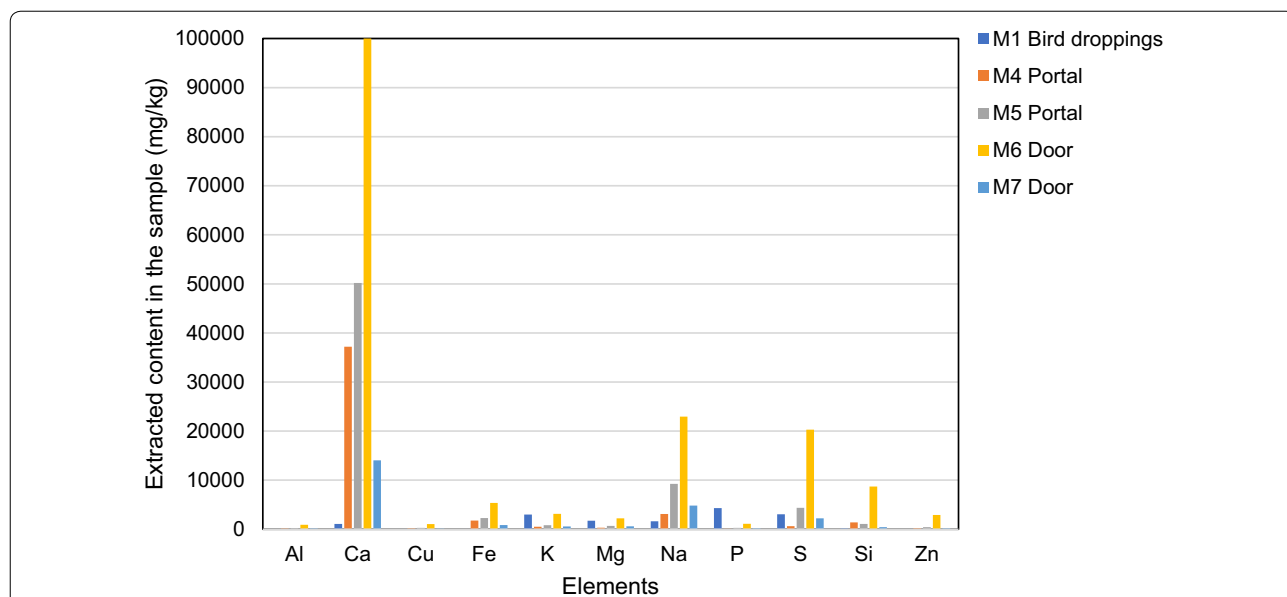
Sample M6, from the exterior southern door, had a significantly higher amount of calcium than the rest of the samples. As seen in Fig. 8, it actually exceeded the possible amount in solution. It had, in fact, a higher amount of all the elements than the other samples with white layer. The amount of calcium was higher than the mass of the samples, which comes from the very high uncertainty on the weighed mass. In fact, it was not even possible to weigh some of the taken samples (due to their extremely low mass and/or electrostatic interaction). This is the reason why the standard deviations were not plotted.

Fig. 8 Extracted content of each element in samples M1 and M4–M7. All the samples from the white substance have a high amount of calcium. The bird dropping sample, M1, has a higher amount of phosphorus than the other samples. Sample M6, from the exterior door, has a higher amount of all the elements, compared to the other samples with white layer

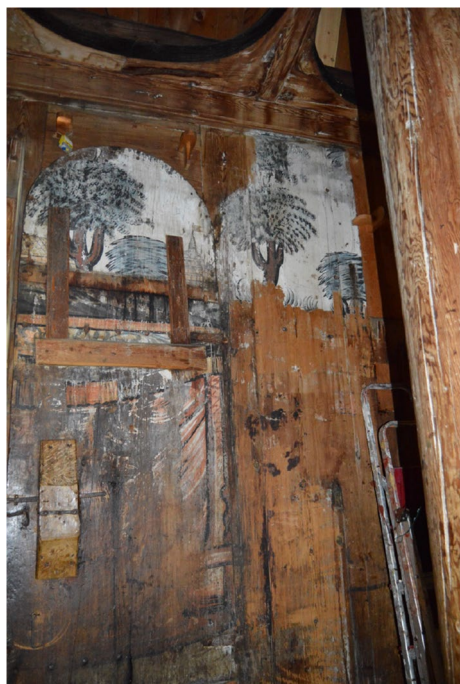
Fig. 11 Glue paint on the interior of the southern door and wall
