The *Samuel F. B. Morse* statue in Central Park: scientific study and laser cleaning of a 19th-century American outdoor bronze monument

Abstract

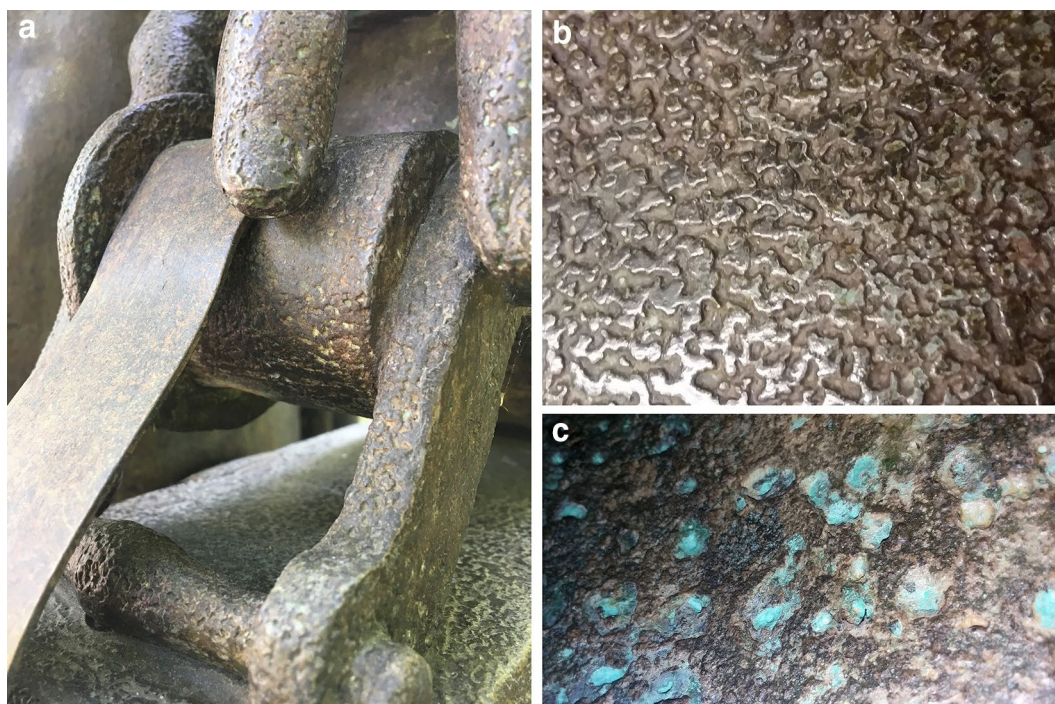
The exposed surfaces have remained stable since being regularly treated with cleaning interventions and protective coatings beginning in the 1990s. However, localized patches of virulent, irregularly shaped pustules of active corrosion were contributing to progressive surface loss (Fig. 3a) and associated coating failure (Fig. 3b) in the deep recesses of the figure's long cloak. The surfaces within the recesses are so well protected that they do not benefit from washing during typical rain events or associated run off. Morse's sculptural geometry may explain the localization of corrosion phenomena in those recessed and protected locations where elevated chloride concentration accelerates surface loss [18]. The aged and degraded coating was otherwise admitting moisture and corrosive agents directly onto the bronze substrate, and was no longer providing adequate protection to the sculpture.

Fig. 2 Condition issues observed on the Morse sculpture (I). Photographs showing (a) a detail of sculptural surface loss, (b) typical pitting and loss pattern on exposed surfaces, and (c) a detail of active corrosion present in the recessed areas

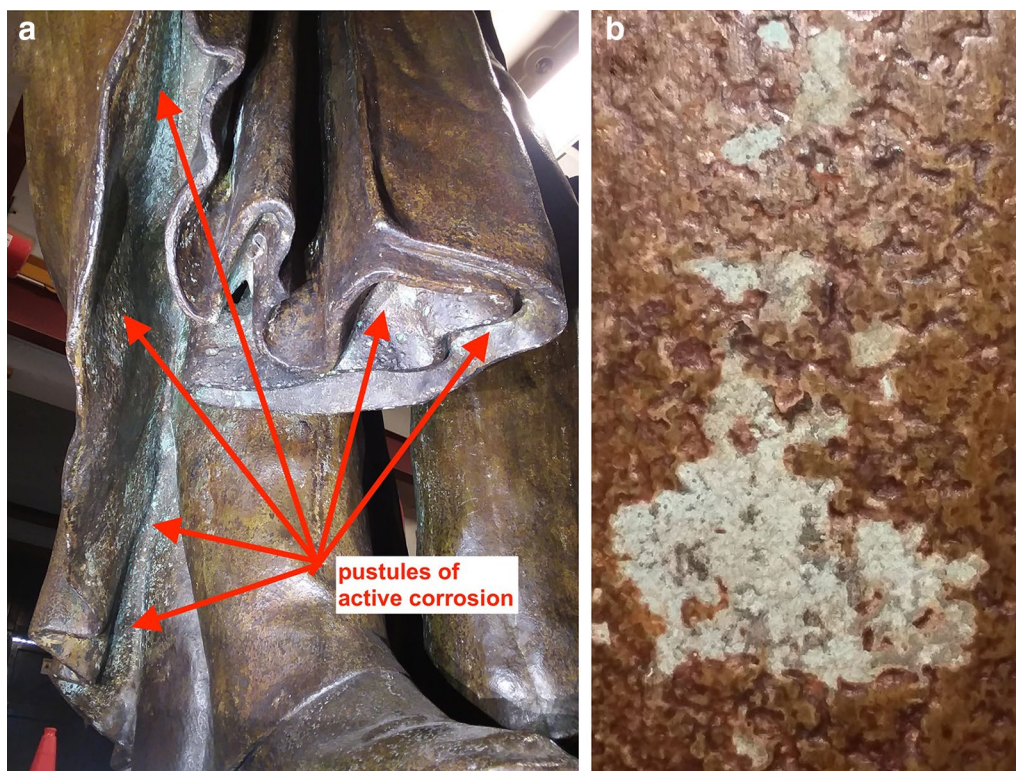
Fig. 3 Condition issues observed on the Morse sculpture (II). Photographs showing (a) the extent of active corrosion in the protected recesses of the figure's long coat, and (b) a detail of toned coating failure and underlying patina

Laser cleaning equipment The goals of laser cleaning were to safely remove the degraded lacquer coating and the active corrosion condition from the recessed surfaces of the figure's long coat. Cleaning was accomplished using a GC-1 laser cleaning equipment manufactured by G. C. Laser Systems Inc. of Chicago, Illinois. This system, equipped with solid state, air-cooled 1064-nm wavelength laser, was selected for its precision, relative speed and safety, environmental consciousness, and tuning capability that optimizes cleaning and limits the potential for damage. In the recent past, lasers' scan patterns had been limited to a minute spot and/or a horizontally orientated line. The GC-1 laser employs a new and unique handheld, circular scanning pattern, which emits pulses through fiber optic to a surface being cleaned in a circular, rotating pattern. A helpful description and illustration of the new scan pattern technology is provided by Dajnowski and Dajnowski [15]. The GC-1 laser is unique in that it exploits tunable settings, a relatively recent innovation in the conservation of art. Among these tunable operating parameters are pulse energy (0–1 mJ), revolutions per minute of the circular scanning pattern (3000–12,000 RPM), pulse frequency (1 kHz–1 MHz), and pulse duration (10–520 ns). The latter has been shown to be the most crucial setting; when optimized, longer pulse duration improves selectivity and precision in cleaning and controls photothermal and photomechanical shock due to lower peak energy delivered at a certain range of fluence (energy delivered per unit area) [5, 16]. Preliminary tests were performed on the sculpture by consulting conservators with G. C. Laser Systems Inc., including the equipment's developer. Their extensive previous experience in removing lacquer coatings and corrosion on historic figurative bronzes was key to establish the appropriateness of the methodology and operating parameters for the treatment [3, 17]. A class 4 laser safety area (LSA) with ample site controls and warning signage was configured inside Central Park's conservation workshop. Two overhead hoists permitted the over 1500-lbs (680-kg) figure to be laid down and manipulated during treatment, providing access to recessed surfaces for optimal laser cleaning and outfitting with new bronze mounting hardware for reinstallation on its granite base. The LSA consisted of a 12' H \times 18' L \times 12' D (about 3.66 m \times 5.49 m \times 3.66 m) opaque, curtained enclosure to prevent accidental viewing from outside during laser operation. A Nederman modular gas and vapor carbon filtration system, outfitted with a #12603461 replacement filter and a 1.5 HP NIB 2001 model blower/fan run on 110 V AC, was used to capture fumes generated by the ablated materials. The handheld laser unit is provided

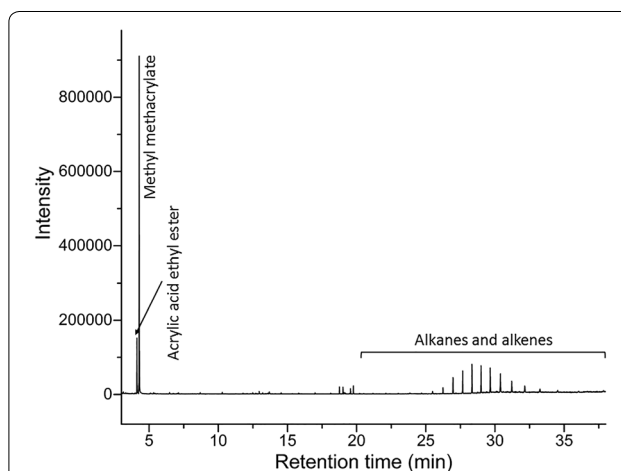
of alkanes organized in a specific distribution that is characteristic of mineral waxes (Fig. 4). From a conservation perspective, mineral waxes are known for having a limited lifetime, ranging from 2 to 5 years, and for being reversible [19]. Bronzes coated with wax are easily cleaned with water, which makes wax suitable for a low cost and low maintenance application. However, the sample examined was found to contain also high relative amounts of acrylics, mostly methyl methacrylate and acrylic acid ethyl ester. The presence of these compounds is consistent with the use of Inctalac® [20], which is, in fact, a product commonly used in the past and reported to have been applied to the Morse statue in the early 1990s according to the available conservation records [21]. Acrylic coatings have a longer lifetime compared to mineral waxes, and they also show good reversibility properties [19]. Acrylic lacquers are coupled with a sacrificial wax topcoat that is renewed yearly in the case of Morse. Since 2003, two types of cyclically renewable wax topcoats have been used by CPC's conservators: (1) Boston Polish™, also known as “butchers” paste wax, a carnauba-based wax, in use from 2003 to 2006; (2) Renaissance microcrystalline wax™, a mixture of Cosmoloid H80 and BASF A wax [22, 23], used from 2007 to

Fig. 4 Py-GC/MS chromatogram of sample S3 (organic coatings). Py-GC/MS chromatogram obtained upon derivatization with TMAH of sample S3, i.e. a scraping of the organic coatings. Compounds identified in the chromatogram indicate the presence of mineral wax and acrylics

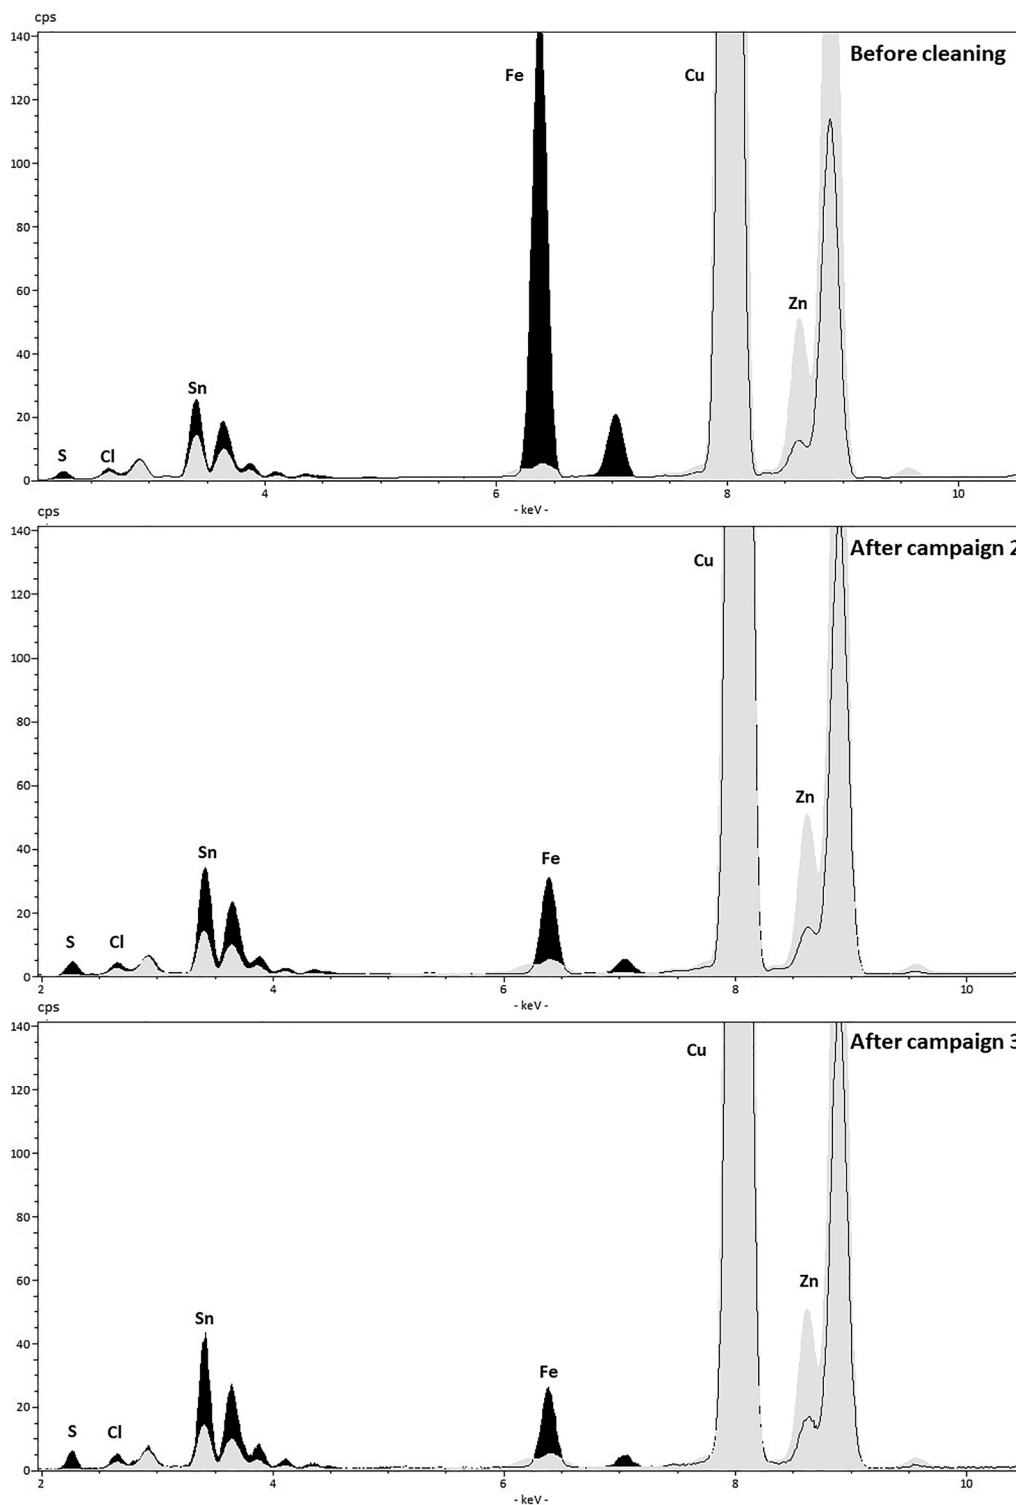
Fig. 5 XRF spectra acquired to monitor the laser cleaning. Examples of XRF spectra collected from the Morse statue before laser cleaning (pXRF campaign 1; black pattern) and during laser cleaning (pXRF campaigns 2 and 3; black pattern). A reference spectrum acquired from an area of bare metal (gray pattern) is also reported in each graph for comparison. The data shows a progressive decrease in the intensity of the iron peak after subsequent treatment phases

Following the initial phase of the cleaning, pXRF measurements showed relatively high levels of iron in all the spots analyzed, with the exception of a reference reading collected from an area of bare metal. Iron tends to decrease from measurements acquired during pXRF campaign 1 to those recorded in campaign 2, while it is found in trace amounts on the uncoated bronze (Fig. 5). This likely indicates that the occurrence of this element might be limited to the superficial organic coating, and, therefore, associated with the presence of iron oxide/hydroxide pigments in such coating, as mentioned earlier. Minor amounts of lead were also detected on locations yet to be cleaned, with a noticeable decrease in

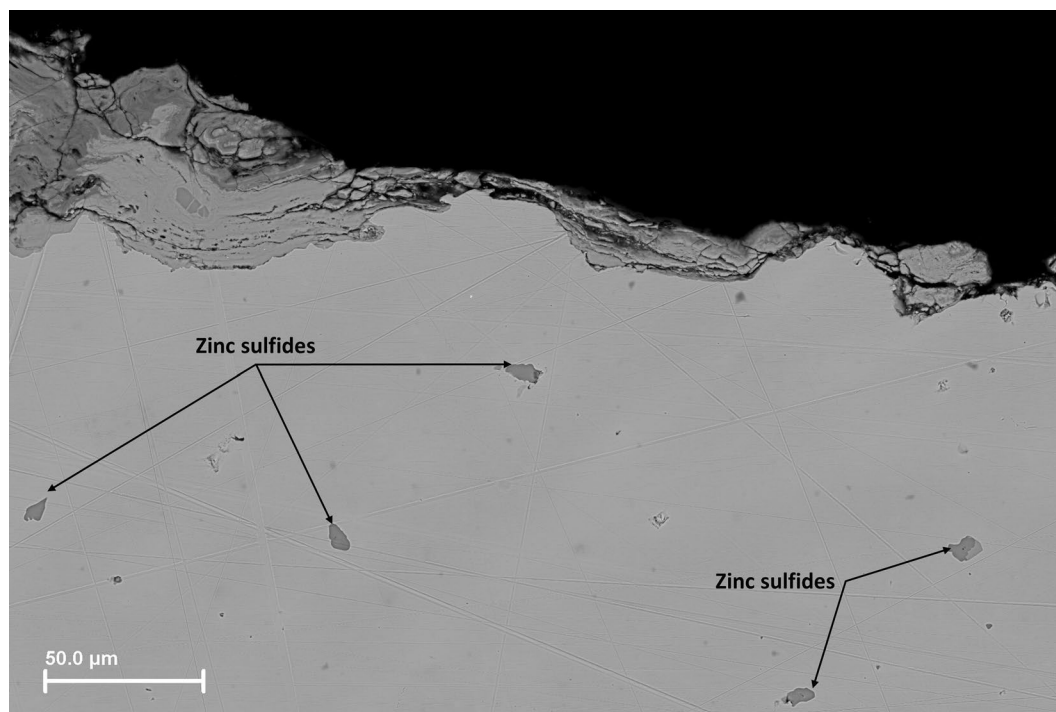
EDS analysis showed the additional presence, in the sculpture’s ternary alloy, of small particles of less than 10 μm in size, with irregular shapes, scattered throughout the metal matrix, which were identified as zinc sulfides (Fig. 8). These compounds appear to be sometimes

associated with copper sulfides. Exact compositions of both zinc and copper sulfides are reported in Table 2. Regarding the pitting phenomenon also observed in the Morse sculpture, one must consider that the presence of pits in copper-based alloys is often related to the dezincification of the alloy [28]. Here, however, this hypothesis is unlikely, as red brass displays less of a proclivity for this type of deterioration than other alloys, in particular when protected by a thin layer of copper oxides, such as cuprite [32]. In the present case, analysis of the corrosion layers shows a clear transition from an underlying cuprite-based layer to a more superficial region that is mostly composed of copper sulfates, as indicated in Fig. 7. The first corrosion layer observed (layer 2, Fig. 7), showing red in the optical microscopy image, was found to be mainly composed of cuprite and enriched in tin. A second corrosion layer (layer 3, Fig. 7) above that, appearing green under polarized light, is characterized by the presence of copper sulfates and is richer in tin than layer 2. Traces of an additional, very thin, green corrosion layer (layer 4, Fig. 7), which contains a mixture of copper chlorides

Fig. 8 BSE image of zinc sulfides in sample S12 (metal alloy and corrosion products). BSE image of a portion of cross section S12, showing the presence of sparse zinc sulfide inclusions in the metal alloy

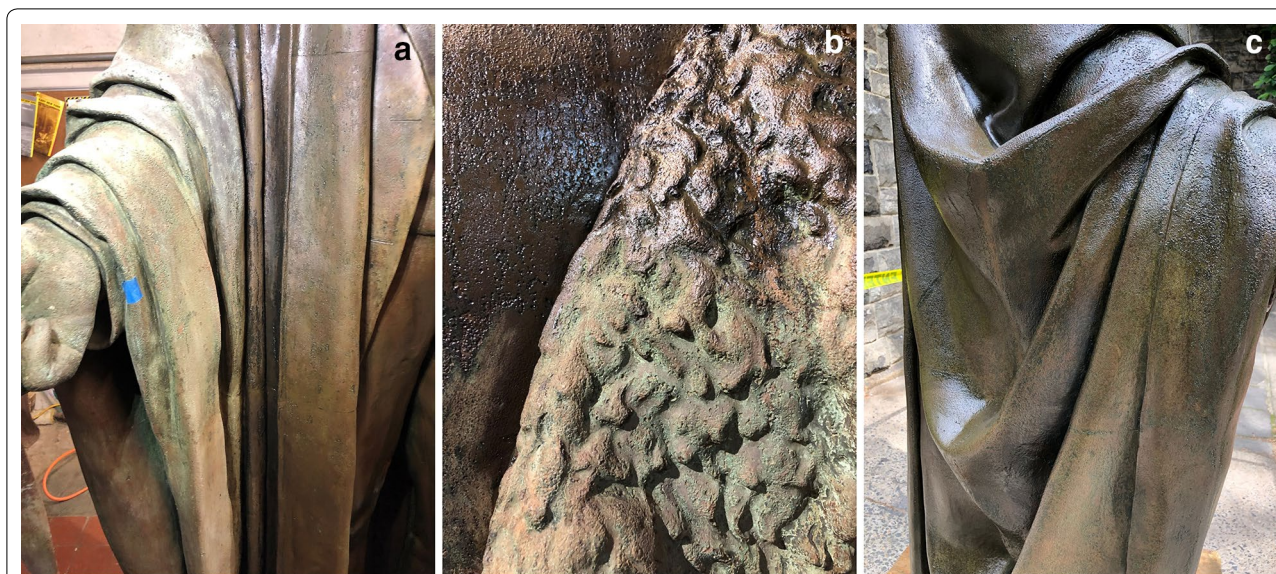
Fig. 9 Application of new coating. **a, b** Details of the Morse statue photographed during the application of the new lacquer coating, including coated and uncoated areas. It is worth noting the contrast between the portion already brushed and the bare surface. **c** Final visual effect upon application of the new coating over the green patina, upon drying

In terms of coloration, a selective application of cupric nitrate and cupric chloride patina solutions to achieve a range of green, and of ammonium sulfate for darker brown in the recesses of the long coat, was used to blend and unify tone and to enhance legibility of the sculptural forms. Finally, a translucent, warm brown coating that established a contiguous protective film and accentuated nuances of the underlying greenish patina was applied as the new finish (Fig. 9). To produce the desired effect, a small sample of the previous coating had been retained on the figure's long coat for matching in situ. Swatches of toned lacquer were applied beside it to approximate the tone and translucency. Members of New York City Design Commission's Conservation Advisory Group (CAG) reviewed the mock-ups and approved of a sample, which was sent to the manufacturer for matching using a BYK Instruments colorimeter (catalog #6830). The identification of iron-containing pigments to color the lacquer finish guided the decision of applying a new coating containing the same type of coloring materials. The Conservancy emphasizes environmental excellence in its management and operations and, hence, a coating product with proven performance that was in alignment with the organization's mission was required [35]. Such lacquer, selected from Nikolas Coatings of Chicago, Illinois, is a low volatile organic compound (VOC) anti-corrosion base mixture that was custom matched and renamed for this project (#15794 Morse brown toner RFU; 317.13 g/L VOCs). Increased VOCs are associated with harmful effects from ground-level ozone and their reduction is a public health benefit [36]. The solvent-borne coating is a chemical mixture of parachlorobenzotrifluoride 50–60%, acetone 20–30%, diisobutyl ketone 1–5%, xylenes (*o*-, *m*-, *p*-isomers) 1–5%, and ethyl alcohol 0.10–1% by weight concentration; with solids content of 5–10% acrylic resin (proprietary), and iron oxide pigment admixture of 3–5% yellow #42, 0.01–0.05% red #101, and 1–3% standard carbon black. BTA is added into the coating mixture 3% by weight. The new toned lacquer achieved various project goals including obtaining the desired visual nuance

for the finish, and the iron contained in it may increase electrical resistance, supplement barrier properties, and provide additional corrosion protection to the bronze [37]. The solvent-borne coating was thinned and brush-applied twice overall to assure penetration into the pitted texture of the Morse sculpture and to obtain complete coverage in deep recesses and undercuts. Three subsequent applications with a high volume–low pressure (HVLP) sprayer completed the coating.
