Studying a 2 millennia old bronze kettle using easily accessible characterization techniques

Marta Kotlar¹, Nives Matijaković Mlinarić², Vladan Desnica³ and Katarina Marušić^{4*}

Abstract

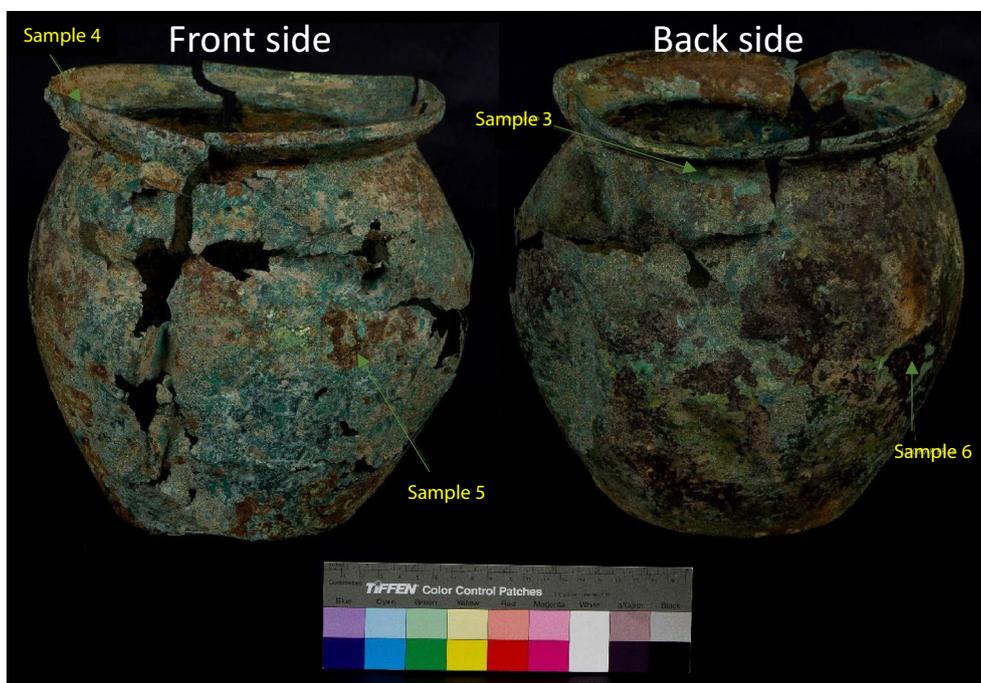
Fig. 1 Image of the bronze kettle and the surface layers' sampling positions

When the kettle was received at the Workshop for restoration treatment it was in a very bad condition and covered with various corrosion products and remains of sand trapped in the corrosion products. According to the museum inventory form the kettle is made by the embossing technique. No X-ray radiography or cross-sectional study was possible, thus after visual examination, six samples were taken from the kettle for further analysis. Two samples were fragments of the kettle which broke off while manipulating the object due to its poor condition and metal fatigue of the thin bronze sheet. Since both samples were observed as metal core, they could be used for determining the composition of the alloy the object is made from. They were covered with corrosion products and analysed as Samples 1 and 2. Four samples (named Samples 3 to 6) were taken from the surface of the object as presented in Fig. 1. Each sample seemed to have a different surface layer based on the difference in colour and structure. These samples were scratched from the surface using scalpel during mechanical cleaning in conservation interventions.

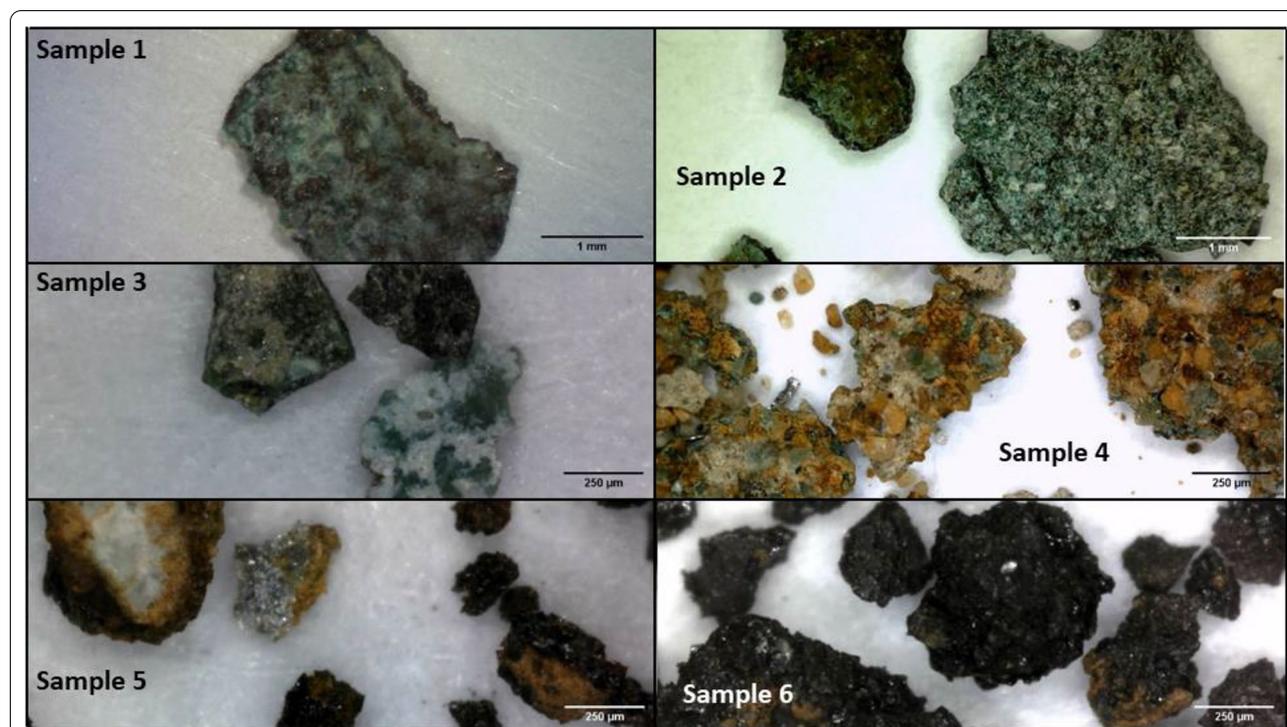
Fig. 2 Images of the examined samples taken by a digital microscope: Samples 1 and 2 which are fragments under 60x and the rest of the samples under 240x magnification

Figure 2 presents the images of the studied surface samples taken by a digital microscope. The most prevalent corrosion product was greenish in colour. It was observed on various samples, most expressed on Sample 3. Also, on the surface of the object, some other impurities have been trapped in corrosion products and accumulation of materials like sludge stones was observed. Other black, brown, white-yellow and blue layers were also visible on the surface. Some of them covered the surface of the green areas, while some were close to the surface of the metal and degraded the metal until they made holes in the material itself. During removal of the layers, it was observed that the black layers (Sample 6) were partially diluted in distilled water and 96% ethanol. They were easily removed by mechanical cleaning with a scalpel. Below the black layers was a layer of green corrosion products. The brown products (Samples 4 and 5) strongly adhered to the substrate itself. Under the brown layers, green products existed only in traces and did not have such a uniformly covered surface as was the case under the black layers. The yellow-white layers observed on Sample 4 were powdery and below them there was a layer of partially formed green corrosion products, while

in other places a very thin layer of reddish-brown layers was observed.

Sample 4 has a blackish colour, as can be seen in Fig. 2. The main colour is not green/blue pigmented, so it is expected that this sample is not a sample where copper corrosion products prevail. The SEM image obtained on Sample 4 is presented in Fig. 7. It shows presence of two different structures pointed by numbers 1 and 2. The structure in Point 1 has a rougher structure, while the structure in Point 2 is smoother. EDS analysis were performed in these two points and the results are also

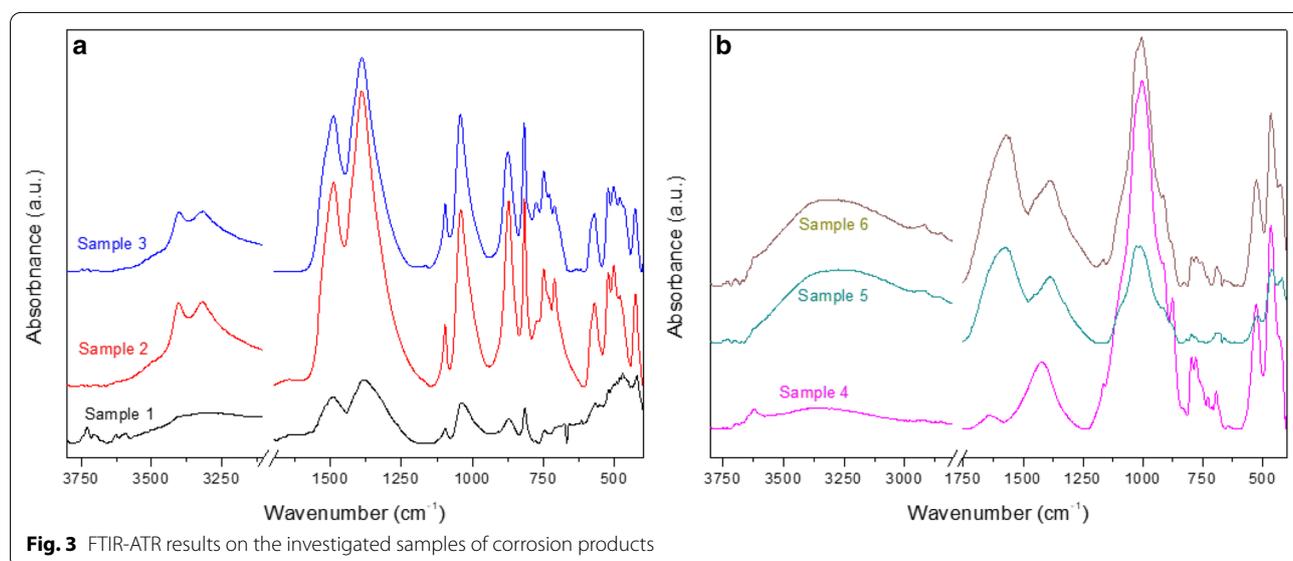
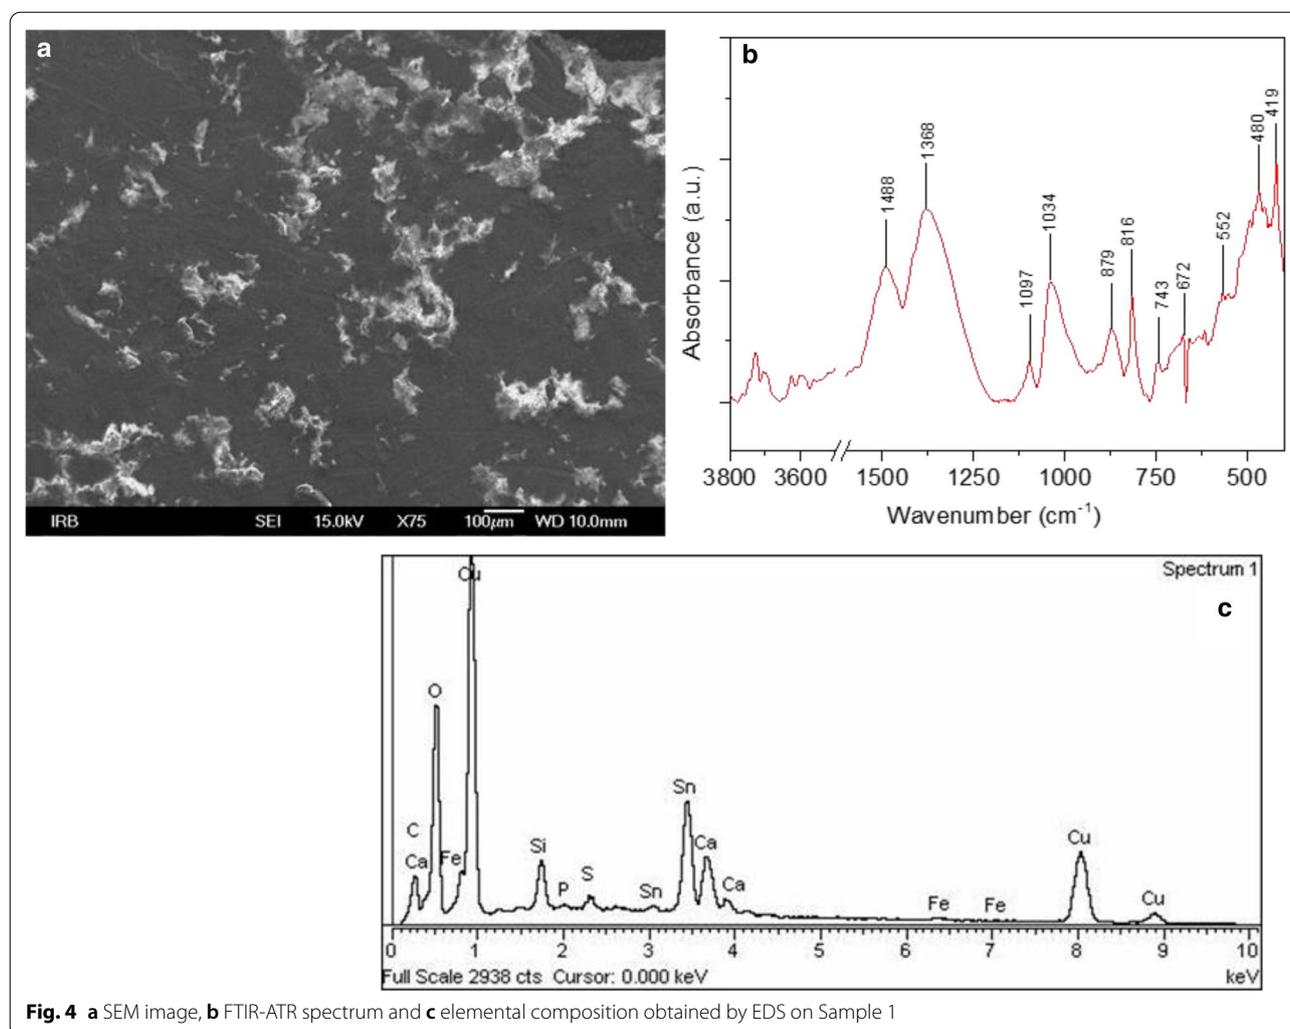
Fig. 4 a SEM image, b FTIR-ATR spectrum and c elemental composition obtained by EDS on Sample 1

Sample 1 shows a predominantly greenish surface as can be seen in Fig. 2. SEM analysis of Sample 1 showed a unified structure, while EDS showed a unified composition presented in Fig. 4.

The EDS results show a significant amount of carbon. As explained earlier presence of a form of calcium carbonate is expected. Also presence of malachite, a green carbonate-based corrosion product on copper-based objects buried in a riverbed is common because the environment may be rich in oxygen as well as carbonate/bicarbonate anions. Carbonate is presented by four normal modes of vibration peaks in FTIR spectra: ν_1 symmetric C-O stretching, ν_2 CO_3 out-of-plane bending, ν_3 asymmetric C-O stretching mode, and ν_4 O-C-O bending (in-plane deformation) mode [4, 10, 12]. In the FTIR spectrum obtained on Sample 1 the bands characteristic

for carbonate that are easiest to observe are the two broad bands in the region around $1500\text{--}1300\text{ cm}^{-1}$. The peak at 1488 cm^{-1} indicates that calcium carbonate is present in the form of vaterite on this sample, since it has been reported that different calcium carbonate phases can be identified using FTIR [13–15]. This is confirmed by the presence of peaks at 743 cm^{-1} and 879 cm^{-1} [13]. Presence of malachite, $\text{Cu}_2\text{CO}_3(\text{OH})_2$, is also observed through various peaks. The bands at ~ 1097 and $\sim 1034\text{ cm}^{-1}$ are assigned to the CO symmetric and asymmetric stretching vibrations. The two bands at 879 and 816 cm^{-1} are attributed to out of phase and in phase bending modes of carbonate in malachite [16]. The spectrum also shows peaks in the OH stretching mode region, but although the different basic copper(II) salts developed on copper during corrosion may be identified by IR reflectance spectroscopy, the OH stretching mode region (above approximately 3000 cm^{-1}) cannot be used

According to both XRF and EDS analysis Sample 1 contains a high amount of tin, actually the highest among the analysed surface samples (21%). Tin as a corrosion product on ancient metals is usually found in the tin(IV)oxide form, i.e. cassiterite, SnO_2 . Due to its characteristics cassiterite is very difficult to characterize as corrosion product. It is also usually covered by other corrosion products and thus the peaks attributed to SnO_2 in a FTIR spectrum are hard to distinguish. The FTIR spectrum obtained on Sample 1 showed different peaks in the fingerprint region presented in Fig. 3b. The spectrum showed a peak at 816 cm^{-1} which corresponds to the metal-oxide stretching vibrations [18], in this case both to Sn-O and Cu-O stretching. The peaks at 533 and 480 cm^{-1} present the bending vibrations [18]. The mineral cassiterite is usually identified in a FTIR spectrum with a peak at around

670 cm^{-1} and a peak at around 550 cm^{-1} [19, 20]. Both of these peaks can be observed in the spectrum in Fig. 3b.

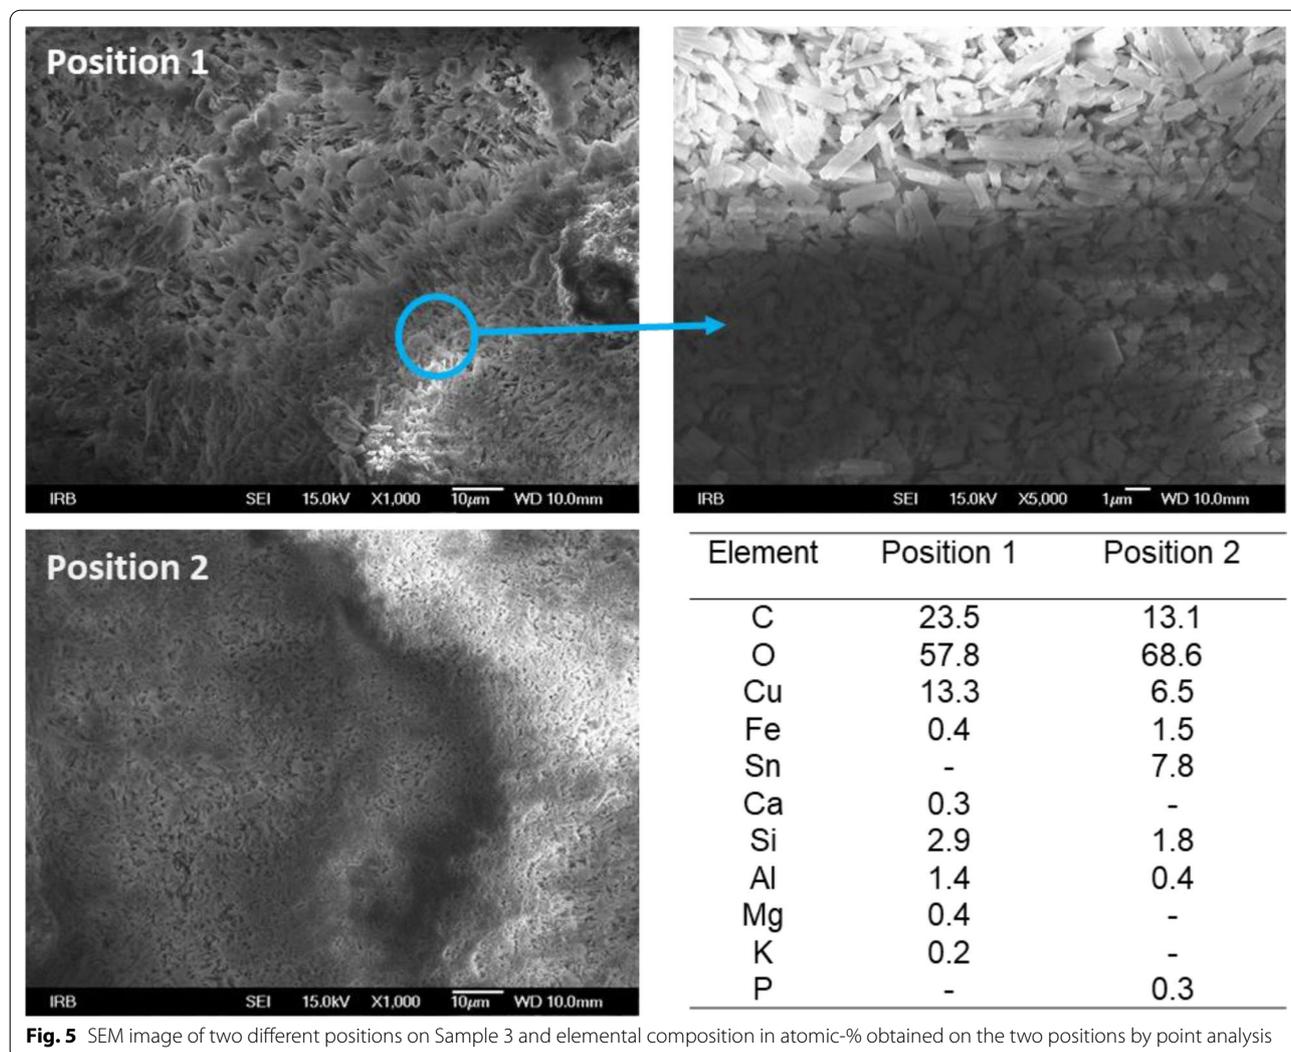
Fig. 5 SEM image of two different positions on Sample 3 and elemental composition in atomic-% obtained on the two positions by point analysis

Sample 3 was the sample with the most expressed green colour with small presence of light blue hues. The surface layers used for the analysis of Sample 3 were prevalent in green. Sample 2 was also green, although its colour was uniform. The SEM image of the surface of Sample 3 showed two different structures presented in Fig. 5. The main difference between the two structures is that the composition of the second structure shows presence of tin, while the first composition does not. Sample 2 showed presence of only one composition that is similar to the composition in Point 1 with slightly higher content of calcium and lower content of aluminium and magnesium, indicating that the oxides composition is the only difference.

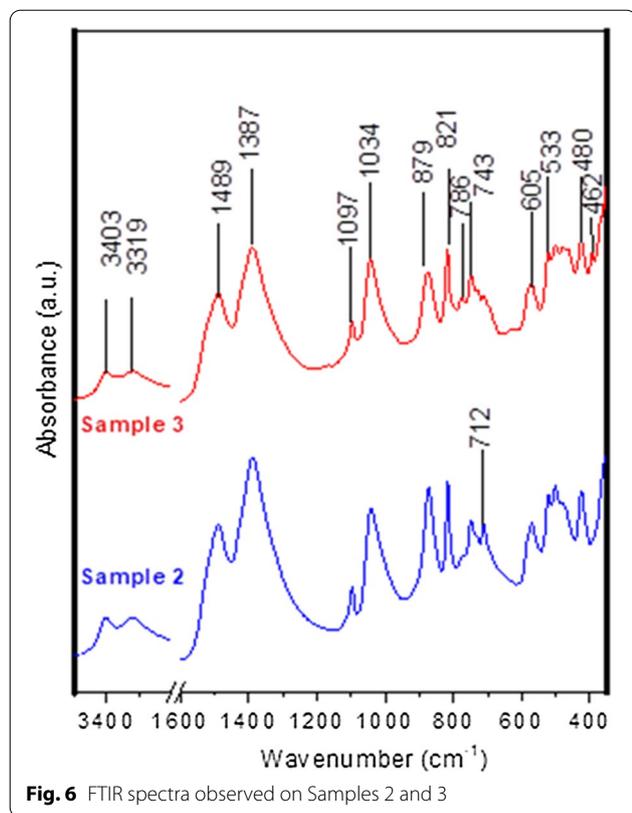
Fig. 6 FTIR spectra observed on Samples 2 and 3

The FTIR spectra obtained on Samples 2 and 3 were very similar as can be seen in Fig. 6. Presence of malachite, $\text{Cu}_2\text{CO}_3(\text{OH})_2$, was observed through various peaks. The bands at ~1097 and ~1034 cm^{-1} are assigned to the CO symmetric and asymmetric stretching vibration. The two bands at ~879 and ~821 cm^{-1} are attributed to the out of phase and in phase bending modes of

carbonate in malachite [16]. The two bands clearly present at ~3403 and ~3319 cm^{-1} are assigned to O–H groups bound to intramolecular H-links [22], but as said earlier they cannot be used for distinguishing presence of different copper patinas.

EDS and XRF analysis showed presence of Si in these samples. The peak at ~1097 cm^{-1} which is also attributed to malachite in combination with the rest of the peaks explained earlier indicated presence of Si-oxides. Presence of calcium carbonate in the form of vaterite is again presented by peaks at 1489, 879 and 743 cm^{-1} on Sample 3, while in the spectrum of Sample 2 the peak at 712 cm^{-1} represents calcite [13]. SnO_2 is presented by 533 and 480 cm^{-1} . These samples showed presence of iron in the form of Fe_2O_3 with very small peaks at 786 cm^{-1} and 462 cm^{-1} .

The broad peak at 1097 cm^{-1} could also be attributed to a sulphate compound. Although by EDS analysis sulphur was not found, XRF indicated its presence on both Samples 2 and 3. Upon observing the FTIR spectra it can be seen that the main peaks that present sulphate copper corrosion products are present [17, 24–26]. They show the internal vibrational modes of sulphate ions at 1097 and 1034 cm^{-1} (ν_3), 879 cm^{-1} (ν_1), 605 cm^{-1} (ν_4), the signals below 500 cm^{-1} are assigned to the ν_2 internal mode of SO_4^{2-} and to Cu–O vibrations, while the peaks at 3403 and 3319 cm^{-1} are attributed to $\nu(\text{OH})$. Samples 2 and 3 were the only samples where sulphate patina was detected, and considering the intensity of the peaks compared to the peaks of malachite it was not the main type of patina on the samples. It is hard to distinguish which sulphate copper patina is present on bronze, brochantite, $\text{Cu}_4\text{SO}_4(\text{OH})_6$, antlerite, $\text{Cu}_3(\text{SO}_4)(\text{OH})_4$, or posnjakite, $\text{Cu}_4\text{SO}_4(\text{OH})_6 \cdot \text{H}_2\text{O}$, using FTIR, but posnjakite is not normally found on archaeological bronzes. On the other hand, brochantite mainly forms in exposed areas and it is a common corrosion product on bronze sculptures located in urban areas where atmospheric sulphur dioxide is present [27]. On bronze objects exposed to freshwater antlerite is most commonly found [5]. The presence of sulphate patina does not exclude presence of inorganic sulphates that were found on Sample 1.

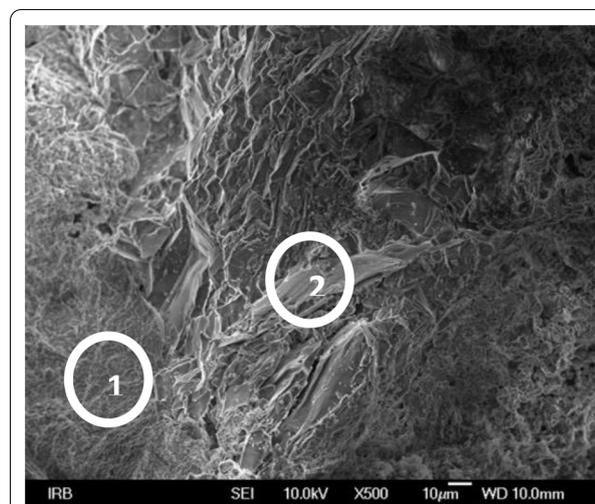
Fig. 7 SEM image of Sample 4 and elemental composition in atomic-% obtained by EDS analysis on the two points marked on the SEM image

presented in Fig. 7. It is clear that in Point 1 iron is a dominant element, while in point 2 silicon is.

Element	Point 1	Point 2
C	14.9	4.5
O	59.2	64.4
Cu	5.4	0.6
Fe	10.9	2.0
Ca	1.8	0.2
Si	5.0	28.3
Al	0.9	-
Mg	1.3	-
S	0.3	-
P	0.4	-

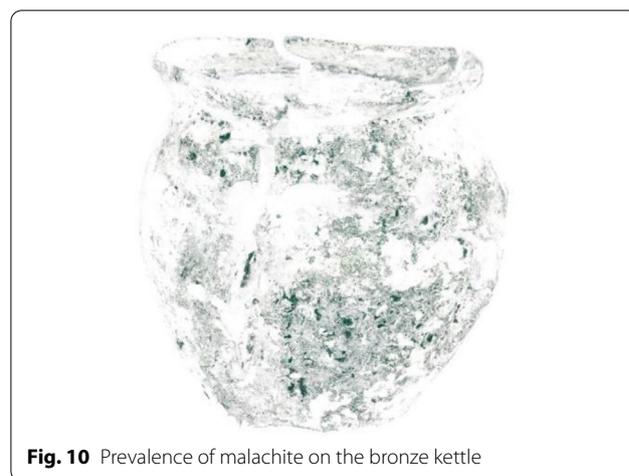
Fig. 10 Prevalence of malachite on the bronze kettle

Table 3 presents the different compounds that were found present on the examined samples. The characteristic green-blue appearance of the patina layer is due to the colour forming Cu(II)-ion in the outer patina layer which needs to be $12 \pm 2 \mu\text{m}$ to fully cover the inner oxide layer [2]. The patina on the kettle was identified as malachite, $\text{Cu}_2\text{CO}_3(\text{OH})_2$. It was formed over most parts of the object's surface, but it is not everywhere in equal amount and thickness. Figure 10 presents the presence of malachite on the kettle. The schematic image was made by isolating only the colour of the malachite from the image of the kettle. It is the corrosion product that was created on the surface of the kettle while the object was buried in the mud of the Kupa River. It was the first corrosion

product that covered the surface during this period. When copper alloys are buried in damp places, they tend to form green corrosion products such as georgite, which forms before malachite. Also, the blue-coloured mineral azurite may appear, however, in little less humid places, but it is also prone to creation under buried conditions [6]. Neither georgite or azurite were found in our case.
