# Economy and fashion: analysing the use of simulated leather upholstery in a nineteenth century Australian coach

The Ranken coach is a landau style horse-drawn vehicle brought to the Australian colony of New South Wales in the 1820s, and now held in the National Historical Collection of the National Museum of Australia. At some point, or points, in the vehicle's history the roof structure has been altered and parts of its original interior and exterior upholstery have been replaced with black coated fabrics resembling imitation leather. Three data sources were brought together to support the hypothesis that the alterations to the coach were made between 1923 and 1938. Two of these sources were historical research on the vehicle and research on materials used to simulate leather in the times when the coach was likely to have been altered. These were used to determine the likely dates for these changes, as well as the types of materials available at the time. The third source involved physical means of investigation to study the chemical composition of the coatings. These included visual inspection, Ultraviolet fluorescence evaluation, solubility tests, the diphenylamine spot test,

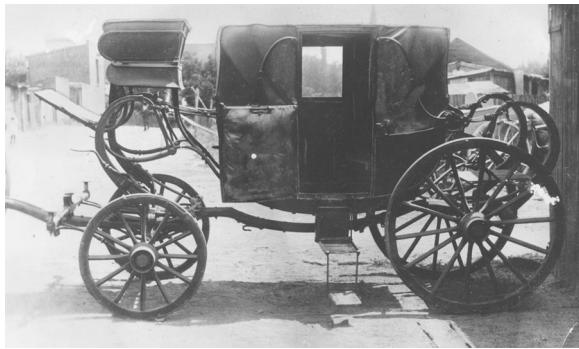
**Fig. 2** Photo of the Ranken coach circa 1823. Reproduced with the permission of Bathurst District Historical Society (BDHS)

The first known photo of the coach (Fig. 2) was published in an article in the *National Advocate* in 1923 [3]. This was just before the Hodge family donated the coach to the RAHS in 1924 and in the photograph, the interior door panel of the coach can be seen, but without the distinctive biscuit pattern upholstery that is present today. A 1938 photograph of the coach (Fig. 3) in the *RAHS* magazine does show the biscuit pattern upholstery [4], and this means that the biscuit pattern material must have been installed between 1923 and 1938.

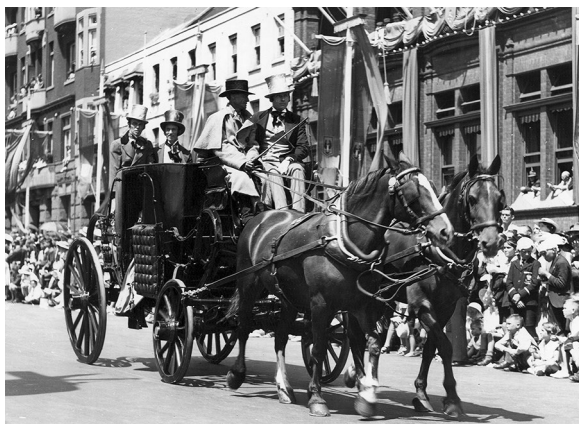
**Fig. 3** Carriage in Procession in Macquarie Street Sydney, image number 20174—Ranken coach: “Australia’s March to Nationhood”. Reproduced with the permission of the RAHS

Photographs, believed to be from an earlier period than 1938, depict the coach in the stables at Vacluse House (Figs. 3, 4). These photos show a torn edge of roof fabric close to the doorframe, and the outline of the landau bars are visible along the length of the material. In a photograph of the coach in the Sydney sesquicentenary parade, the roof appears to have a smoother line at the top, with the landau bars less prominent and some edge

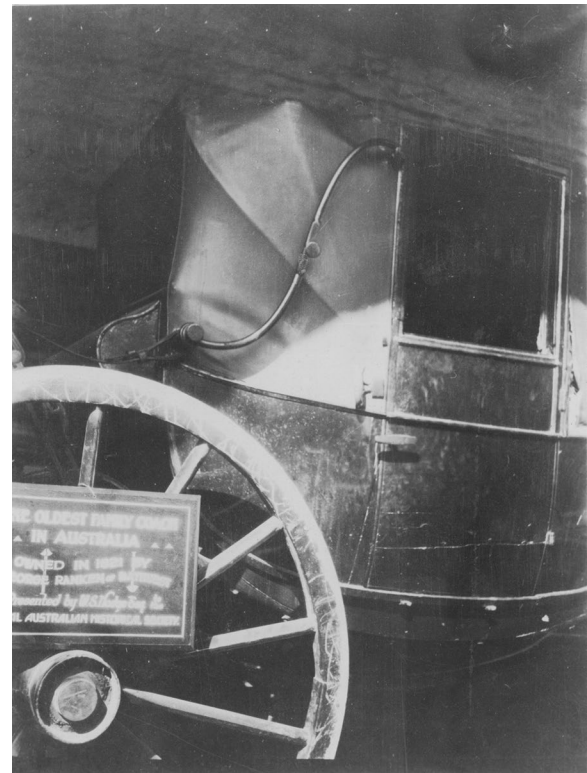
**Fig. 4** The oldest family coach in Australia, 1927. Number 021/021621—Reproduced with permission of the RAHS (image shows roof structure and tear in upholstery along door edge on far right of photograph)

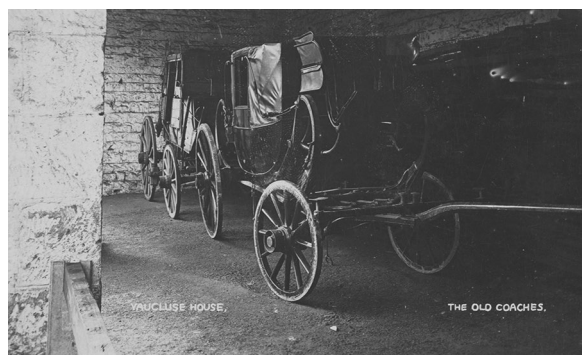
**Fig. 5** Postcard depicting the Ranken landau coach at Vauculuse House prior to acquisition by the NMA in about 1980. Reproduced with permission from NMA, Historic Horse Drawn Vehicles archive collection no. 1, NMA

trim present. This strongly suggests that the roof coating present today was applied between May 1937 and January 1938 while the coach was in the possession of the RAHS, to improve its appearance and robustness for the sesquicentenary parade. There is no mention of the interior upholstery in the RAHS documents, so the date for the reupholstering of this portion of the coach has not been confirmed (Fig. 5).

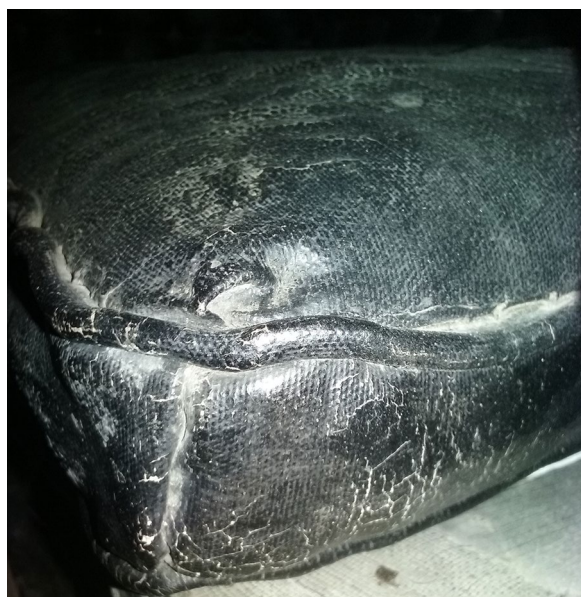
**Fig. 6** Photo of seat of Ranken coach showing evidence of woven substrate and repeating surface pattern. Source: Ison 2015

Visual examination showed that the substrate is a woven material which indicates that this is a relatively early type of coated material (Fig. 6). Doyal mentions

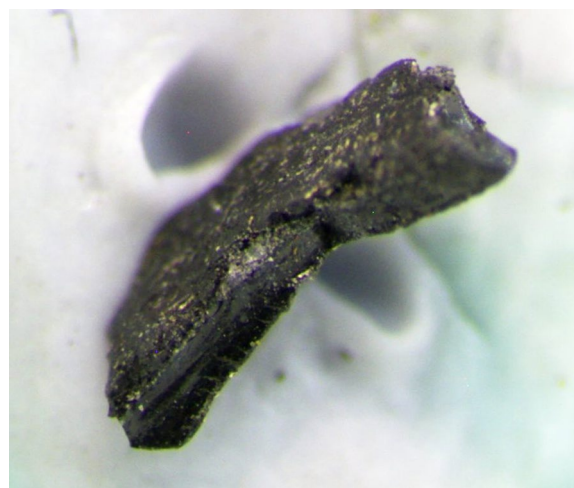
**Fig. 7** Microscope photograph of piece of interior upholstery on cross-section showing contracted surface and smoother main body. The sample is approximately 3 mm wide. Source: Ison 2015

Under a microscope, the interior upholstery coating samples appear thick and brittle. While the main body of the cross-section appears homogeneous, smooth and glass-like, there is a distinctly different surface layer. This surface layer appears to have shrunk at some point, suggesting that some loss has occurred, or that the surface has contracted more quickly than the rest of the coating—possibly due to a drying process where the surface forms a skin. This detail is shown in Fig. 7. All surface layers on every sample contain dirt and small embedded impurities.

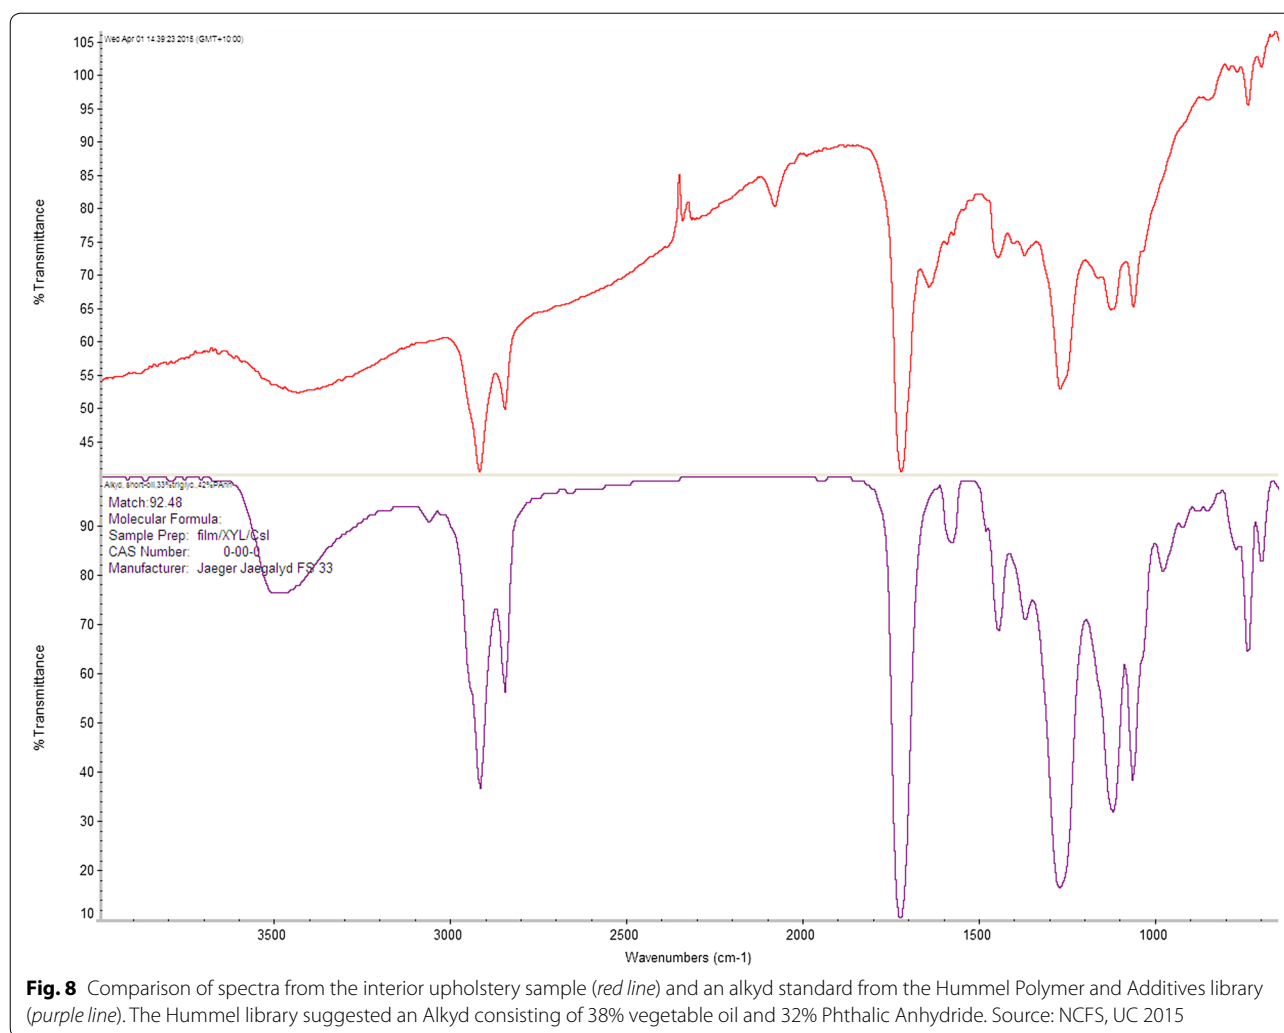
**Fig. 8** Comparison of spectra from the interior upholstery sample (red line) and an alkyd standard from the Hummel Polymer and Additives library (purple line). The Hummel library suggested an Alkyd consisting of 38% vegetable oil and 32% Phthalic Anhydride. Source: NCFS, UC 2015

The FTIR tests obtained in 2014 at the Museum of Applied Arts and Sciences (MAAS) and in 2015 at The National Centre for Forensic Studies (NCFS) at the University of Canberra (UC) produced largely similar spectra. However, there are slight discrepancies between the spectra in the region between  $\sim 1710$  and  $650\text{ cm}^{-1}$ . When the spectra were compared to polymer libraries at MAAS and NCFS, the suggested matches included respectively shellac, and alkyds with varying combinations of oils and anhydrides. The NCFS spectra are shown in Fig. 8.

These variations in the spectra support the interpretation that there are multiple materials within the sample bag, and that the coating could be a combination of ingredients, as discussed in the section on “Coating mixtures”. It was also noted that there were peaks at around the  $3700\text{--}3600$  and  $1050\text{--}900\text{ cm}^{-1}$  regions which are found in spectra for calcium carbonate and calcium sulphate. Peaks in this region

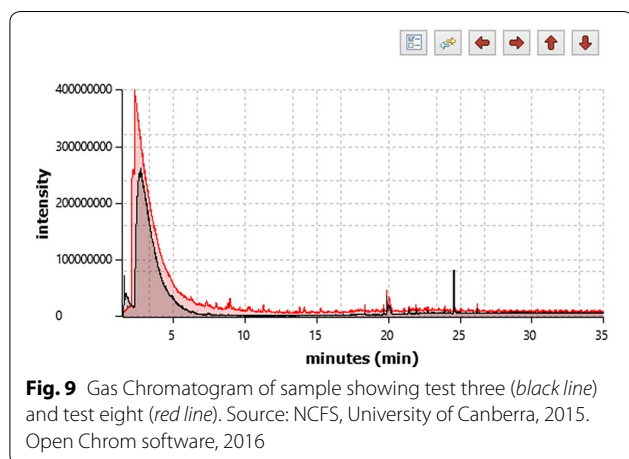
In test three and eight (Fig. 9), there were peaks in common in the 19.88 min region, which produced a number one hit for dibutyl phthalate in the NIST mass spectra library for test eight and 1,2-benzenedicarboxylic acid, butyl octyl ester for test three. These substances are both used as plasticisers. Ploeger and Chiantore do not specify the type of “phthalate plasticiser” found in their samples, but the presence of these phthalate plasticiser matches strongly suggest that the interior upholstery samples, while likely consisting of a mixture of different substances, contain the types of compounds which would be present in an alkyd coating.

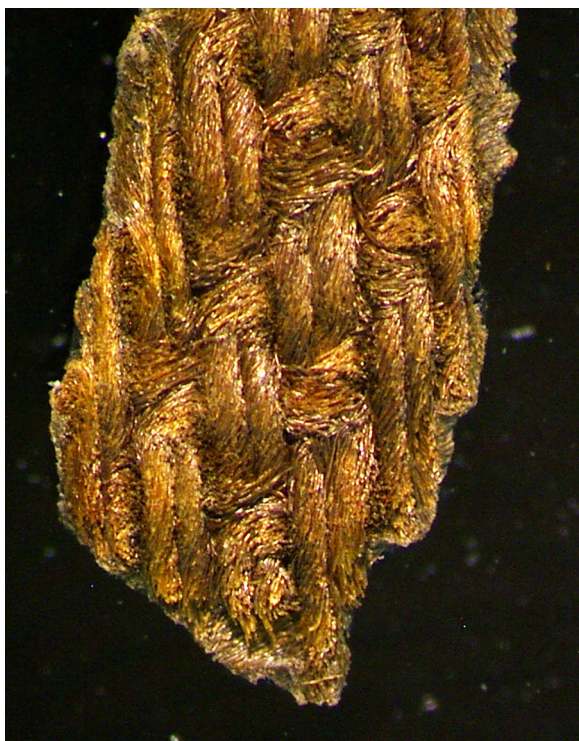
**Fig. 10** Substrate of roof coating under microscope. The sample is 8 mm long. This microscope photo shows a 4 mm section of the 8 mm length. Source: Ison 2015

Visual examination showed that the substrate is a woven material, which again indicates that this is an early type of coated material (Fig. 10). The coating is of a slightly shinier black appearance than the interior

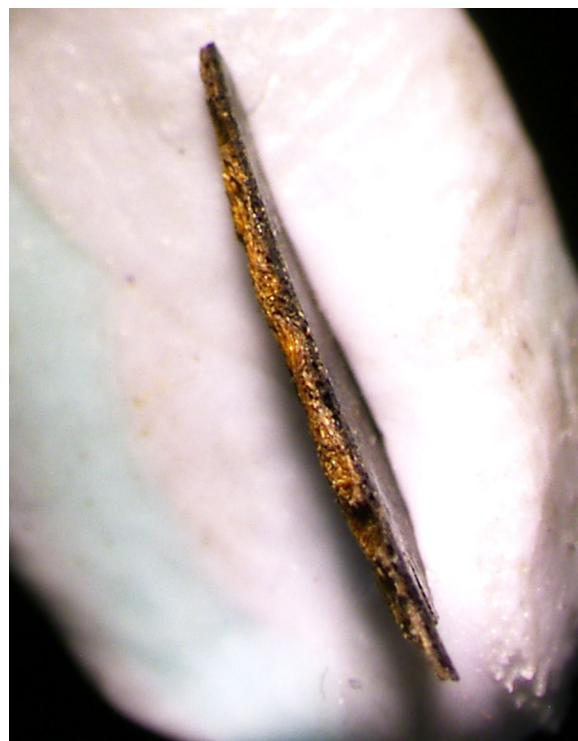
**Fig. 11** Cross-section of roof coating. Sample is approximately 6 mm long. Source: Ison 2015

A cross-section (Fig. 11) shows that the coating is embedded into the woven substrate. Visual examination showed that there is a difference in thickness between the roof coating and the interior upholstery, and a difference in the attachment to the substrate. These differences may be due to the use of different rolling conditions including different apparatus, drying times, consistencies, or other factors.

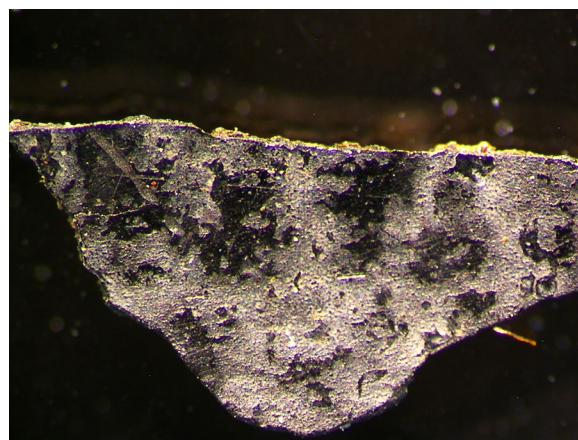
**Fig. 12** Cross-section of roof coating showing light and dark surfaces. The area shown is 4 mm in length. Source: Ison 2015

On the upper surface of the coating, there appears to be light and dark components, and under magnification (Fig. 12), it appears that the darker layer is a very thin black coating on top of a lighter-coloured surface. As with the interior upholstery, all surface layers on every sample contain dirt and small embedded impurities.

The black areas of this coating did not fluoresce under UV light, but the lighter material did. This suggests that the dark black is a topical coating of a different substance.

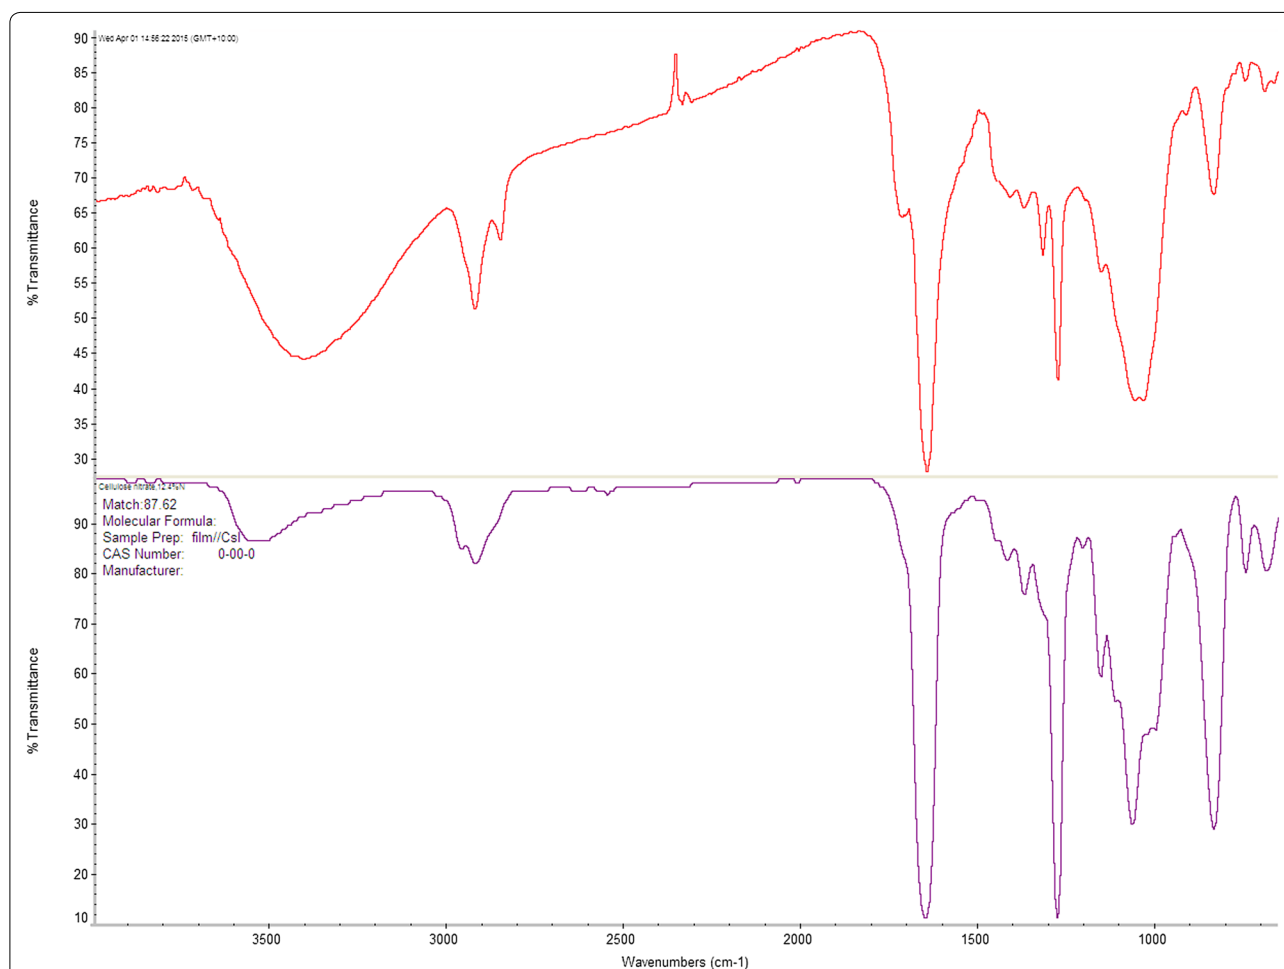
**Fig. 13** Comparison between roof coating sample (red line) and cellulose nitrate with 12.4% nitrogen (purple line) from the Hummel Polymer and Additives library. Source: NCFS, UC 2015

Physical analysis of the roof coating material suggests that it was primarily composed of cellulose nitrate. This conclusion was supported by solubility testing, the diphenylamine test described above, and FTIR instrumental analysis. Literature on the development of coated fabrics indicates that cellulose nitrate fabric coatings were in use in the 1920s and 30s, which includes the period in which structural and cosmetic repair works on the coach were approved by the RAHS in order to make it ready for the Sydney sesquicentenary celebrations in 1938. It is, therefore, quite possible for cellulose nitrate coatings to have been used on the coach at this point. Darker patches on the surface of the sample were apparent under both visible and UV light which suggested that, as for the interior upholstery, a topical coating may have been applied at some stage over the top of the coated fabric surface. As with the potential coating on the interior upholstery, however, it was not possible to identify the nature of this material in more detail in this study.
