Experimental study on the effects of hydrochemistry and periodic changes in temperature and humidity on sandstone weathering in the Longshan Grottoes

Abstract

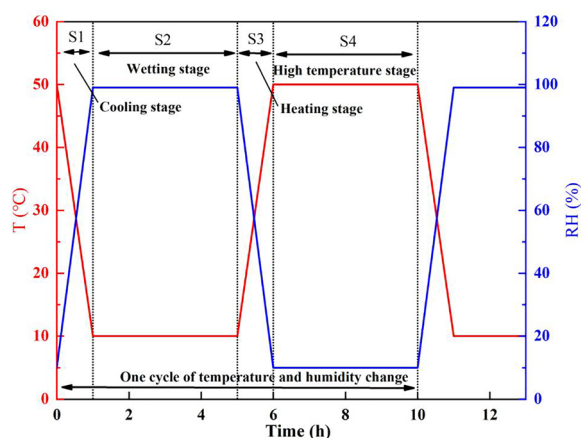
Fig. 5 Schematic diagram of the temperature and humidity change in the dry and wet cycle

- Cyclic test: a fast temperature and humidity variation test box (model: RHPS-408BT) was used to simulate the temperature and humidity changes in the natural environment. After immersing the samples in 4 different solutions for 48 h, they were placed in the test box for 5 temperature and humidity cycles (50 h), with 1 test cycle, as shown in Fig. 5. Combined with summer temperature monitoring data, the test temperatures in the cycle were in the range of 10–50 °C, and the relative humidities were in the range of 10–99%. A degradation test consisting of 48 h of soaking and 5 temperature and humidity cycles was set, and the numbers of test cycles were 3, 6, 9, 12, 15, and 18.

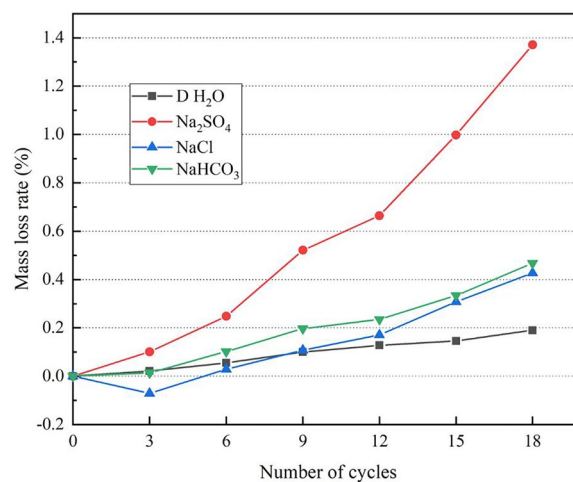
Fig. 6 Relationship between the number of cycles and the rate of mass loss in different solutions

By determining the mass of the rock samples after different cycles, the macroscopic qualities were characterized by the mass loss rate, as shown in Fig. 6. The results of the changes were as follows: (1) after being subjected to different cycles, the mass loss rates of the 4 groups of samples generally increased with increasing number of cycles. After 3 cycles, the mass loss rate of the rock sample soaked in distilled water was higher than that samples soaked in NaCl solution and in NaHCO_3 solution; the mass loss rate of the rock sample soaked in NaCl solution increased. With the increase in the number of cycles, the mass loss rates of the rock samples soaked in NaCl solution and in NaHCO_3 solution exceeded those of the sample soaked in distilled water for 6 cycles and 9 cycles; the mass loss rate of the rock sample soaked in Na_2SO_4 solution showed an exponential increase with the increase in the number of cycles; and (2) throughout the cycle, the rates of change in the degrees of mass loss of the samples after soaking in different solutions decreased in the following order: Na_2SO_4 solution, NaHCO_3 solution, NaCl solution and distilled water. After 18 cycles, the mass loss rates of the rock samples soaked in distilled water, Na_2SO_4 solution, NaCl solution and NaHCO_3 solution reached 0.190%, 1.371%, 0.427% and 0.467%, respectively.

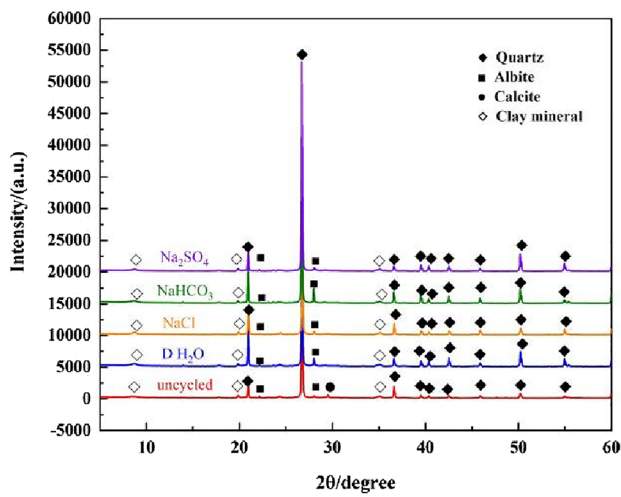
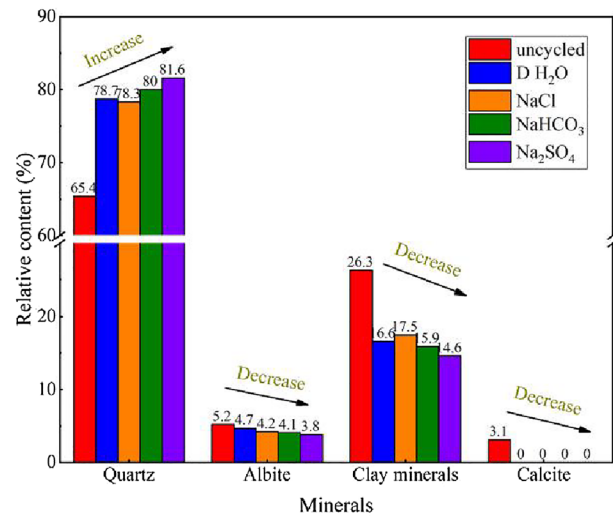
a) XRD identification of sample powder

b) Relative mineral content

Fig. 13 Analysis of relative mineral composition of rock samples after 18 cycles: **a)** XRD identification of sample powder; **b)** Relative mineral content

Figure 13 shows the relative content analysis results of rock sample minerals after 18 cycles. Three samples were tested under every operating condition. It can be seen from Fig. 13a that a mineral has multiple diffraction peaks with similar change rules, among which quartz has the most significant diffraction peak, indicating that its content is the highest. Other minerals are mainly albite, calcite and clay minerals. The relative contents of other minerals have also changed, the relative contents of quartz have increased, and the relative contents of albite and clay minerals have decreased. Under the combined action of the chemical solution and the cycle of temperature and humidity changes, the minerals in the rock sample may have undergone some changes. The mineral content of rock samples in four different solution environments has the same variation rule, but the variation amplitude is different to some extent. Among them, the relative content of minerals in Na₂SO₄ solution changed most obviously, the relative content of feldspar decreased by 1.4%, and the relative content of quartz increased significantly by 16.2%. The relative mineral contents in the four solutions were in the order of Na₂SO₄ > NaHCO₃ > NaCl > D H₂O. This is due to the different degrees of damage to the mineral composition of rock samples caused by different solutions.
