Application of computer vision technology in surface damage detection and analysis of shedthin tiles in China: a case study of the classical gardens of Suzhou

Lina Yan^{1,2}, Yile Chen¹, Liang Zheng^{1*} and Yi Zhang³

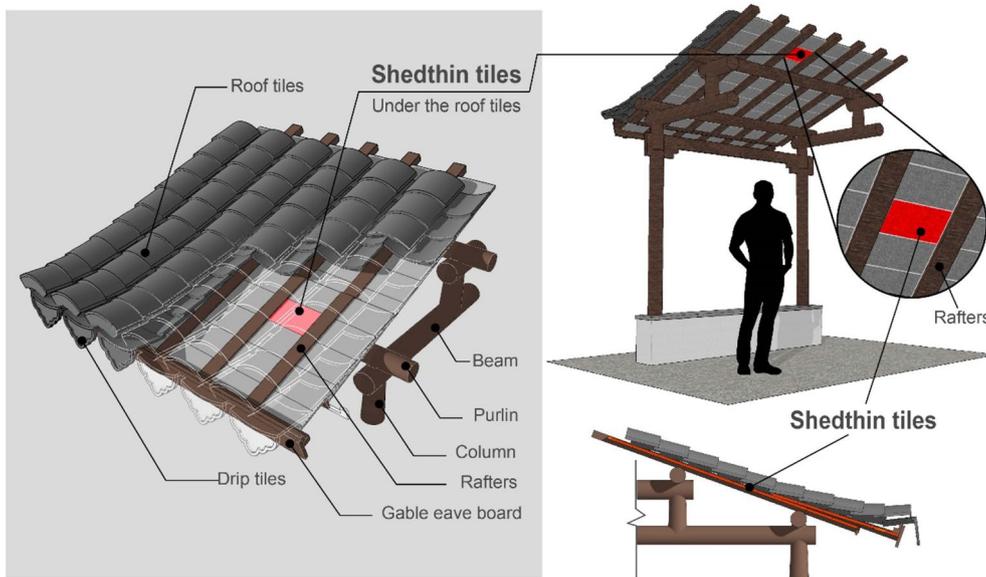
Fig. 2 Shedthin tile location on the roof. (Drawn by the author)

The shedthin tile is a kind of thin brick used for roof bases in southern Jiangsu. It is located between the rafter and roof. It plays an important role in water and dustproofing the roof base. It also makes the roof surface smooth and aesthetically pleasing (Fig. 2). The earliest use of the shedthin tiles in architecture can be traced back to the Song Dynasty (960 AD). By the Ming and Qing Dynasties (1368–1840 AD), it was only used on small buildings. Since laying shedthin tiles requires considerable workmanship, it is usually used in higher-grade buildings. Shedthin tiles come in long strips and square gray bricks; the specifications are not uniform. Shedthin tiles are used in different specifications according to the size and grade of different buildings. Among them, the long type is mostly used on the roofs of corridors and pavilions, with a general specification of 220 mm*110 mm*20 mm. The square shedthin tiles are less common, with general specifications of 220 mm*220 mm*25 mm or 300 mm*300 mm*30 mm, and are used in high-level halls or ordinary halls. Modern shedthin tile specifications are smaller, with three specifications: 210 mm*100 mm*13 mm, 220 mm*100 mm*16 mm, and 220 mm*90 mm*12 mm.

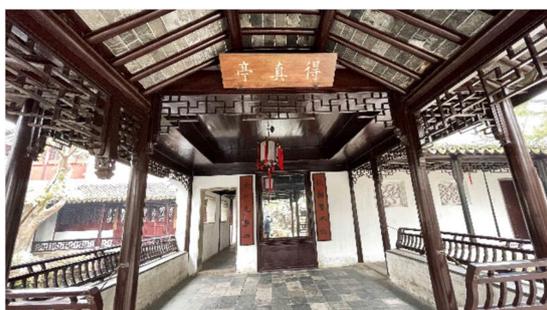
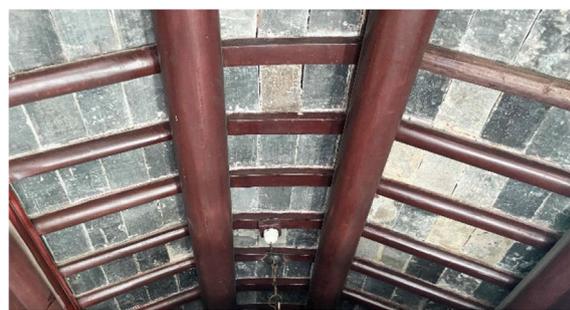
(1) Shedthin tile on the roof of Truth Ting in Humble Administrator's Garden

(2) Shedthin tile on the roof of Small Feihong, Humble Administrator's Garden

Fig. 3 Shedthin tiles photographed during a field trip. (Image source: photographed by the author)

Suzhou and the Jiangnan area, such as the tops of pavilions and corridors in The Humble Administrator's Garden (Fig. 3).

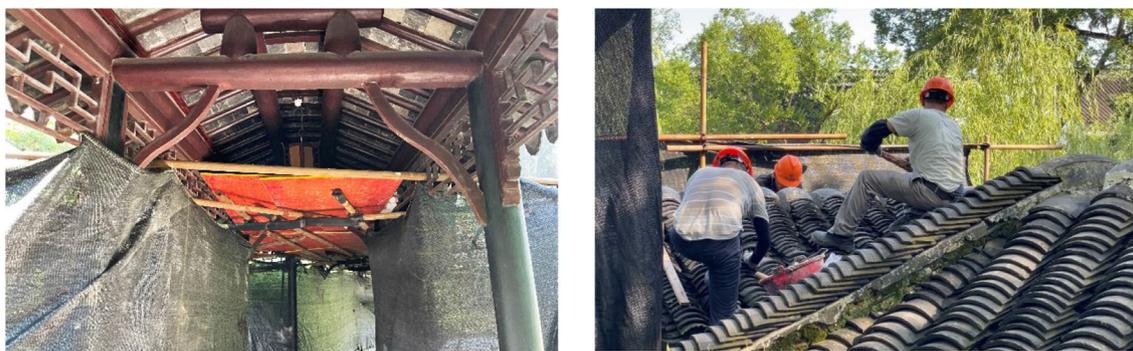
(1) Repair site of shedthhin tiles on a roof in The Humble Administrator's Garden

(2) Craftsmen are repairing the roof and replacing damaged tiles and shedthhin tiles

Fig. 4 On-site image of the shedthhin tiles restoration site. (Image source: photographed by the author)

Most of the pavilions and corridors in Suzhou Classical Gardens use shedthin tiles as the roof base laying material. Today, these preserved, historically protected buildings have experienced hundreds or even nearly a thousand years of history. Although it has undergone many repairs, due to the loss of firing techniques and the gradual reduction in the number of craftsmen, the number of old shedthin tiles of good traditional quality has gradually disappeared. The protection and repair of shedthin tiles are urgent (Fig. 4).

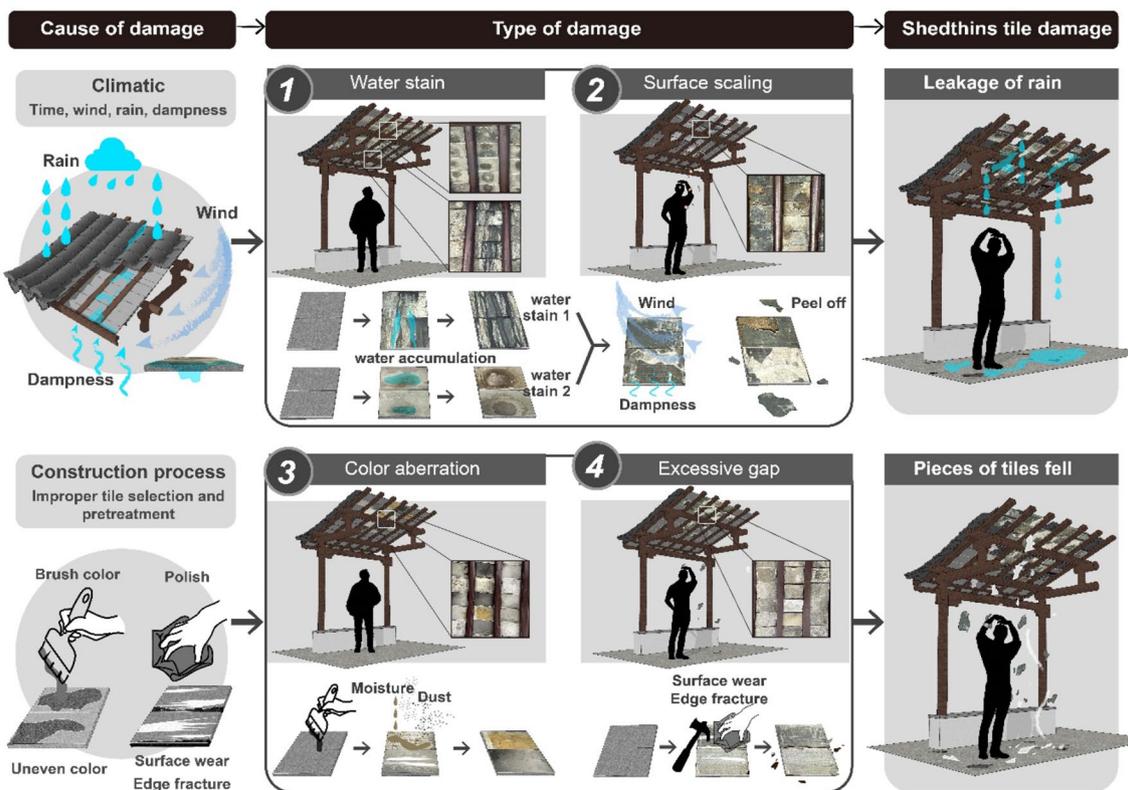
Fig. 5 Causes and processes of damage to shedthhin tiles. (Drawn by the author)

Based on the above two main reasons, the researchers summarized four common damage types through analysis (Fig. 5): water staining, surface scaling, color aberration, and excessive gap.

(1) Water staining: the shedthhin tiles have certain moisture-proof and breathable properties; however, long-term moisture and freeze–thaw cycles cause water to stay inside the brick, forming water stains, which accelerate brick aging. There are two types of water stains on shedthhin tiles: surface water stains and penetrating water stains. Surface water stains are strips of water stains left behind when rainwa-

ter leaks from the roof and flows onto the surface of the shedthin tile, damaging the mortar on its surface. Penetrating water stains occur when rainwater flows onto the shedthin tiles in the horizontal laying direction of the roof. After a long period of retention, the rainwater penetrates into the interior of the tiles to form circular water stains. The occurrence of these two water stains on the shedthin tiles indicates a roof leak.

- (2) Surface scaling: under the influence of long-term rain and moisture, the mortar on the surface of the shedthin tiles gradually degrades, and the deeper areas penetrated by water form a bulging air layer as a result. These bulging air layers accelerate aging due to moisture-laden winds, which cause the surface to peel off. Since the shedthin tiles is located on the inside of the roof, the bulging mortar on the surface will fall downward with gravity and affect the area where people walk.

- (3) Color aberration: the surface of the fair-faced shedthin tiles is usually painted with gray water and grout to unify the color of the bricks. Bricks of different thicknesses are also polished. Color differences are caused by improper repair processes. There are two types of color differences. First, the color of the gray water and grouting mixture is not uniform because the gray color will differ between batches, producing different shades. Second, wear marks will be produced after polishing. These wear marks can easily accumulate dust and oil from the air, resulting in yellowing and deterioration of the brick surface.

- (4) Excessive gap: shedthin tiles are thin and not particularly hard. In Suzhou World Heritage buildings, the practice of retaining as many old bricks as possible is usually adopted. The service life of most shedthin tiles has been exceeded. The specifications of old bricks continue to shrink due to wear and tear, and when they are reused in their original positions, they cannot be aligned with other bricks, resulting in leaks and excessively large seams between spliced bricks. Excessively large brick joints not only cause serious rain leakage and dust fall but may also cause rafters on both sides to fall and injure pedestrians.

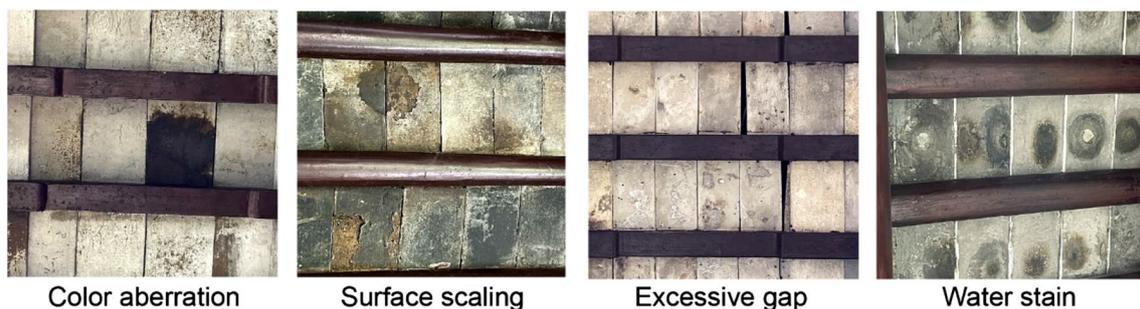
Fig. 6 On-site collection of shedthin tiles damage types. (photographed by the author)

The shedthin stile sample collection locations were selected on the inner roofs of buildings and corridors with obvious damage features and good lighting and were shot with high-definition cameras to ensure sample clarity. After the samples were collected, the damage characteristics were manually classified, and the four damage types summarized above were obtained (Fig. 6).

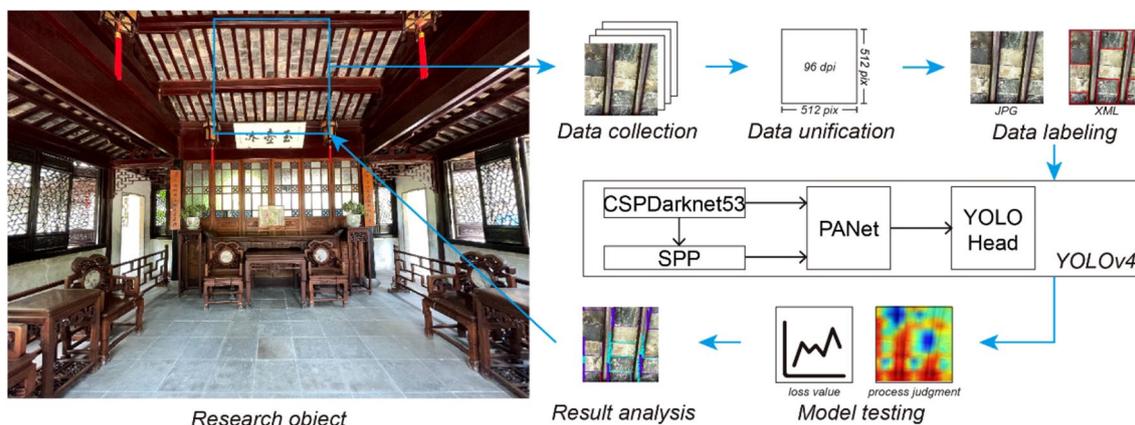
Fig. 7 Research process. (Drawn by the author)

This study adopted an experimentally verified and effective research process and systematically explored the application possibility and practical value of computer vision technology in shedthin tile damage detection in Jiangnan Classical Gardens through a series of steps from data collection to final application [33]. In this process, an automatic detection method for shedthin tile damage was proposed and verified based on the YOLOv4 model (Fig. 7). By integrating computer vision technology with the actual needs of ancient building protection, this research aims to construct a model that can accurately and quickly detect damage to shedthin tiles. Its ability to provide solid scientific and technological support for

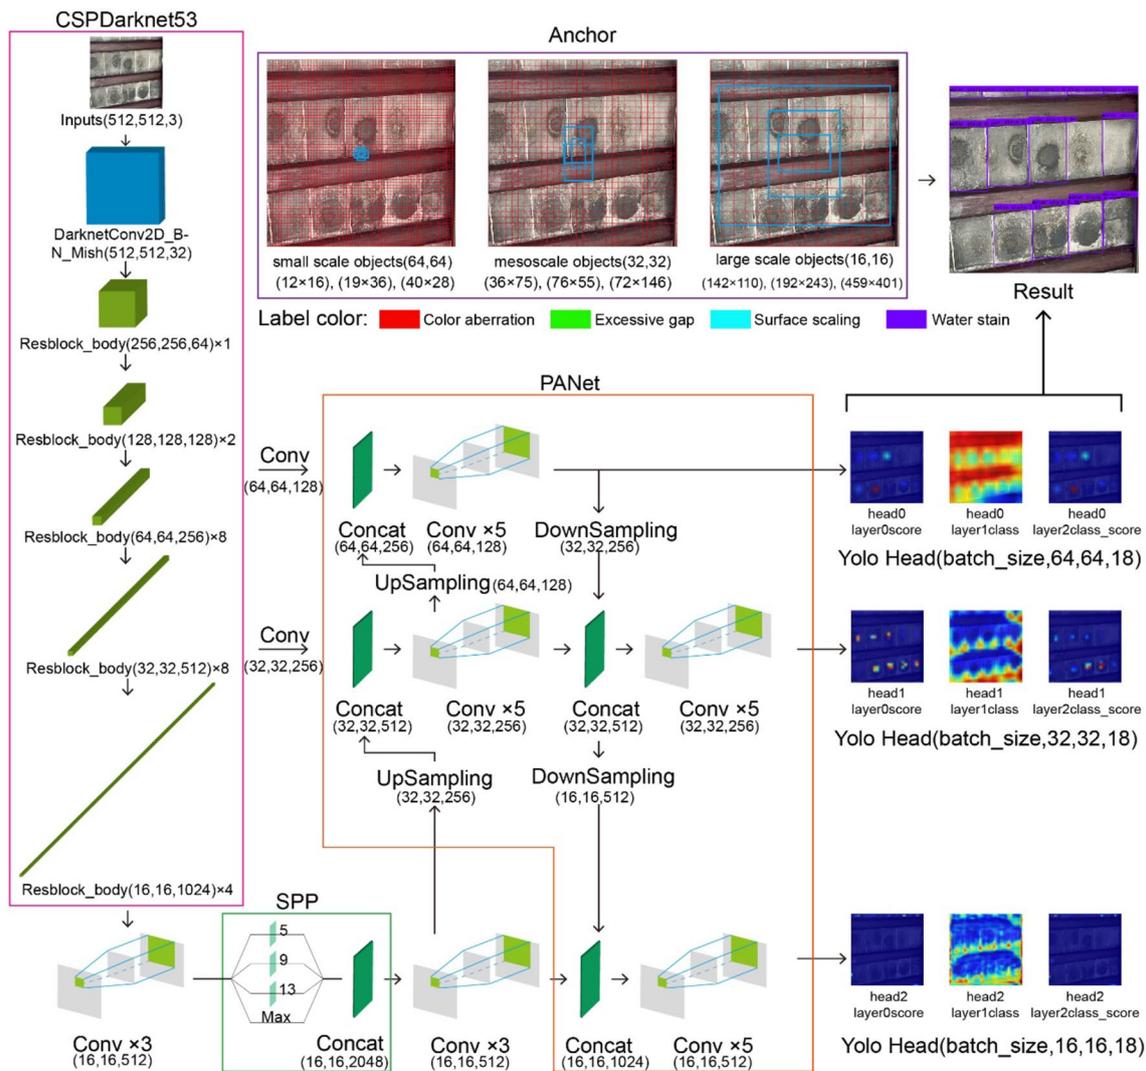
Fig. 8 YOLOv4 network framework. (Drawn by the author)

The network framework of the YOLOv4 model is shown in Fig. 8. The overall architecture consists of the DarkNet53 backbone network, the PANet feature extraction layer integrated with SPP structure, a step in the 'convolutional neural network that turns the picture into a feature vector, and the final detection head. DarkNet53 serves as the backbone network for extracting basic features from images. In the feature extraction layer, PANet enhances the feature expression ability of the model at different levels through top-down and bottom-up information flow guidance to balance the gradient propagation of features and the propagation of activation values, improving the model's learning ability. By introducing the SPP structure, multiscale feature fusion is achieved,

allowing the model to adapt to and accurately identify targets of different sizes. The detection head predicts the bounding box coordinates and categories of the target at multiple scales. The generator is responsible for the final target detection and classification, using the generated feature maps to predict bounding boxes, target scores, and category scores. The detection head makes predictions at multiple scales and can detect targets of different sizes. Strategies such as the Mish activation function, CIoU loss function, and learning rate cosine annealing scheduling are also used during the model training process to ensure that the model achieves stable and accurate detection results in complex scenes and diverse target scales [34].

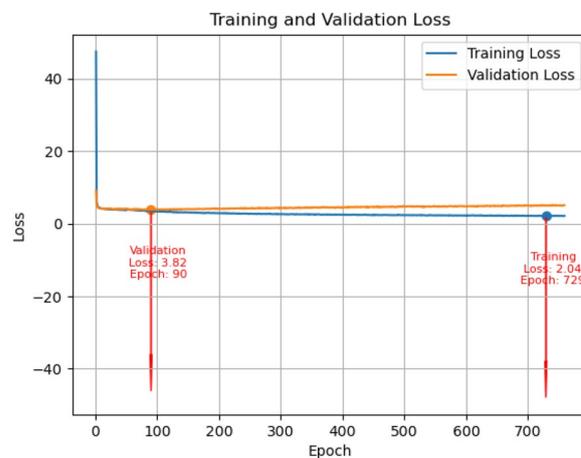
Fig. 9 LOSS values of the model training logs. (Drawn by the author)

Figure 9 shows that the model learns and converges in important ways during the training process. This is done by examining how the training loss and validation loss change over time. The loss value in the initial stage experienced violent fluctuations, especially for large outliers that appeared in the training loss value. This may be due to the rapid adaptation of the model to the data and the rapid optimization of parameters in the early stages. As the number of epochs increases, the training loss value steadily decreases and finally approaches a relatively stable level, indicating that the model is continuing to learn and gradually converges. Although the verification loss value remains relatively stable throughout the training process, its slight fluctuations and differences from the training loss may indicate a certain degree of overfitting in the model. On this basis, in this study, several key models were selected for subsequent in-depth analysis and comparison. The 90th epoch model exhibited the lowest validation loss (loss = 3.82), which indicated that it performed well on the validation set and exhibited good

generalizability. The 729th epoch model showed the lowest training loss (loss=2.04) on the training set, indicating a strong fitting ability. The 750th epoch model is the model when the training cycle is completed, and its performance reflects the learning results of the model under the full amount of training data. The 100th epoch model serves as a randomly selected reference point, providing this study with a performance snapshot in the early training stage.

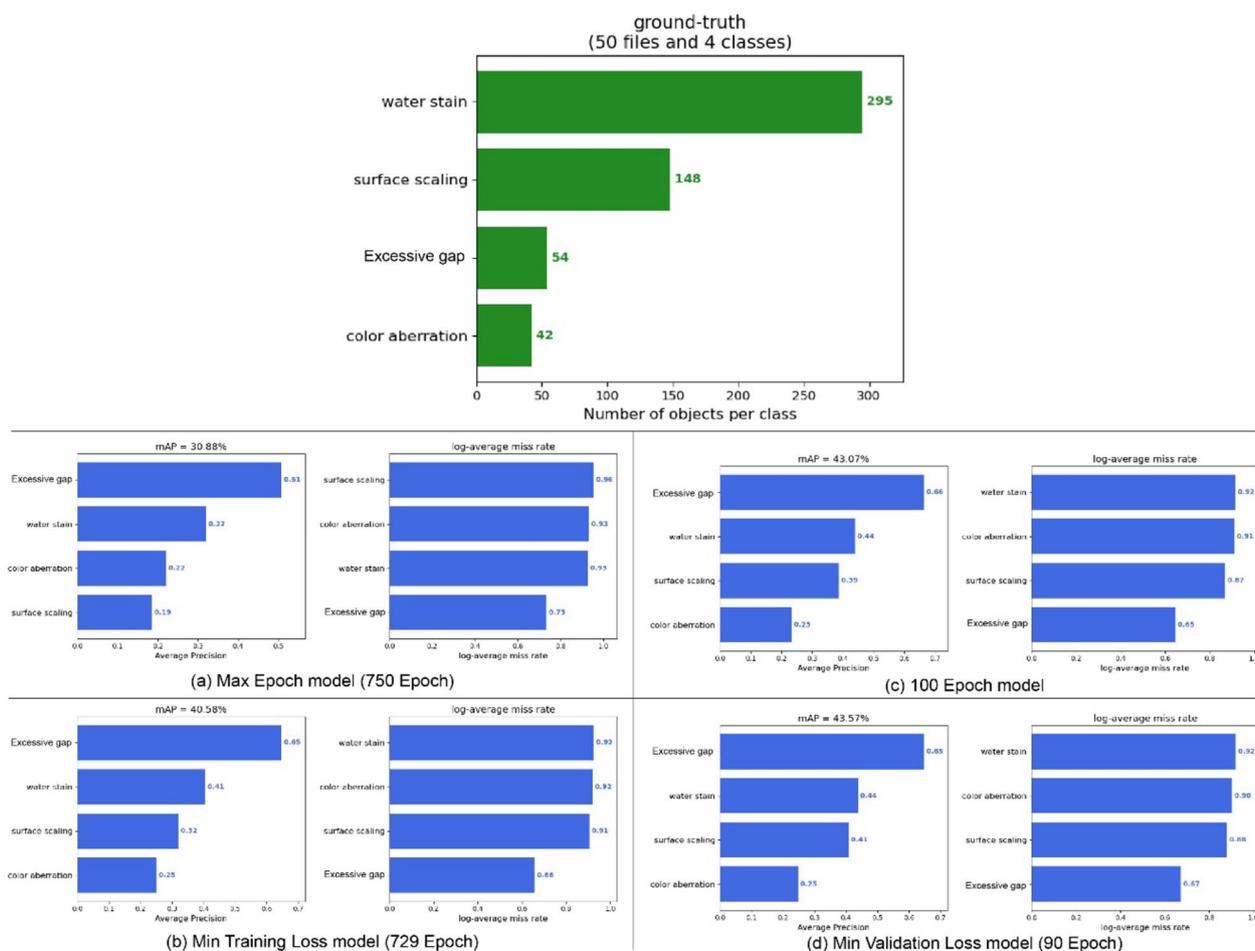
Fig. 10 Comparison of AP and MR indices between different models. (Drawn by the author)

annotation information in the dataset, including the category and location information of the object, and is the basis for model training and evaluation. On this basis, by observing and analyzing the performance of the model in each training stage, some phenomena and patterns of the model can be discovered (Fig. 10).

In general, the longer the training period is, the better the model should perform. However, in this study, the min validation loss model at 90 epochs achieved an mAP of 43.57% (mean average precision), which was much greater than the 30.88% mAP of the max-epoch model at 750 epochs. This reveals that the model locked in the key information of shedthin tile damage features in a relatively short training period and that later training may have paid too much attention to noise or secondary features in the training data, resulting in no further improvement in performance. In detecting various damage types, a EG (excessive gap) generally has a high AP value, which may be related to its visually prominent feature—a wider gap can make an obvious difference in the

image. The performances of SS (surface scaling) and CA (color aberration) are relatively weak, especially in the max-epoch model, where the AP value of SS is only 0.19 and the MR value is as high as 0.96. This may reflect the complexity of the visual characteristics of these two types of impairment and the potentially less noticeable forms of impairment. Considering the sample distribution of each category in the ground truth (WS (water stain): 295, SS: 148, EG: 54, CA: 42), the difference in sample size between different categories may have a certain impact on model learning. Further research may find optimization directions for balancing sample distributions or improving model structures.

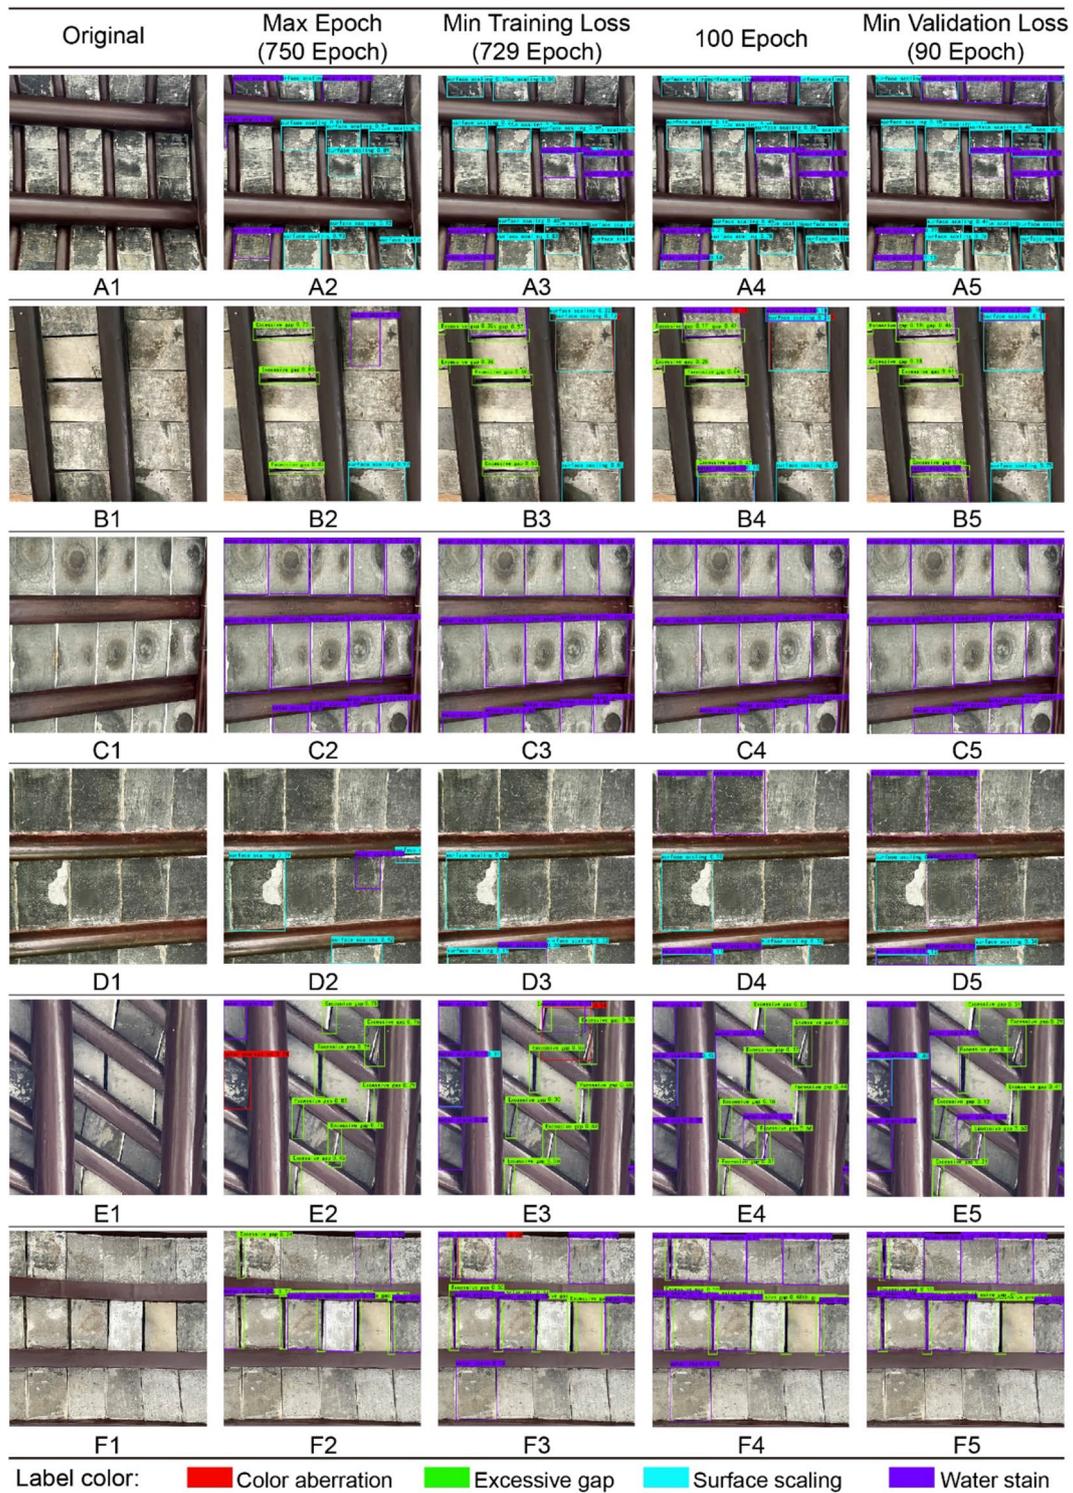
Fig. 11 Model test results for different epochs. (Drawn by the author)

In the model measurement and analysis process, six representative test photos were selected as experimental samples to further verify the detection performance of each model through actual application scenarios. All the models use unified parameter settings during the testing phase; that is, the confidence threshold (confidence) is 0.1, and the intersection-over-union (IoU) threshold (nms_iou) of nonmaximum suppression is set to 0.3 to ensure the comparability of the outputs of each model. The experimental results are shown in Fig. 11. There are common phenomena of missed detection and false detection in the detection of each model, but the degrees of detection are different. The model trained for 750 epochs exhibited more severe missed and false detections. For example, in Figs. 12A2, C2 and 13B2, and, the number of shedthin tile damage incidents recognized by the model is significantly less. In Fig. 12E2, the model incorrectly identifies "surface scaling" (SS) as CA. Relatively speaking, the minimum validation loss model performs more prominently, with relatively fewer missed detections and false detections. It can identify shedthin tile damage more accurately in the six test images. However, the model still misses situations when the damaged areas are dense or widely distributed. As shown in Fig. 12D5, although the damage type of the entire photo is SS, the model can only detect part of the damage type and mis-detect it as WS in some areas. This reveals, to a certain extent, the similarity in certain visual features between SS and WS, making it more challenging for the model to distinguish between them. Taken together, these results are generally consistent with the conclusions of the previous indicator analysis stage.

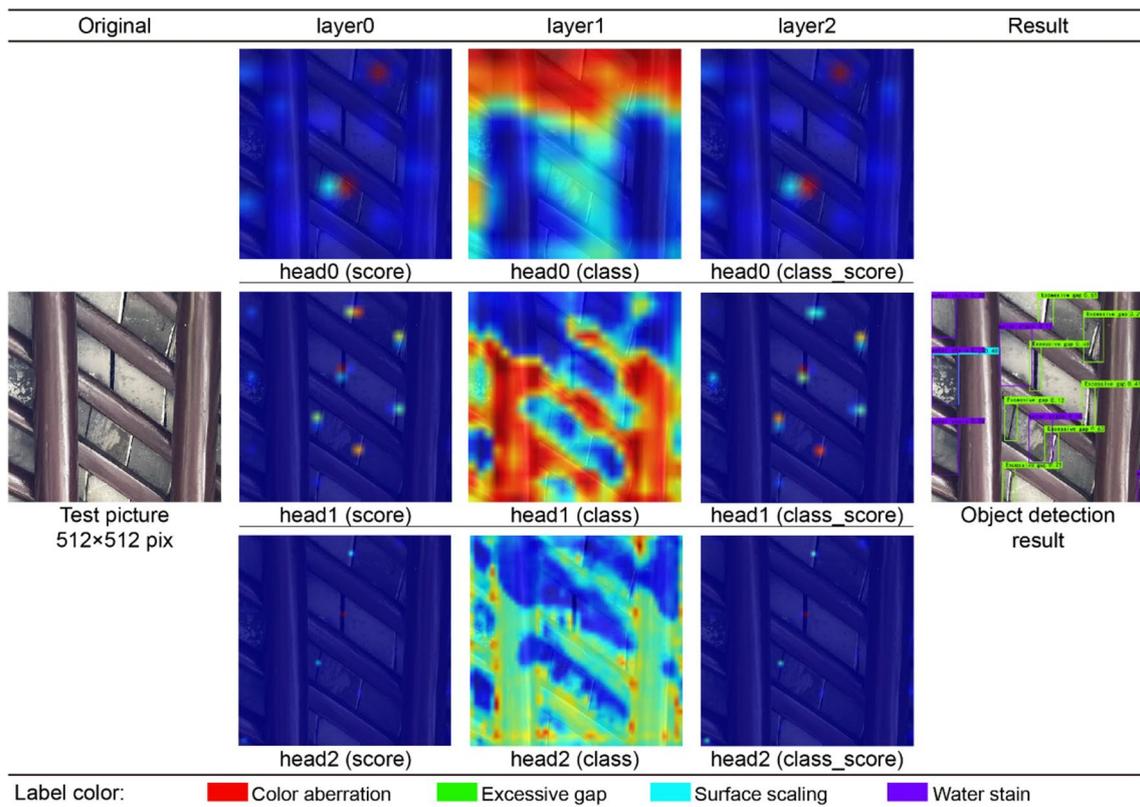
Fig. 12 Heatmap analysis of test images. (Drawn by the author)

inside during the damage detection process. These output results are presented in the form of heatmaps, with particular attention given to their ability to identify shedthin tile damage at different scales. In YOLO's architecture, different detection heads are usually responsible for identifying targets of different scales. By analyzing their output, we can further understand the model's adaptability and recognition strategies for object scales. As shown in Fig. 12, due to the relatively short shooting distance, head0 and head1 show more significant feedback, mainly focusing on smaller-scale target detection, while head2's response to the image is relatively weak, which also confirms that it is usually responsible for detecting the characteristics of larger-scale targets. In the multilayer output of the model, the "score" layer functions as a quick location target, highlighting the approximate location of the damaged area in the image. The "class" layer is responsible for determining the category of the located area, that is, distinguishing different types of shedthin tile damage. The "class_score" layer combines the information from the first two layers and outputs the final heatmap, which reveals the model's judgment and confidence in different damage types in each area. Finally, the model locks and outputs the final detection result through the pre-defined anchor box strategy.

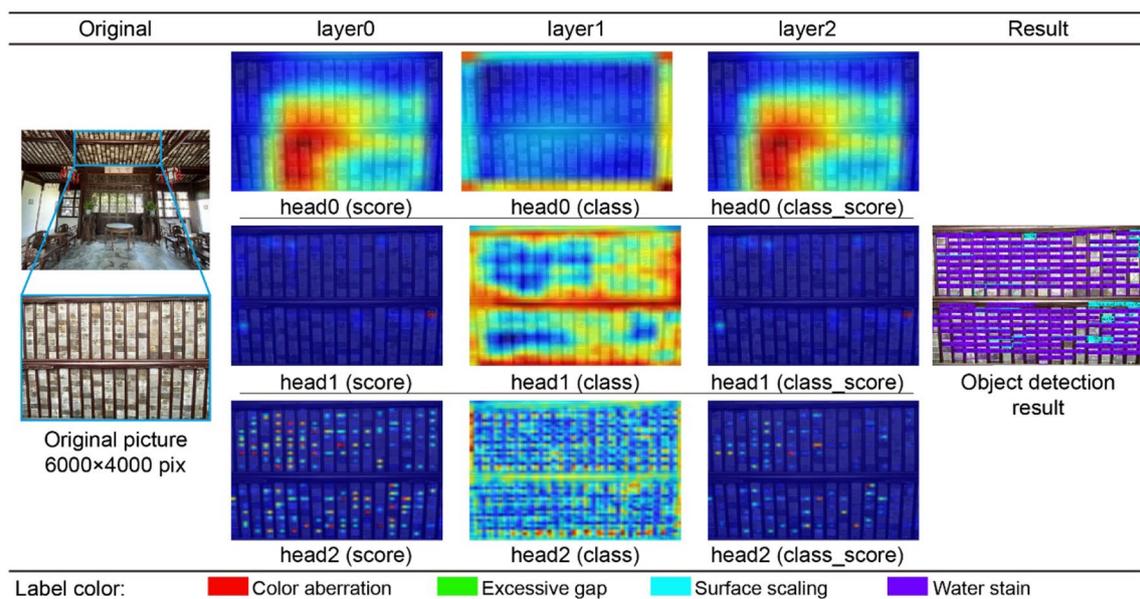
Fig. 13 Heatmap analysis via on-site photo inspection. (Drawn by the author)

In the practical application stage of the model, this research adopted a real-scene experiment method, specifically taking an original picture from the interior of the building in the Jiangnan Classical Garden. Its size is 6000×4000 , which is much larger than the 512×512 image used in the model training and testing stages to simulate and evaluate the detection effect of the model in actual field applications. Figure 13 presents the results of this application experiment. Given the larger size of the captured images and the longer shooting distance, the model was able to capture more visual brick damage phenomena. In the generated heatmap, the "score" layer of head2 successfully locks the exact location of the damage, and the "class" layer also achieves relatively accurate classification of damage types. The overall output results mainly focus on two damage types, "surface scaling" (SS) and WS, which are consistent with the actual situation on site. In addition, the performance of the model in terms of error correction capabilities is worthy of attention. For example, in the "score" layer of head0, there are large areas of false positives (red areas). However, these locations are not strongly reflected in the corresponding "class" layer. This shows that the model suppresses these erroneous detection responses during the type judgment

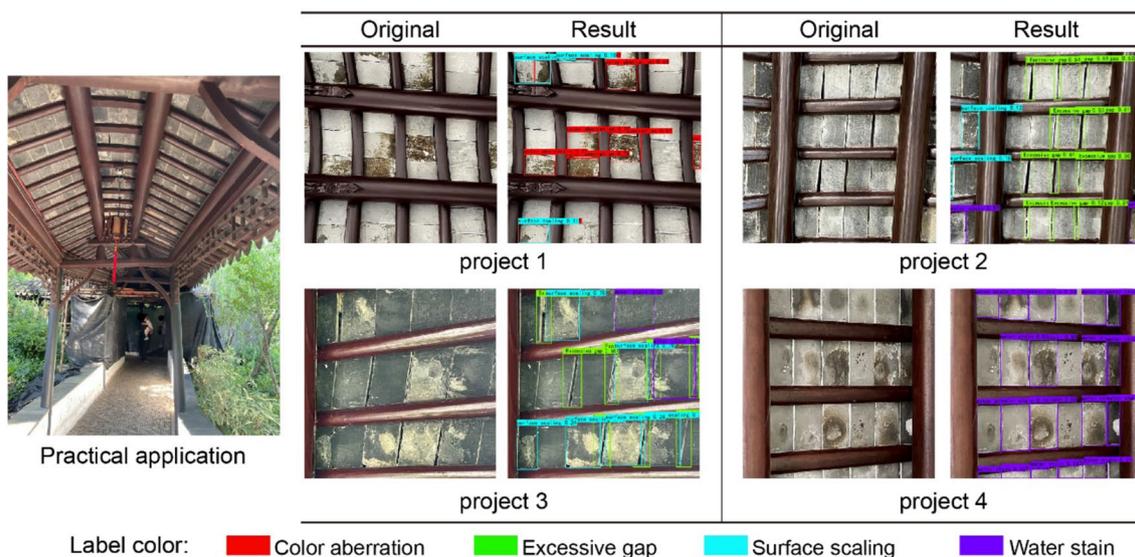
Fig. 14 Detection results for different types of shedthin tile damage. (Drawn by the author)

Figure 14 shows the detection results of four groups of experiments. In the image dominated by CA in Project 1, the model successfully captured all CA damage and identified some "surface scaling" (SS) damage. In the images dominated by the EG in Project 2, the model accurately located each EG and could also detect other types of damage, but some SS were misjudged as WS. In the images dominated by SS in Project 3, the model generally performs well, but there are still a few cases where SS is misdetected as WS. In the image dominated by WS in Project 4, the model successfully completed the detection task, every WS was accurately detected, and there were no false detections or missed detections.

The above experimental results indicate that, in most cases, the model can ideally complete various damage detection tasks. However, in some cases, especially in SS and WS detection, the model exhibits a certain degree of confusion, misdetecting SS as WS. However, overall, the detection performance of the model is excellent, laying a solid foundation for its deployment in practical application scenarios.
