# Damage and restoration technology of historic buildings of brick and wood structures: a review

Yunhong Hao<sup>1,2,3</sup>, Zhonghe Yao<sup>1\*</sup>, Rigen Wu<sup>1</sup> and Yuanyuan Bao<sup>1</sup>

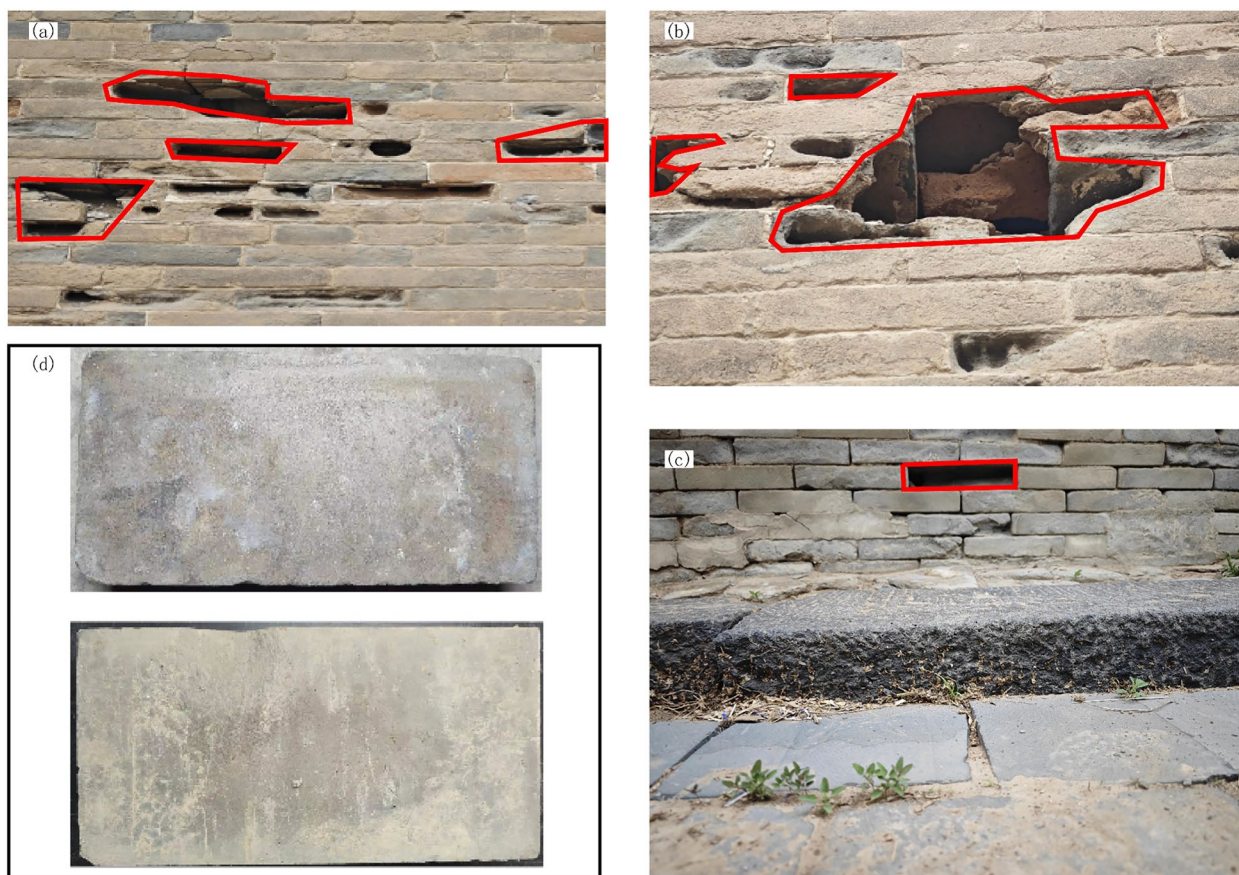
**Fig. 13** Material comparison and application of brick repair. (a) The case of discrete severe injury (b) The case of centralized severe damage. (c) Process the replacement area (d) Ancient building brick and archaizing brick

When the ancient brick materials on the historical wall surface are subject to severe weathering, resulting in substantial material spalling, or when the wall surface exhibits extensive material loss due to historical changes and human-induced damage, new bricks are selected and replaced using methods such as removal and subsequent re-infilling [13], as shown in Fig. 13. The specific treatment steps are as follows: First, the specific repair area should be marked, and the dimensions of the new bricks should be determined based on the specifications of the bricks in the wall to be repaired. An impact drill or hammer is then used to carefully remove the damaged bricks and mortar within the marked area to ensure that the new bricks can be inserted into their respective positions. Next, mortar is applied to the old brick positions and the new bricks are immediately attached to the wall. During the installation process, the position of the new bricks should be constantly observed to maintain the wall's visual harmony. Finally, mortar is used to fill the gaps between the bricks and smooth the surface, allowing the mortar to cure and complete the replacement process. The selection of brick and mortar materials should be flexible based on the actual situation. New bricks should not only match the size of the old bricks but also have a color that is similar to minimize the visual impact of the repair. Additionally, the mineral composition, element types, and physical and mechanical properties of the new bricks should be similar to those of the old bricks. For sustainable restoration of historical buildings, there is a high requirement for the interface bond performance between the mortar and the substrate. The pore characteristics and hydration products of the mortar, to some extent, determine its bonding strength with the substrate. The internal water migration and redistribution significantly affect the durability of the repaired area. The impact of water exchange between different repair mortars and porous brick materials on the mortar's pore structure and overall hygroscopic properties is a key focus in mortar performance research. Many scholars have conducted extensive research on this issue, including microscopic studies of mortar types [92], admixtures [93], and water-cement ratios [94]. Common approaches include using high-bonding strength and well-compatible mortars such as lime mortar [95], cement mortar [96, 97], and polymer mortar [98] as

the base materials. These materials can be enhanced in terms of compressive strength, shear strength, and bonding strength through changes in their preparation methods [95], fiber modification [98], or component replacement [99]. In practical applications, the optimal material should be chosen from multiple perspectives, such as pore characteristics, mechanical properties, and durability, considering the environmental conditions and the specific characteristics of the building to improve the repair effect.

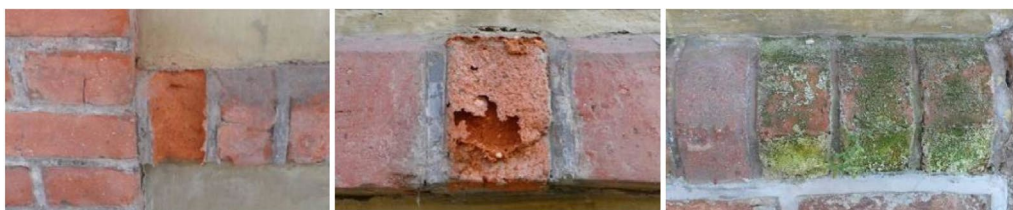
**Fig. 14** Corrosion of Attached Building Brick Surface [78]

This method has been applied in restoration projects such as Yongqing Fang, adjacent to the site of the First National Congress of the Communist Party of China [29], and the Qingdao Changzhou Road Prison restoration [78]. During the construction process, on the basis of brick replacement, a transparent coating was sprayed on the ancient wall surface for protective treatment against corrosion and moisture. Additionally, in the Yongqing Fang project, a large amount of sand-containing cleaning agent was used to wash the new bricks to achieve an aged effect. The Qingdao Changzhou Road Prison, located in a region with high humidity, exhibited phenomena

not observed in the Yongqing Fang project after the restoration. The brick blocks in the replacement parts of the prison showed obvious local peeling, weathering, and mold growth, and the situation was becoming increasingly severe (Fig. 14). Certainly, this is not a technical issue with the brick replacement method itself but rather a reflection of the traditional craft not being integrated with other protective and maintenance techniques suitable for the unique climatic environment of the historical building. If consolidators were used for pre-treatment before the repair and hydrophobic agents were applied to the wall after the repair for moisture protection, it might have enhanced the timeliness and durability of the repair. The method of brick replacement has high requirements for construction techniques and causes minimal disturbance to undamaged or slightly damaged ancient brick walls, to some extent reflecting the principle of preserving the authenticity of historical materials. The choice of replacement bricks is diverse and can be old bricks removed from the building interior or new bricks that have been artificially aged using technical means, such as regenerated waste geopolymer bricks

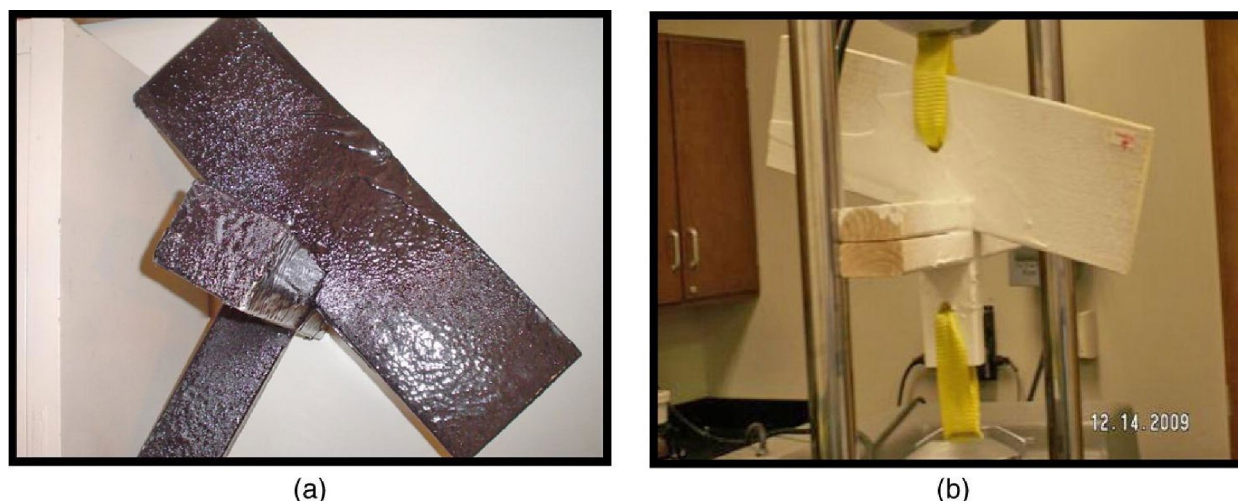
**Fig. 22** Schematic diagram of polyurea coating reinforcement [135] (a) Black polyurea material with high elongation and low elastic modulus (b) White polyurea material with low elongation and high elastic modulus

enhancing the stiffness of the nodes. David et al. [135] found that the addition of polyurea coating increased the load-bearing capacity of the nodes by about 200–400%, while ordinary metal spiral fasteners only increased it by 25%. Additionally, the polyurea coating also prevents wood rot and cracking (Fig. 22). Such repair methods that combine chemical adhesives with internal metal components not only improve the performance of the repaired nodes but also minimize interference with the appearance of historical buildings, enhancing the sustainability of the repair and maximizing the authenticity required by the restoration principles of historical buildings.

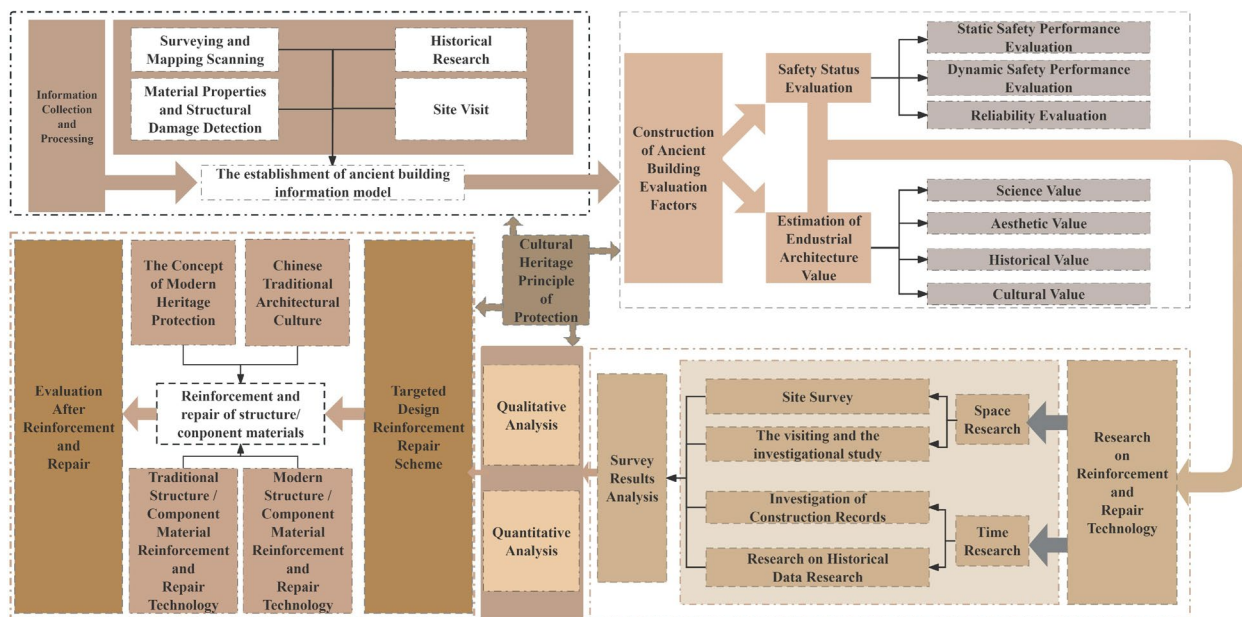
**Fig. 23** Technical roadmap of the whole process of historical building restoration

By conducting historical research and field surveys, the construction age, historical evolution, and architectural form of the historical building are clearly defined. Utilizing laser scanning or three-dimensional modeling techniques combined with traditional surveying, a three-dimensional refined stereo model that includes the overall structure and components of the building is established. Through technologies such as image recognition quantification, thermal imaging, or three-dimensional stress wave, the material properties and damage information of the structure or components are identified, allowing for a systematic understanding of the damage characteristics of the historical building. This understanding is then used to establish a building information model and construct evaluation factors for assessing the safety performance of the structure and components.
