The deterioration process of limestone in the Anahita Temple of Kangavar (West Iran)

Vahid Barnoos, Omid Oudbashi*

Abstract

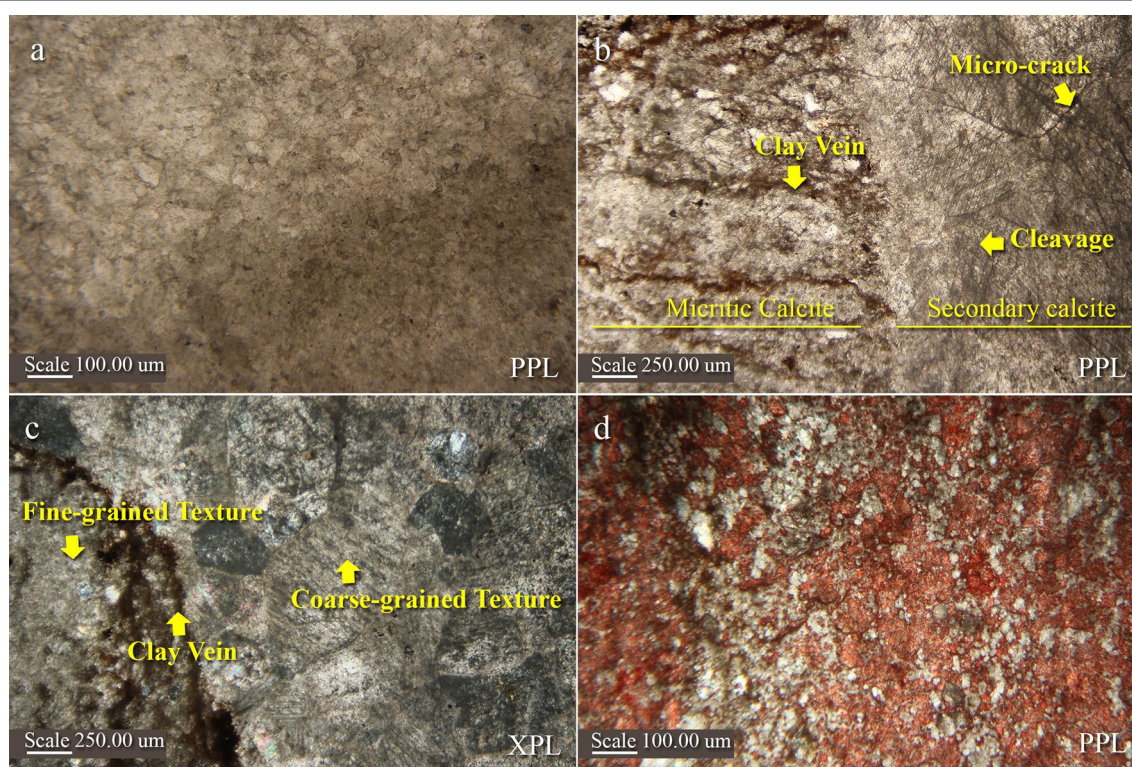
Fig. 3 Thin section petrography micrographs of stones samples from the Anahita Temple. **a** The micrograph of the sample K3, showing the matrix of micrite with a compact texture and low porosity; **b** the micrograph of the sample K4, which shows secondary calcite formed within the compact calcite matrix, clay veins, and the presence of cleavage and micro-crack in the stone structure; **c** the micrograph of the sample K3 in dark field (XPL); the image shows multi-texture structure of stone in form of “fine-grained texture (micritic)” and “coarse-grained texture (sparite)” and placement of clay veins between two textures; **d** the micrograph of the sample K4 indicating the dolomite phase in the stone texture using Alizarin Red S test

Petrographic studies on the thin section of two samples (K3 and K4) showed a presence of calcite (CaCO_3) as the matrix of stone samples (Fig. 3a–c). All samples have sedimentary features with two different calcite textures (Fig. 3b), including a fine-grained matrix and coarse-grained veins. The size of calcite crystals in the matrix and veins are not equal, although it is almost the same in the veins. The coarse-grained calcite veins include secondary calcite crystals that are different in size with the fine-grained calcite matrix, probably due to the different conditions of crystallization. On the other hand, some fine and narrow veins are visible in the microstructure of the samples, being compositionally different from the calcitic texture. These are consisting of very fine veins filled with non-carbonate (probably silicate) phases especially of clay minerals. In fact, perhaps differences in the matrix and veins (secondary calcite and clay) due to the diagenesis conditions of sedimentary stone. Based on the petrographic observations, stones consist of fine-grained texture (micritic calcite) and coarse-grained

Furthermore, several micro-cracks are evident in the microstructure of stones, which can be observed particularly in the thin section of sample K4 (Fig. 3b). Also the cleavage is clearly visible in the texture of the sparite veins of this sample (Fig. 3b). As noted above, narrow veins are present in the stone microstructure probably filled with fine-grained clay minerals that are not formed in the coarse-grained sparite veins. In some areas, some holes are formed in the clay veins that probably contain

iron compounds. The clay veins are located in the boundary of two main calcitic textures of the stone: micritic matrix and secondary sparite. Figure 3c shows secondary sparite with large and coarse grains beside micritic texture, and clay veins of dark color are located at the boundary of these textures. The Alizarin Red S test was performed on the thin section of sample K4 and revealed a presence of fine-grained dolomite ($\text{CaMg}(\text{CO}_3)_2$) phase within calcite crystals in this sample. Therefore the presence of dolomite mineral proved in the texture of the Anahita Temple's stones in previously published works, is proved once more with this test [42].

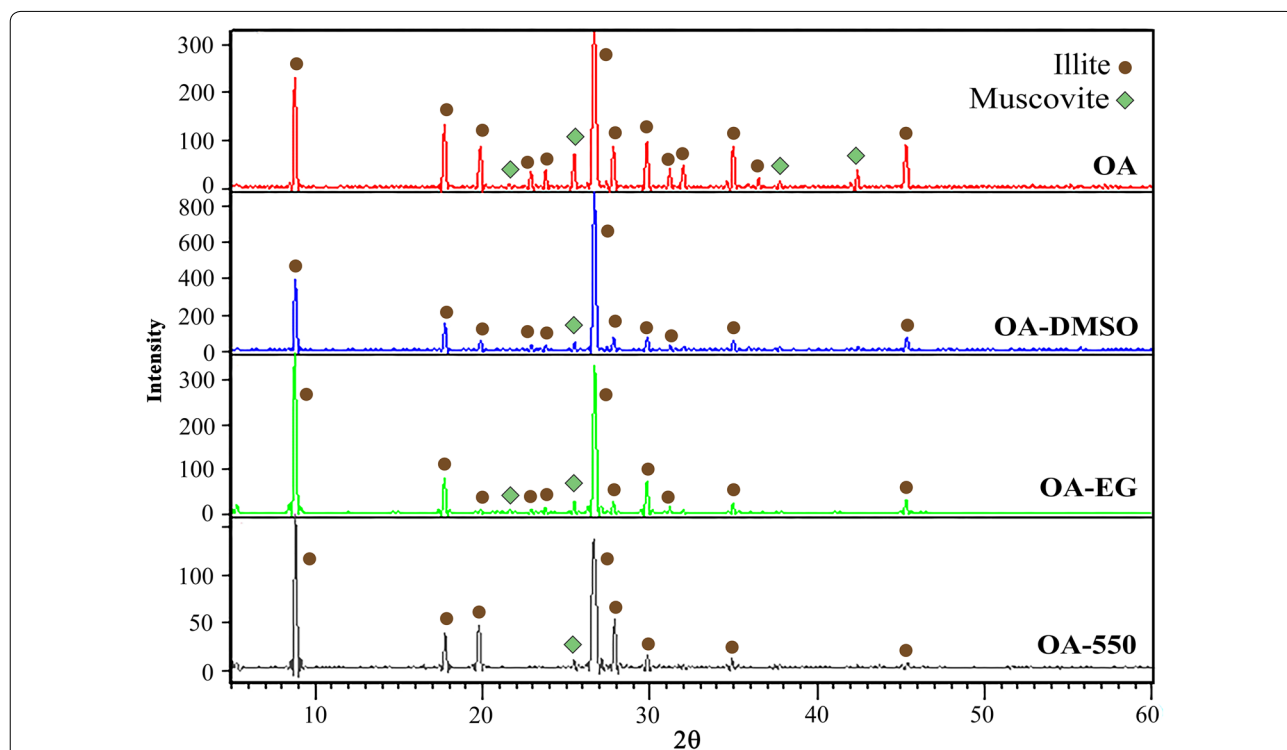
Fig. 5 The comparative X-ray diffractograms of the separation of clay minerals; the sample is from the Chel Maran quarry (sample M1); the results show illite and muscovite as the major phases in different types of sample

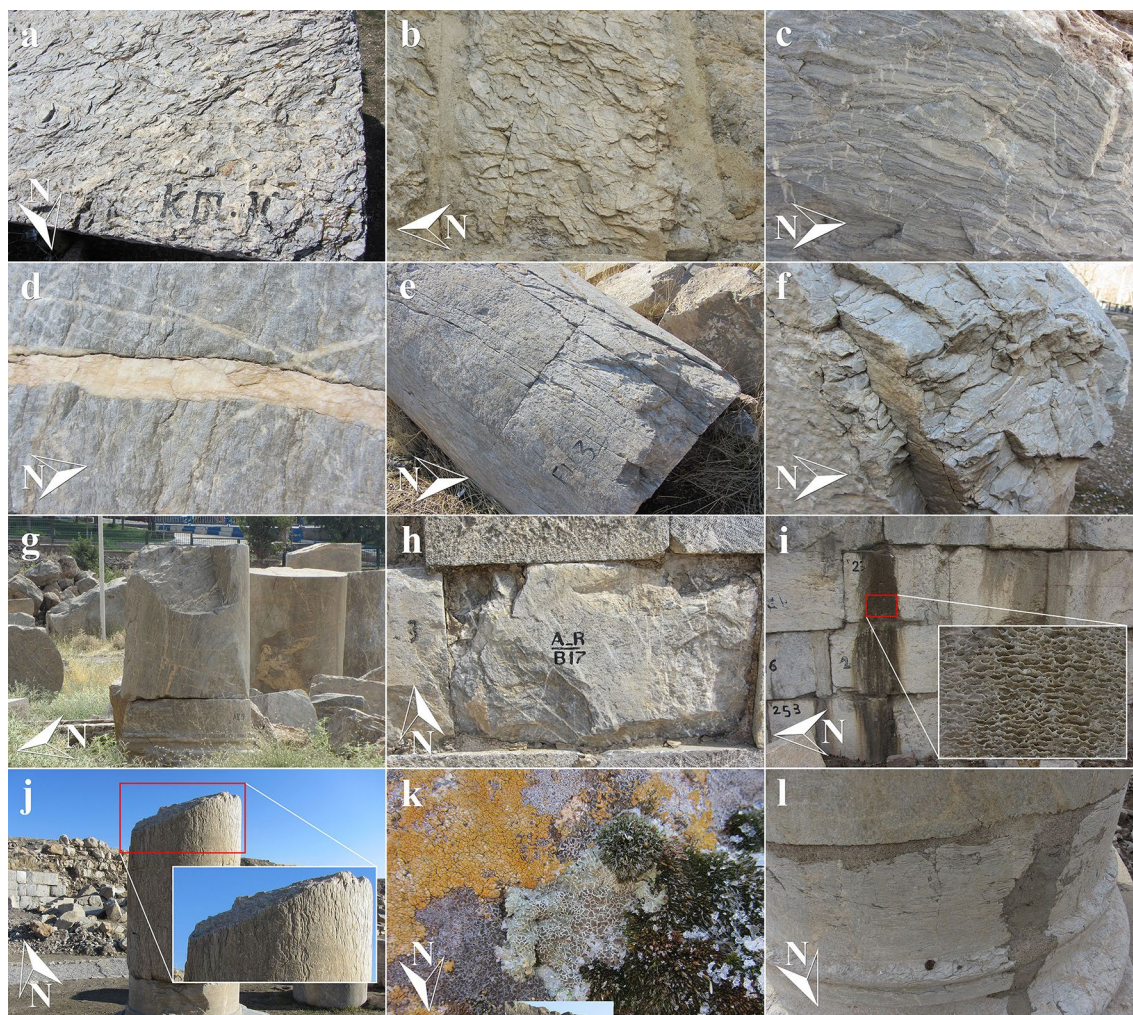
Fig. 6 Image of decay patterns of the stones used in the construction of Anahita Temple of Kangavar. **a** The scaling occurred in the south side of the monument which located in the area around the main building; **b** the scaling of the stone blocks forming the wall of the western side; **c** delamination of the layers of stone, the southern side of the monument; **d** the image showing the detachment of two layers with different colours from the columns located on the south side of the monument; **e** cracking occurred in a stone column, the eastern side of the site; **f** the detachment in a stone column on the western side of the monument; **g** the image of the bursting and the loss of stone in the south side of the monument; **h** bursting of the edges in the blocks of wall construction on the south side of the monument; **i** Alveolization and the formation of hard depositions on the surface of the wall of the western side of the monument; **j** the occurrence of the rillenkarren phenomenon in one of the columns located on the southern side of the site; **k** the growth of lichens on the stone surface located on the eastern side of the monument; **l** unsuitable intervention in the form of widespread use of cement to fill the loss parts of stones; the image shows the columns located on the western side of the monument

The on-site observations show that highest frequency of this type of deterioration pattern covers “delamination”, “scaling” and “fragmentation” forms (Figs. 6a–f) [60]. One of the important reasons for happening of delamination in stones could be cracks at the original used stone [61], as this pattern occurred in the stones of the Temple. In many areas, scaling has caused the separating pieces of small and large scales in the forms of spalling (or contour scaling) and flaking [60, 62]. These detachment’s type deteriorations have been occurred along the sedimentation layers and veins. “Bursting” is another type of deterioration pattern that occurred in some stone blocks in the Temple (Fig. 6g, h). This decay type might be caused by geological factors such as an earthquake, as it is apparent in the column shown in Fig. 6g. In the literature, the high risk possibility of the earthquake in the Kangavar region is mentioned and in fact the happening of an earthquake has been recorded in the past [28, 63]. As there is still some ambiguity on the subject, another

reason could be the displacement of the stone blocks and their falling off from the platform. In some stone blocks used in the south wall of the monument, another type of bursting is visible in the edges of blocks, which may be occurred due to stress exerted from the heavy stone blocks (Fig. 6h). The other type of deterioration patterns is “alveolization” on the surface of stone blocks, which is observed in some blocks of the eastern and western walls of the Temple and was probably produced by some contaminations (depositions) on the surface of few stones (Fig. 6i). These depositions often form by introduction of soluble or insoluble substrates from the materials surrounded the stone blocks such as mortar, resulting the formation of hard crust on the surface of stones. The main reason for this movement may be either rainfall or water-moisture raised from the ground. In some blocks, a phenomenon similar to “rillenkarrén” is occurred in the form of fissures parallel to the curved and perpendicular edges at the surface, as seen in Fig. 6j. Rillenkarrén are patterns of tightly packed, small solution rills or channels with about 20–30 mm found upon bare and separated by sharp angular ridges, sloping surfaces of soluble rocks in all climates [64, 65].

Biological colonisation (including lichens) is another phenomenon observed as a significant deterioration pattern in some areas of Anahita Temple of Kangavar (Figs. 6k and 7e, f). Though the intensity and development is partially low on the surface of stone blocks, it is a little more considerable in the eastern and south-eastern sides of the monument that shows more biological activities of lichens in this area of the monument, probably due to lower average stone surface annual temperature in the area [66]. In some columns and in many of the stone blocks used in walls of the monument’s platform, cement mortar is used for joining and filling large cracks

and empty veins of the stone as a restoration measure in recent decades (Fig. 6l); these cement layers are also detached from the stone surface as a deterioration event in some parts.

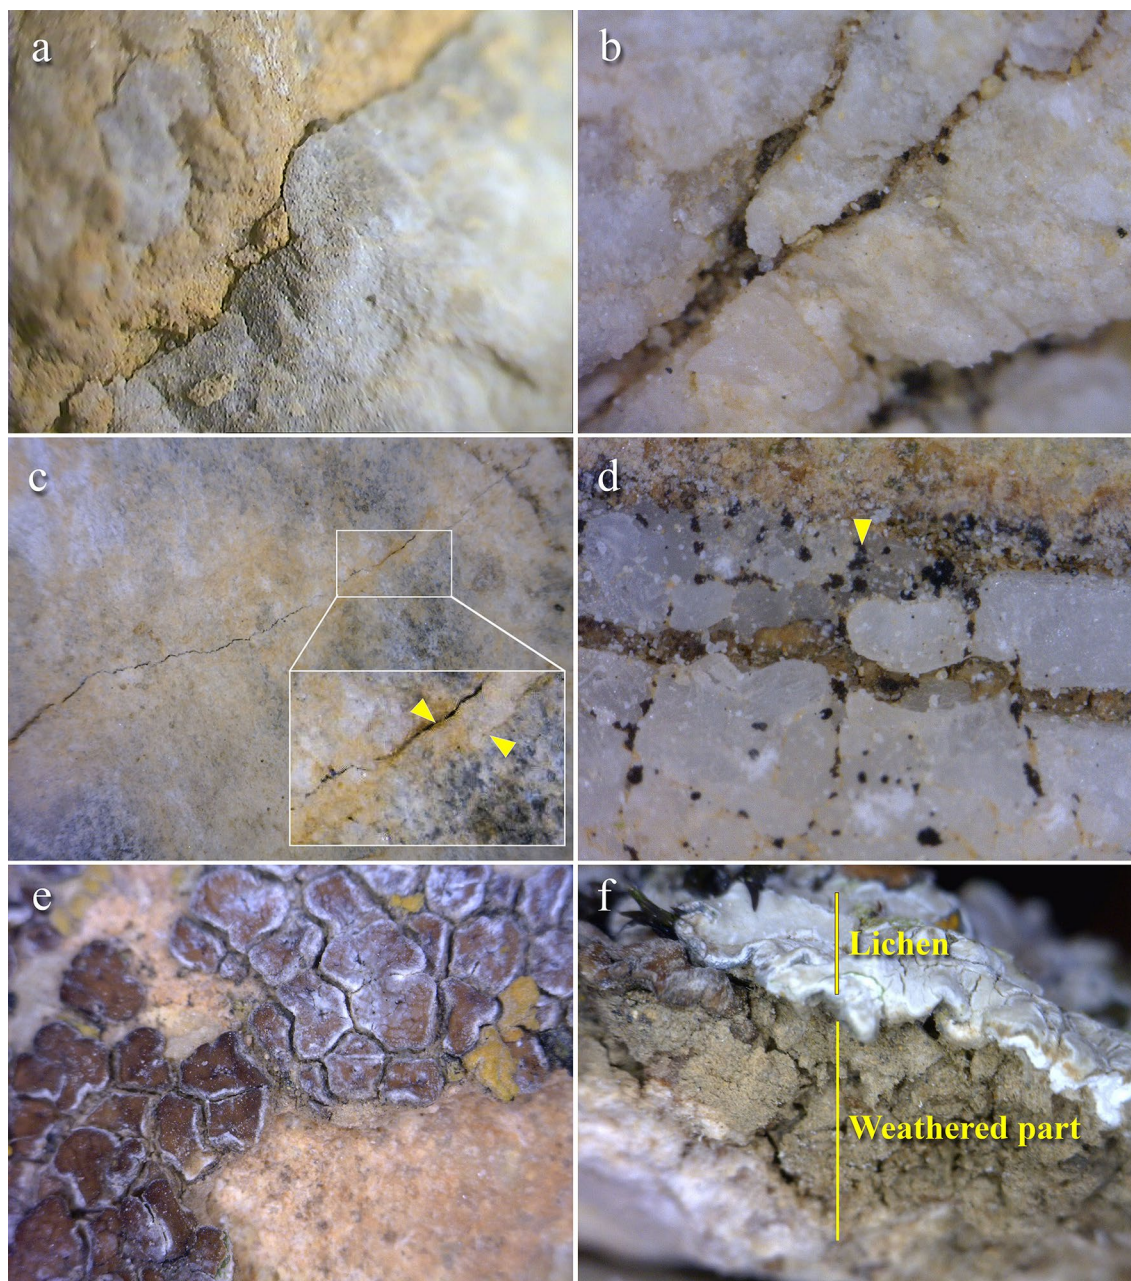
Fig. 7 Optical microscopy (OM) images of the surfaces of stones taken by stereomicroscope in low magnification (50×). **a** The weathering surface of stone belonging to sample K2 that indicates the process of deterioration of the stone by separating clay vein and stone matrix; **b** the image of cracks in stone texture from sample K6; **c** the image of the detachment of secondary calcite from the texture of micrite, sample K1; **d** the image of fungi on the surface of stones, sample K7; **e** growth of lichen on the surface of stones and its influence on stone deterioration (sample K10); **f** the image of the stone deterioration by the growth of lichens in the weathered cross section of sample K10

Study of the surface of stones in low magnification by stereomicroscope revealed two layers with different colours (limestone and soil) with detectable detachments (Fig. 7a). Figure 7b illustrates the weathered surface of calcareous stone occurred in the form of small cracks. Furthermore, Fig. 7c shows large secondary calcite veins

in the stone texture as one of the important features of the stones. In Fig. 7c, a small detachment at the boundary of the secondary calcite vein and the micritic texture is visible. Presence of microorganisms such as fungi and lichens is another type of deterioration that observable in cracks, veins and holes in the low magnification (Figs. 7d, e and f; see small colonies of fungi in Fig. 7d). Microorganism presence leads to chemical and physical deterioration of stone [67–70]. In some areas, the surface of the stone blocks has been lost due to the chemical

and mechanical activities of lichens and transformed to powdery material. Figure 7f shows the deteriorated section of a stone block due to activity of lichens. This phenomenon is occurred in the form of the powdering of the stone surface which exposed to the lichens and resulted as by-products of lichen activities such as clay

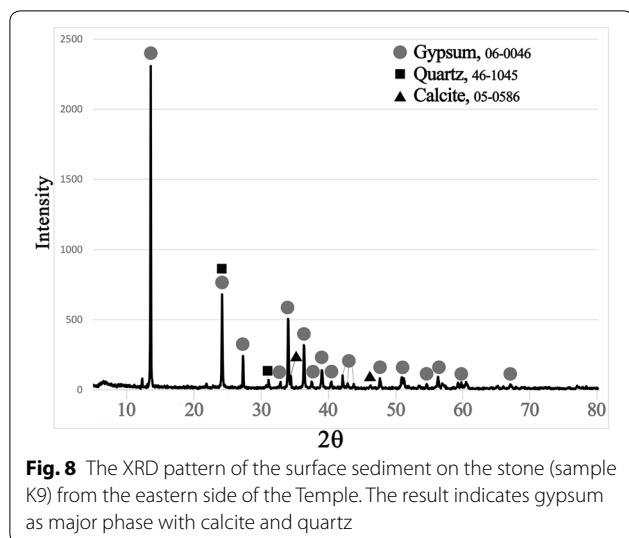
The X-ray diffractogram of thick crust on the surface of some stone blocks (sample K9) indicated gypsum as the major phase and calcite and quartz as the minor phases (Fig. 8). In fact, this crust is formed from gypsum and

its composition is strongly different from the limestone itself. The gypsum crust may be related to the gypsum mortar used in the construction of the Anahita Temple, as had previously been observed in the construction of the inside core of the building [42]. The formation of the crust may be related to solubility of gypsum in presence of moisture/water followed by its recrystallization on the surface of the stone blocks.

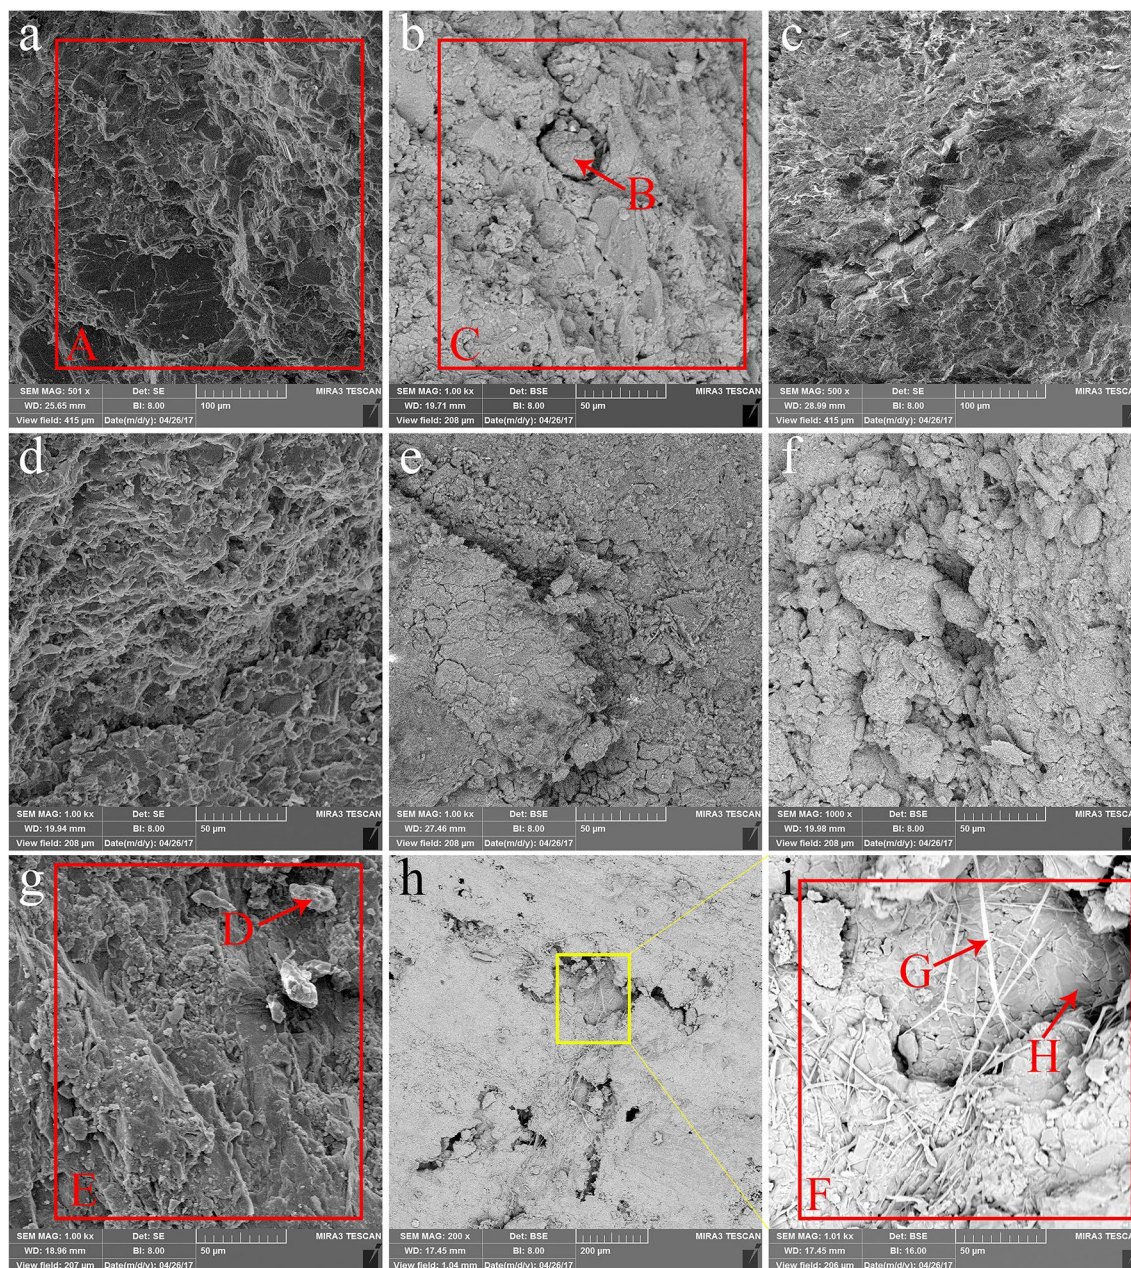
Fig. 9 SEM micrographs of the stone samples from the Anahita Temple including section and surface of stone samples. **a** The SE micrograph of the sample K2 that shows the compact structure and the intact texture of the stone; **b** the BSE micrograph of the sample K1 that indicate evidence of detached stone particles; the replacement of a phase is occurred in a cavity of the matrix texture; **c** the SE micrograph of the sample K8, in which a deterioration in the form of detachment of the stone’s texture is visible. **d** the SE micrograph of sample K5 which represents the detachment of the layer; **e** grain detachment at stone surface in sample K8 in the form of BSE micrograph; **f** the BSE micrograph of sample K1 which shows the deterioration of stone as a grain detachment; **g** the image shows evidence of dissolution at the stone surface in sample K6 in the form of SEM micrograph; **h** the BSE micrograph of sample K10, the lichens hyphae in the stone texture; **i** the BSE micrograph of the area specified in yellow from sample K10, In the image, the lichens hyphae and degradation in the stone are visible. Results of EDS analyses are presented in Table 4

Matrix of sample K2 (analysis A) represents the calcite-based texture along with other minerals such as probable clay with sulphur and phosphorus. EDS analysis of a phase in stone matrix in sample K1 (analysis B) shows evidence of clay minerals with less content of calcium and sulphur. In matrix of sample K1 (analysis C), calcium and the elements of clay minerals are detected. Analysis of the phase observed in sample K6 (analysis D) as well as matrix analyses of samples K6 and K10 (Analyses E and F respectively) show the calcite texture of the stone with silica, magnesium, iron, aluminium, potassium and sodium, as well as evidences of sulphur, phosphorus and chlorine. Analysis G in sample K10 represents calcite phase with about 10% sulphur. Other elements, such as silicon, are measured less than 1% in this analysis. Also analysis H in sample K10 represents a calcite-rich phase in the structure. The SE and BSE micrographs are presented in Fig. 9

SEM observations and semi-quantitative EDS analyses were performed on both unchanged section and surface of the stone. Figure 9 shows SE and BSE micrographs of the stone sections and deteriorated surface of the stone samples. SEM micrograph of the stone section in sample K2 (Fig. 9a) shows a significant compact texture of the limestone, while there are very few pores in its microscopic texture. Furthermore, the deterioration process of limestone is visible as micro-cracks and micro-detachments. The micro-cracks and detachment can be observed in samples K1 and K8 (Fig. 9b, c). EDS analysis of stone matrix in sample K2 (analysis A) shows that the main element is calcium, but low amounts of sodium, magnesium, aluminium, and silicon are also detected (Table 4). This analysis is well matched with the XRF analyses undertaken on the stone samples. BSE micrograph of sample K1 (Fig. 9b) shows a different phase from the Ca-rich matrix which is located in a cavity formed in the microstructure. EDS analysis of the phase (analysis B) revealed a Si-rich phase containing some amount of aluminium and magnesium beside low amounts of calcium and sulphur. Analysis of stone matrix in sample K1 (analysis C, Fig. 9b) shows also a Ca-rich matrix beside silicon and about 4.3 wt % of magnesium. Sulphur is also measured in low amount in the EDS analysis of the matrix of sample K1 (Table 4, Fig. 9b).

Detachment of outer layer in the surface of the stone is occurred in the form of micro-cracks formed at the boundary of the grains in SE micrograph of sample K5 (Fig. 9d). One of the important events is detachment of grains; being shown in Fig. 9e, f (samples K8 and K1). In sample K6, there are evidences of dissolution at the grain boundaries in the surface of the stone (Fig. 9g). It can be a natural event due to the calcium carbonate solubility over time [51]. This type of deterioration is considerably less observed than the physical weathering events mentioned above (as micro-cracks and detachments). The EDS analysis of a phase in sample K6 (analysis D in Fig. 9g and Table 4) shows that the major element is calcium, while low amounts of silicon, sodium, aluminium, and potassium are detected too. Sulphur, phosphorus and chlorine have also been measured as minor elements. Matrix analysis of sample K6 (analysis E) also shows a Ca-rich texture beside other elements such as silicon, potassium, aluminium and sodium as possible representatives of clay minerals. The presence of lichen hyphae is another aspect observed in SEM micrographs of sample K10 (Fig. 9h, i). Some parts of stones were suffered by the biological attacks in the form of variable pores surrounding the lichen hyphae, with evidences of plate form clay minerals. Matrix analysis in sample K10 (analysis F in Table 4 and Fig. 9i) also presents calcium as the main element with 36.89 wt % beside others representing chemical composition of clay as a minor phase. Phosphorus, sulphur, and chlorine have also been detected in low amount in analysis F. Presence of phosphorus may be an evidence of surface weathering exerted by biological agents [70]. Increasing the amount of some elements such as silica and aluminium in the analysis of surface occurs due to soil deposition on the surface of limestones. Analysis G in sample K10 of the lichens hyphae represents Ca with an almost high sulphur content as 9.87 wt % (Table 4, Fig. 9i) which may indicate a presence of by-products of biological activity. The results of analysis H from sample K10 also shows Ca and O as main elements showing partially pure calcite phase (Table 4, Fig. 9i).

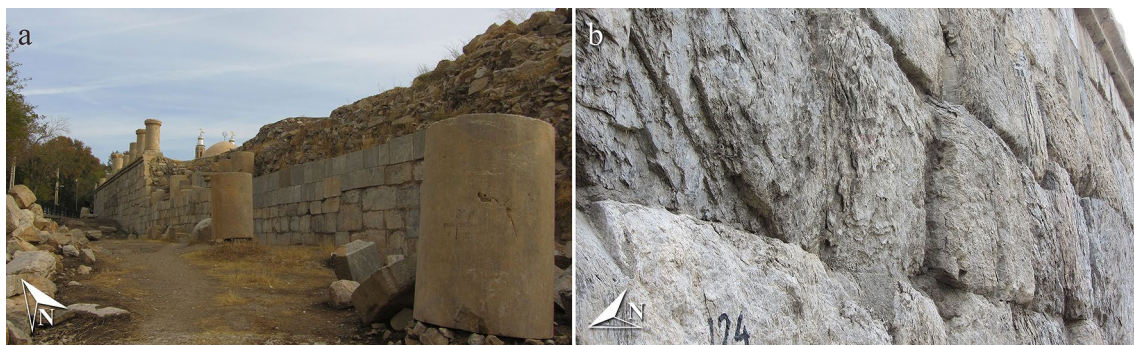
Fig. 11 **a** Images of the mass of soil behind the western wall of the monument; **b** close-up image of deteriorated blocks on the wall in the northwest area of the monument

limestone [99–102]. The presence of mass of soil under and behind the stone structure acts as a water storage, especially during the rainy seasons, and can make conditions even more proper for continuing deterioration in the stone blocks used in the construction of stone walls. These parts of the monument have underwent a long-term soaking and water absorption from behind of the stone wall during precipitation seasons (Fig. 11a). This is the reason of the high intensity of deterioration in the stone blocks used in the wall construction, especially in the eastern and western sides of the monument (Fig. 11b). These evidences prove that an integrated conservation plan, as a part of the site's management plan, is necessary so as to establish a strategy to make decisions on the conservation-restoration methods and materials, based on the results of study and characterization of the decay process occurred in the stone blocks of the Anahita Temple of Kangavar.
