RESEARCH ARTICLE

Sustainability problems of the Giza pyramids

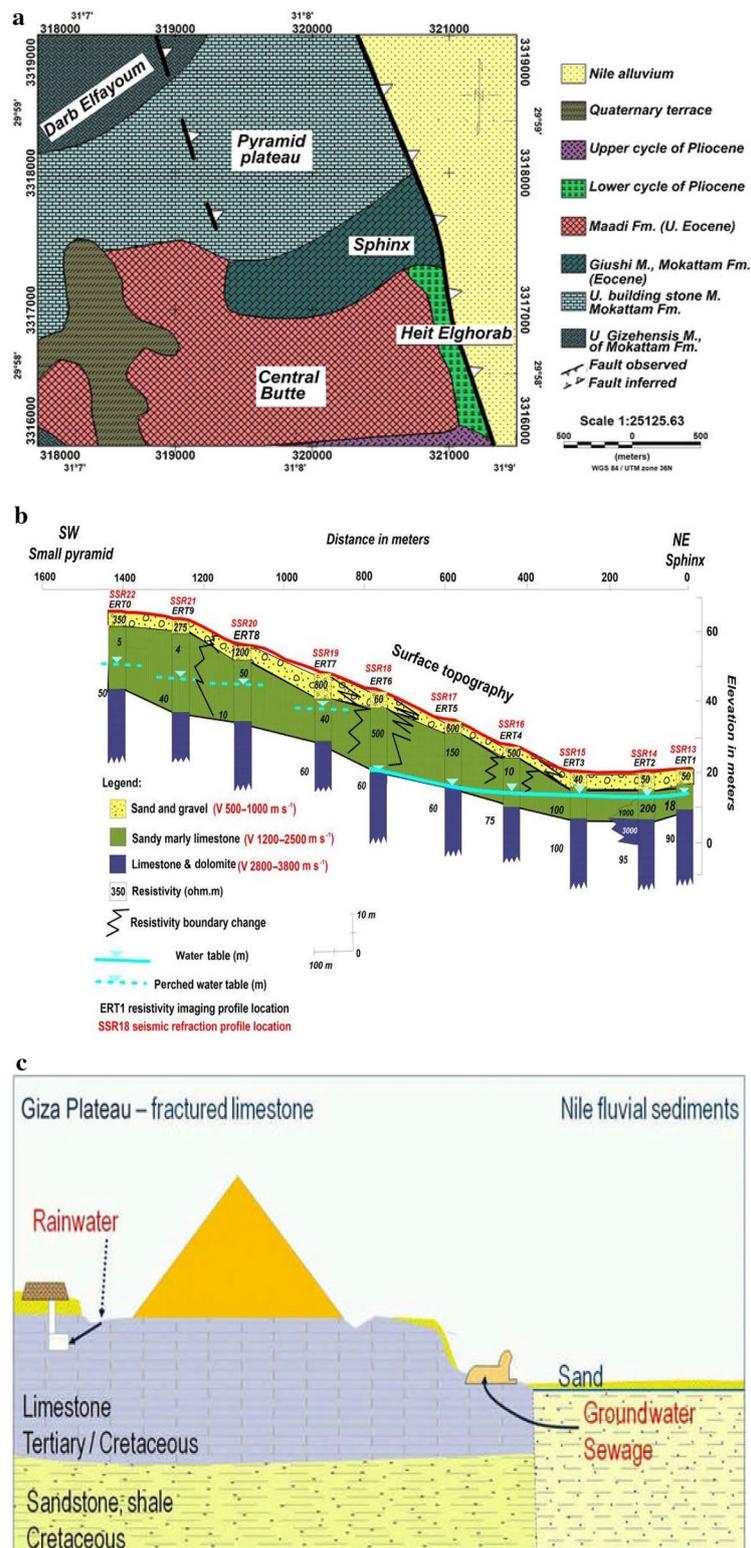
Fig. 4 **a** The geological setting of the Giza plateau, where the pyramids are built (modified after Yehia [12]). **b** A cross section using the ERT data shows how the groundwater elevation changes from the Sphinx to Menkaure Pyramid. It indicates an increase in groundwater elevation from west to east) (modified after Sharafeldin et al. [17]). **c** Groundwater aquifers affecting the Giza Plateau (modified after ElArabi et al. [30])

The studies show that the monuments of the fourth dynasty of the plateau of Giza are built on a sedimentary sequence with dominant carbonated formations deposited in an epicontinental sea of variable depth. All the authors agree that these sedimentary layers have the characteristics of the Mokattam formation and Maadi formation, from Middle to Late Eocene age, as shown in (Fig. 4a–c).

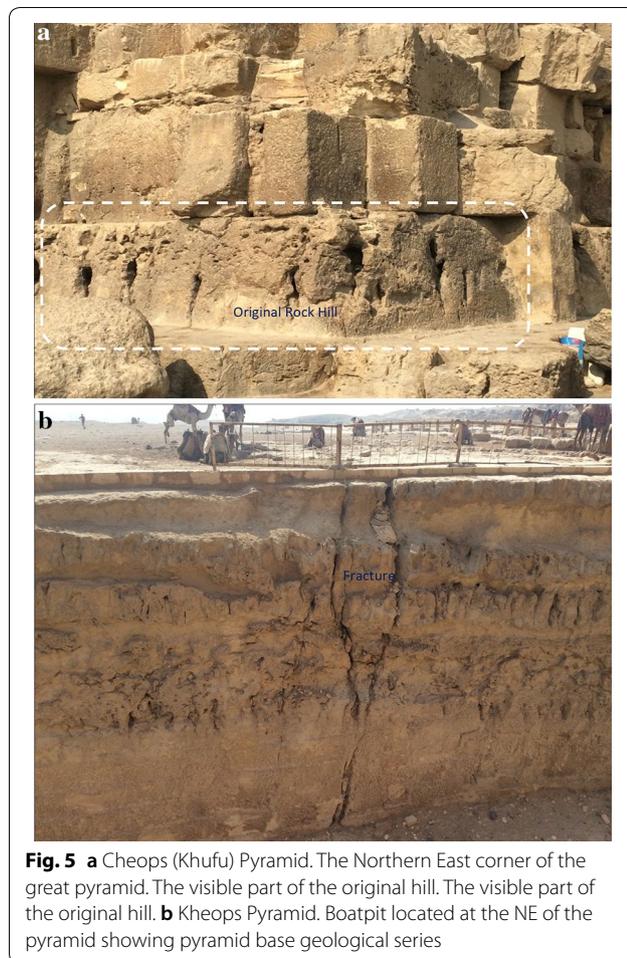
Fig. 5 **a** Cheops (Khufu) Pyramid. The Northern East corner of the great pyramid. The visible part of the original hill. The visible part of the original hill. **b** Kheops Pyramid. Boatpit located at the NE of the pyramid showing pyramid base geological series

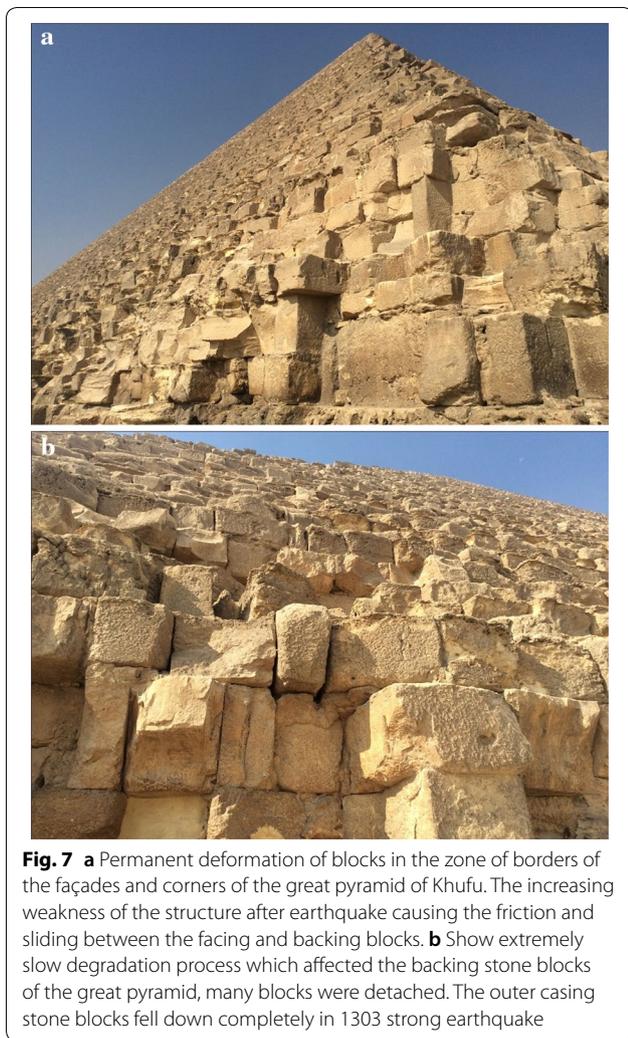
Fig. 7 **a** Permanent deformation of blocks in the zone of borders of the façades and corners of the great pyramid of Khufu. The increasing weakness of the structure after earthquake causing the friction and sliding between the facing and backing blocks. **b** Show extremely slow degradation process which affected the backing stone blocks of the great pyramid, many blocks were detached. The outer casing stone blocks fell down completely in 1303 strong earthquake

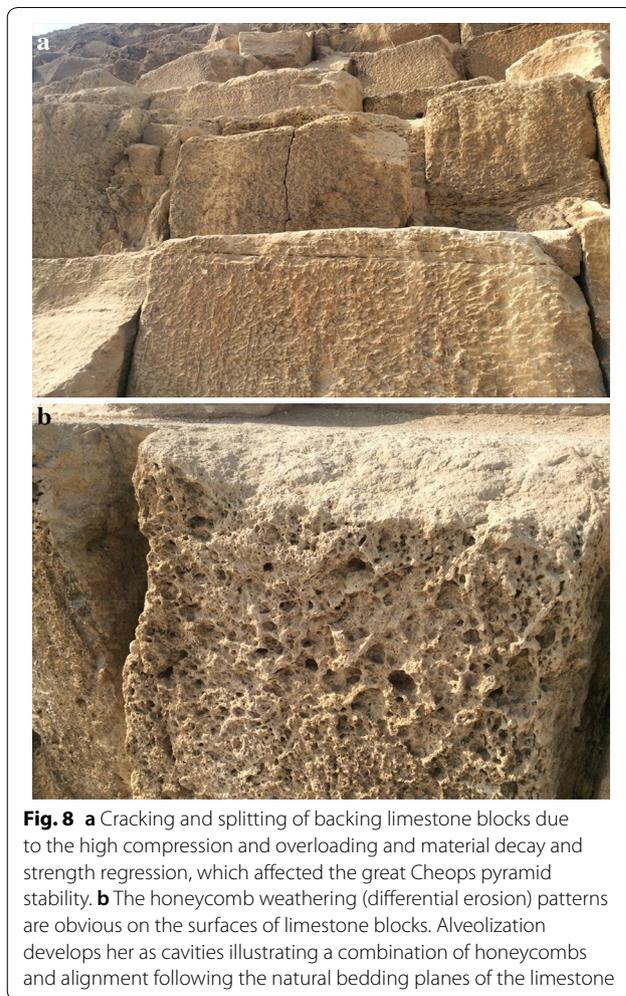
Fig. 8 **a** Cracking and splitting of backing limestone blocks due to the high compression and overloading and material decay and strength regression, which affected the great Cheops pyramid stability. **b** The honeycomb weathering (differential erosion) patterns are obvious on the surfaces of limestone blocks. Alveolization develops here as cavities illustrating a combination of honeycombs and alignment following the natural bedding planes of the limestone

The walls of the pyramid complex suffered from shear forces due to previous earthquakes; vertical cracks and

cracks with a direction of about 35–45° above the horizontal, shows the corresponding failure mechanism. Some cracks affect specific elements such as thresholds for openings, doors and foundation stones, as shown in (Fig. 8a, b). Cracking of backing limestone blocks due to the overloading and material decay and strength regression, which affected the great pyramid stability. The honey comb (differential) weathering aspects are obvious on the surfaces of backing limestone blocks. The outer facing limestone blocks are missed completely.

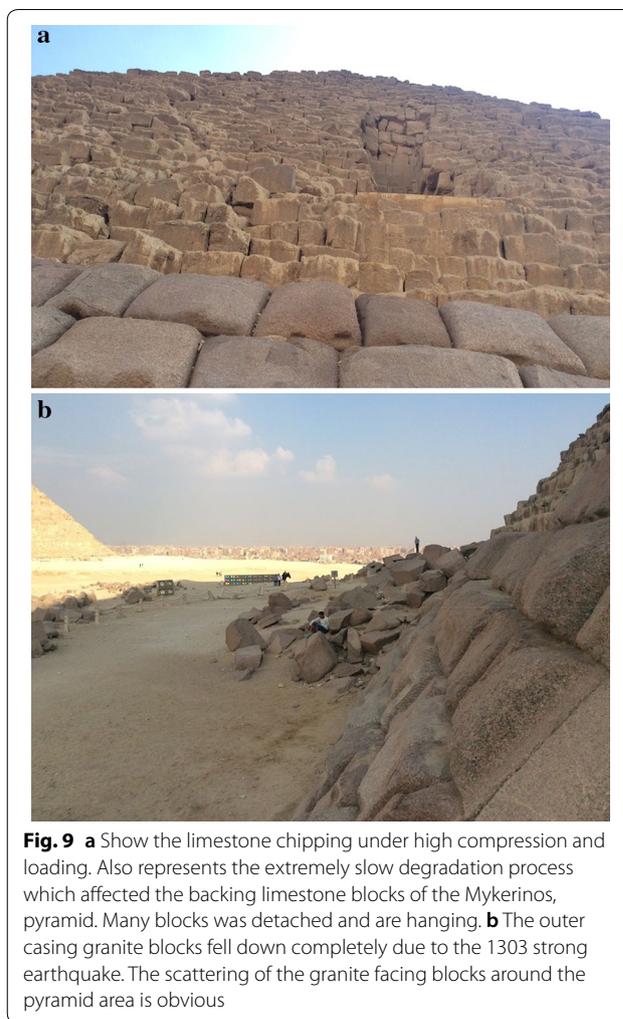
Fig. 9 **a** Show the limestone chipping under high compression and loading. Also represents the extremely slow degradation process which affected the backing limestone blocks of the Mykerinos, pyramid. Many blocks was detached and are hanging. **b** The outer casing granite blocks fell down completely due to the 1303 strong earthquake. The scattering of the granite facing blocks around the pyramid area is obvious

There is deterioration in many parts of the three pyramids, associated with the aging of materials and the

impact of aerial and ground water attack, and extreme stresses and cracks have accelerated the related phenomena, as shown in (Fig. 9a, b), extremely slow degradation process which affected the backing limestone blocks of the Cheops, Chephren and Mykerinos pyramids is obvious. Many blocks was detached and are hanging.

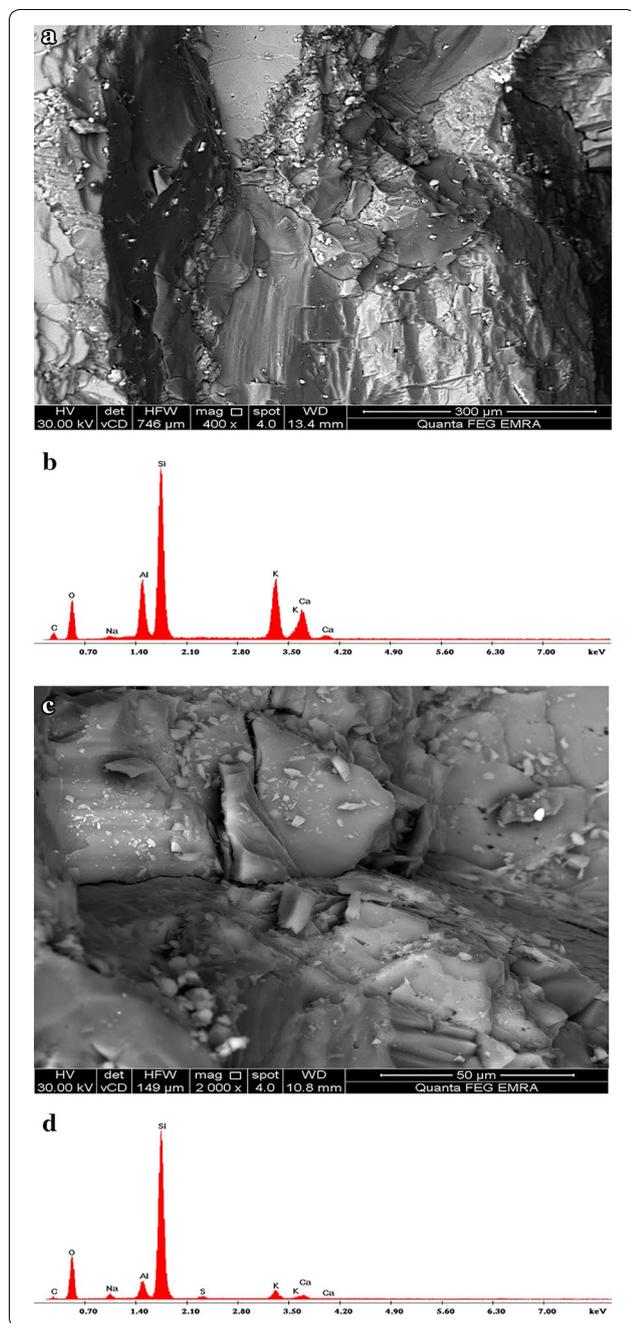
Fig. 15 **a** SEM microscopic examination and micro structure of the outer facing granite blocks of Mykerinos pyramid. Micrographs show heavy materials disintegration and few trace elements are slightly immobile, whereas most major (particularly Ca and Na) and trace elements are mobile from the beginning of the granite weathering. On the other hand, there were mineralogical changes initiated from a plagioclase breakdown, which shows a characteristic circular dissolved pattern caused by a preferential leaching of Ca cation along grain boundaries and zoning. The biotite in that region is also supposed to be sensitive to exterior environmental condition. **b** EDX spectrum of the previous image of the grains of the facing granite blocks of Mykerinos pyramid. A strong silica, aluminum and potassium signals are observed. **c** SEM microscopic examination and micro structure of the facing granite blocks of Mykerinos pyramid. It seems that some rock-forming minerals in the granitic facing blocks are significantly unstable due to the environmental condition. **d** EDX spectrum of the previous image of granite grains of the facing granite blocks of Mykerinos pyramid. A strong silica signal is observed

The cortex samples consist of (Si, Al, K, Ca, O, K, Na, C), (Fig. 15b, d).

The primary oxide averages for cortex or crust samples are (SiO₂, 31%), (Al₂O₃, 9%), (K₂O, 21%), (O, 20%), (CaO, 12%) and (NaO, 0.37%).

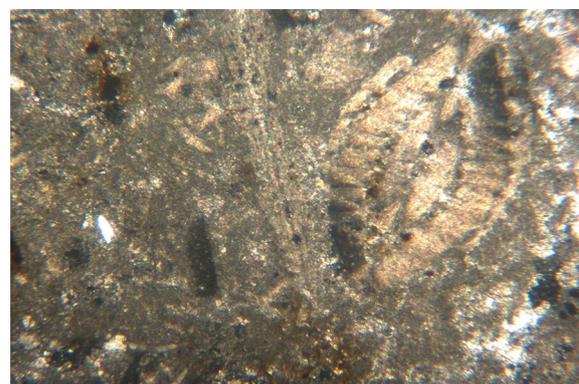
Fig. 16 Microscopic photograph shows the backing Fossiliferous limestone (Biomicrorite) blocks of Cheops pyramid, which composed mainly of calcite as the essential component associated with minor amount of iron oxides and quartz and rare of dolomite, opaque minerals and halite

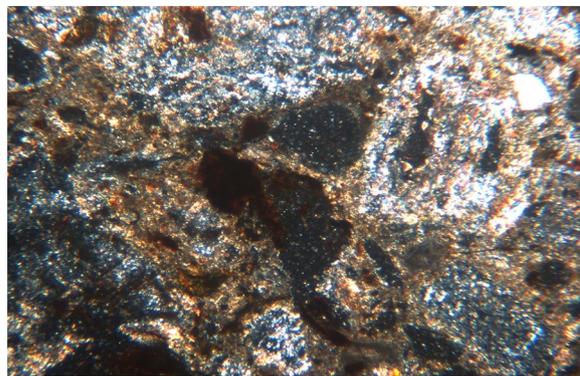
Fig. 17 Microscopic photograph shows the structural mortars joining the backing limestone blocks of Cheops pyramid. The joining mortar is very fine to coarse-grained and composed of gypsum, rock fragments (composed of calcite and dolomite), biotite, muscovite and rare quartz grains cemented by very fine-grained matrix of gypsum, anhydrite, calcite admixed with minor iron oxides

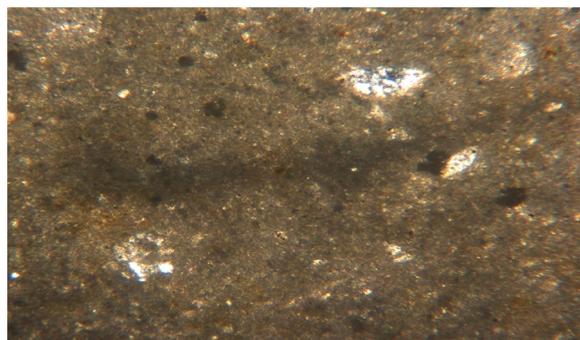
Fig. 18 Microscopic photograph shows the backing Fossiliferous limestone (Biomicrite) blocks of Chephren pyramid. The limestone is very-grained and composed mainly of calcite as the essential component associated with rare amounts of iron oxides, microcrystalline quartz and opaque minerals. Calcite represents the matrix of the rock and occurs as very fine-grained (micrite), anhedral to subhedral interlocked crystals. Quartz is detected as very fine-grained crystals scattered in the matrix

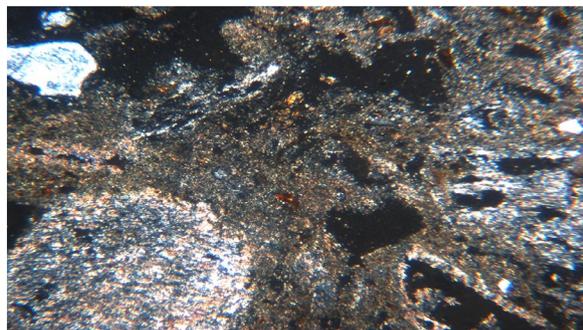
Fig. 19 Microscopic photograph shows the structural mortars joining the backing limestone blocks of Chephren pyramid. Very fine to coarse-grained, showing prophyritic texture (fine to medium-grained of quartz, gypsum and rock fragments enclosed in very fine-grained matrix). Significant amounts of irregular pore space are detected in the sample. The sample is composed of gypsum, anhydrite and rock fragments (composed mainly of calcite) associated with minor amounts of quartz, biotite, iron oxides and opaques cemented by very fine-grained matrix of gypsum admixed with calcite, anhydrite, halite and iron oxides

occur as very fine to medium-grained scattered in the sample. Significant amounts of irregular pore space and cavities (vugs) are detected in the sample (Fig. 19).

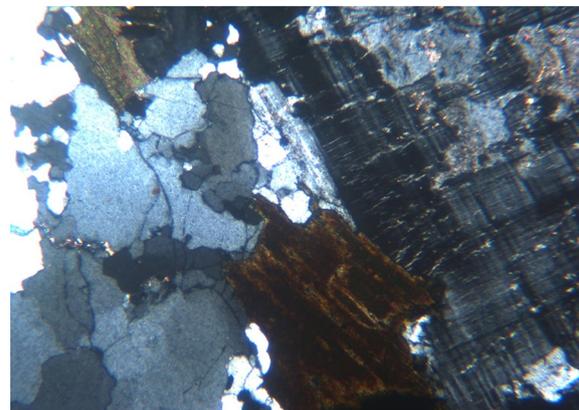
Fig. 20 Microscopic photograph shows the facing granite, plutonic, acidic igneous rock blocks of Mykerinos pyramid. The rock is medium to coarse-grained showing, equigranular, hypidiomorphic, perthitic and piokilitic texture. The rock is composed mainly of potash feldspar (microcline, orthoclase and perthite), quartz and plagioclase associated with considerable amounts of hornblende and biotite and accessory amount of muscovite, titanite, zircon and opaque minerals. Secondary minerals are represented by iron oxides sericite and clay minerals

thin films and fine inclusions intergrowths in microcline perthite. Hornblende presents as fine to medium-grained aggregates, prismatic crystals in association with biotite. Biotite occurs in minor amount as medium to fine-grained aggregates, tabular, flaky crystals at the interstices of feldspars and quartz. It is partially altered to iron oxides (Fig. 20).

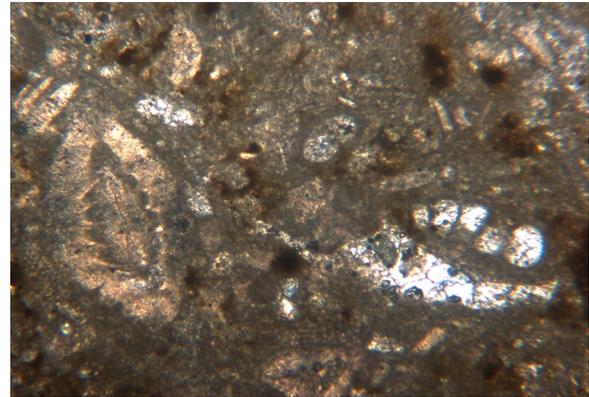
Fig. 21 Microscopic photograph shows the backing Fossiliferous limestone (Biomicroite) blocks of Mykerinos pyramid. The rock is very fine to fine-grained. Significant amount of microfossils of different sizes and shapes are present in the matrix. Few pore spaces (irregular shapes and sizes) are present in heterogeneous distribution in carbonate matrix of the rock. The rock is composed mainly of calcite as the essential component associated with minor amount of iron oxides and rare amounts of quartz, gypsum and opaque minerals. Calcite represents the majority of the matrix of the rock and occurs as very fine-grained aggregates, anhedral crystals interlocked with each other's. Iron oxides occur in considerable amount as fine-grained aggregates and also as patches stained some parts of the sample

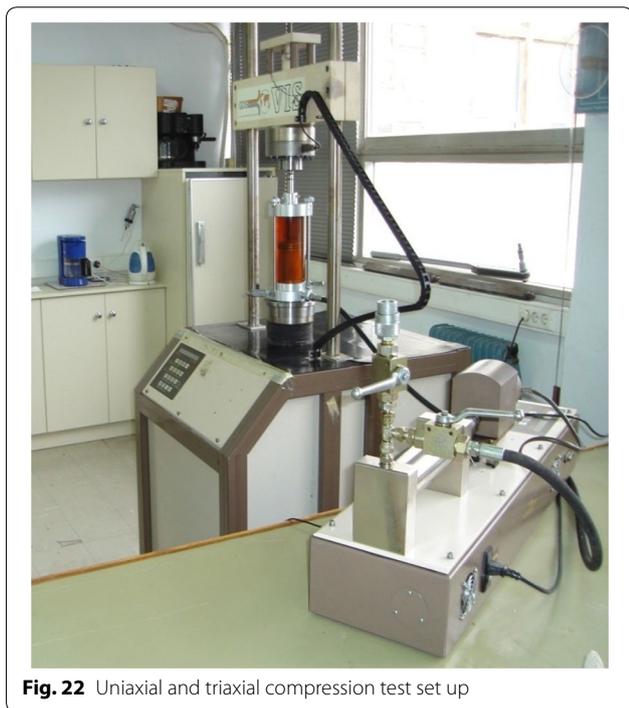
Fig. 22 Uniaxial and triaxial compression test set up

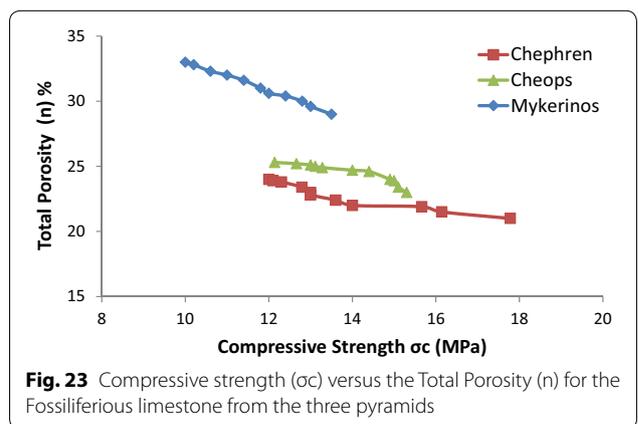
Fig. 23 Compressive strength (σ_c) versus the Total Porosity (n) for the Fossiliferous limestone from the three pyramids

its stiffness and strength, (see Fig. 23). According to the ASTM C 170, C 880, C 99 test methods and ASTM C568/C568M-15 specifications [33] the physical and mechanical characteristics of the construction materials of the three pyramids is low, since the standard requirement for

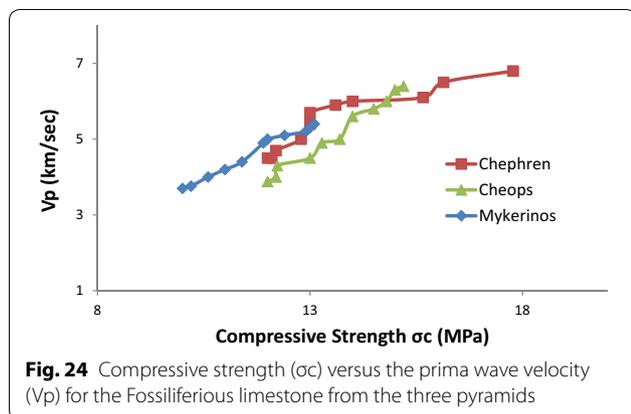
Fig. 24 Compressive strength (σ_c) versus the prima wave velocity (V_p) for the Fossiliferous limestone from the three pyramids

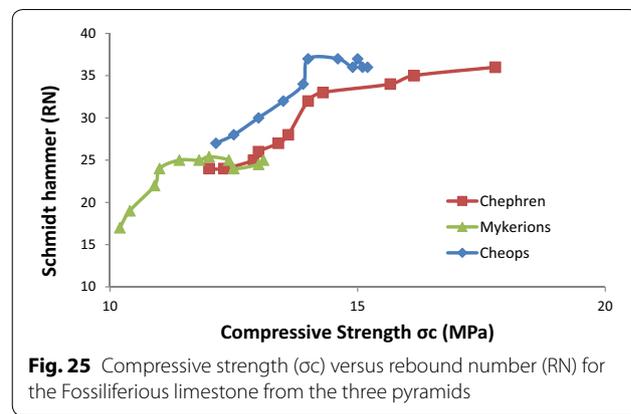
Fig. 25 Compressive strength (σ_c) versus rebound number (RN) for the Fossiliferous limestone from the three pyramids

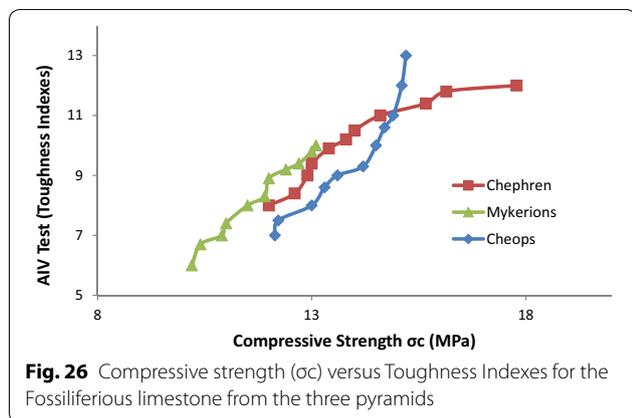
Fig. 26 Compressive strength (σ_c) versus Toughness Indexes for the Fossiliferous limestone from the three pyramids
