# The history of rescuing reinforcement and the preliminary study of preventive protection system for the cliff of Mogao Grottoes in Dunhuang, China

Xudong Wang<sup>1,2,5</sup>, Yanwu Wang<sup>1,2,3,4\*</sup>

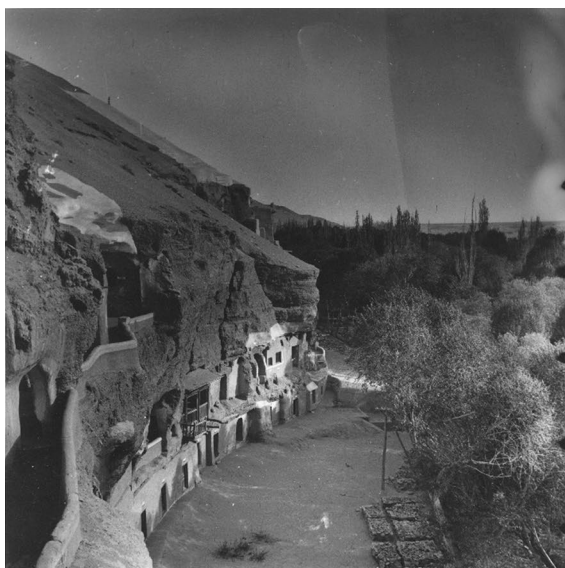
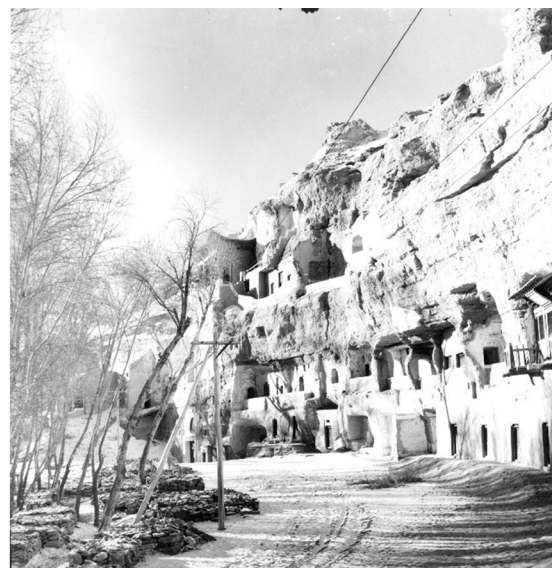
**Fig. 2** Preservation state of Mogao Grottoes before reinforcement

**a** Fissures on cliff (April 16, 1955)

**b** Collapse on cliff (January 25, 1956)

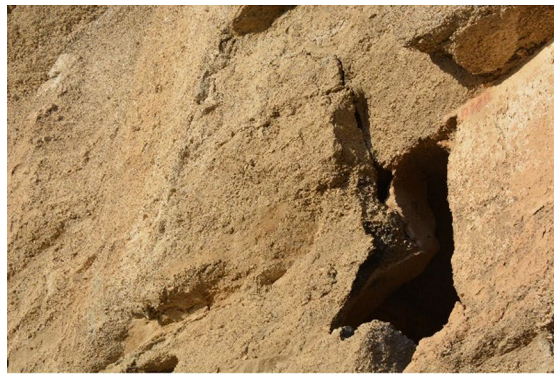
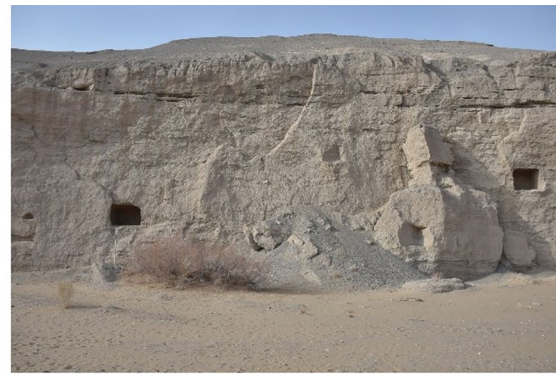
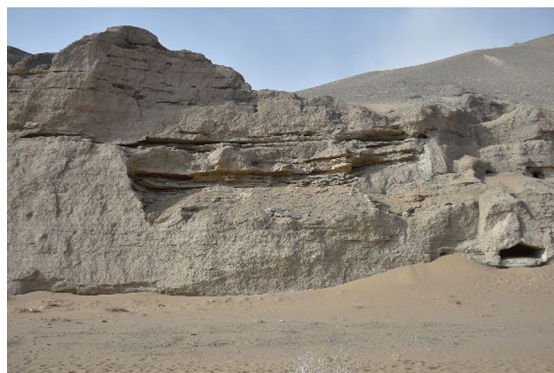
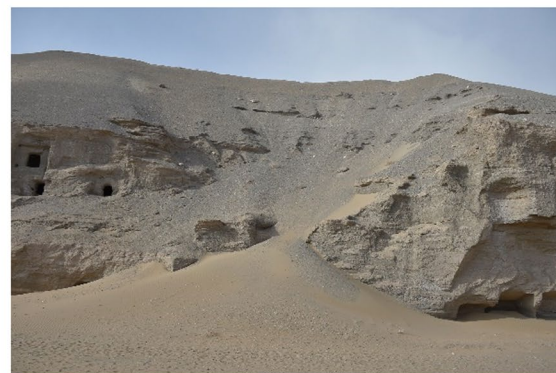
**d** A gully in the cliff**Fig. 9** The four types of diseases in Mogao cliff

**a** A fissure of the cliff

**b** The disease of collapse

**c** Weathering

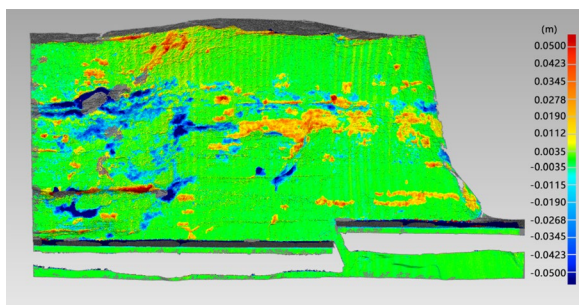
**Fig. 16** Deformation map based on the comparison between 2009 and 2016 results

the 3D models obtained by comparing the two laser scans is shown in Fig. 16. The green part indicates the deformation section within 3.5 mm, which means that there was no deformation on the cliff over the last eight years. Hence, the blue and orange sections may have originated from the consolidation and repairs that took place from 2009 to 2016.
