# Structural stability and microscale behaviors of the fortress wall from the sixth century Baekje Kingdom in ancient Korea

Jun Hyoung Park, Seok Tae Park and Chan Hee Lee\*

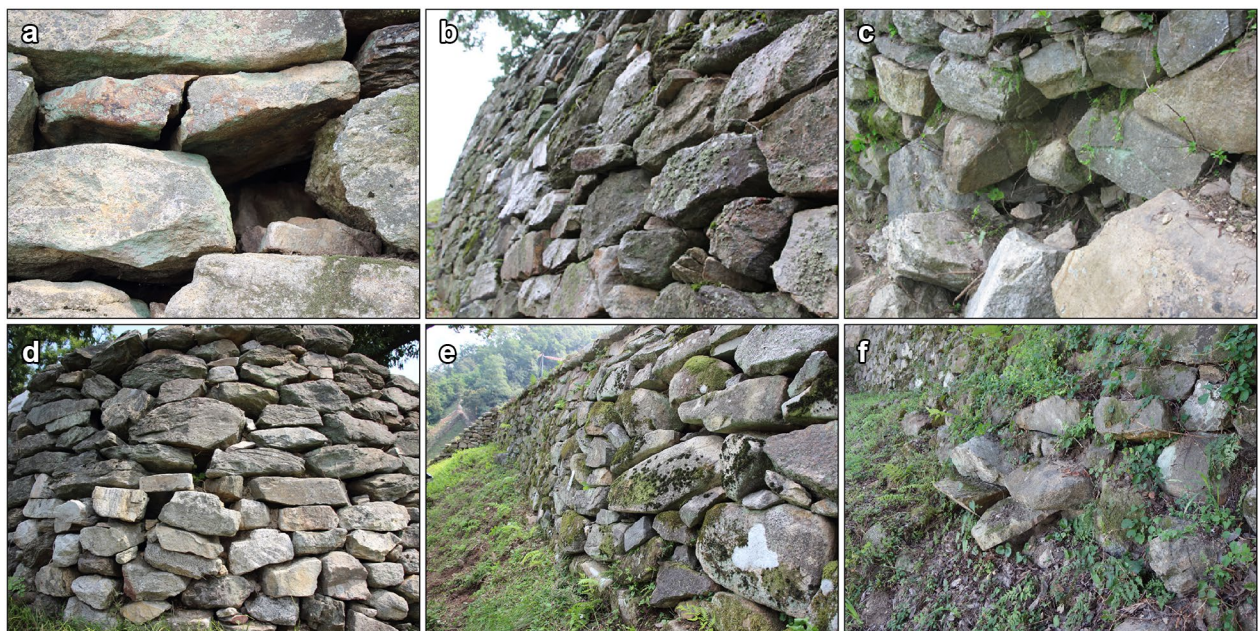
**Fig. 2** Occurrences of representative deterioration status. **A** Crack. **B** Protrusion. **C** Loss. **D** Structural relaxation. **E** Inflating phenomenon. **F** Unstable foundation

Damage types on individual rocks are manifested in the form of cracks, protrusion and loss while structural deformations of the ramparts are further categorized into the structural relaxation, inflating phenomenon and unstable foundation (Fig. 2). Only a single type of damage may be observed on the fortress wall but, from time to time, a number of damage types occur complexly. Also, it is possible to observe damages on individual rocks without any structural deformation but, on the ramparts that have experienced a structural deformation, damages are often identified on individual rocks.

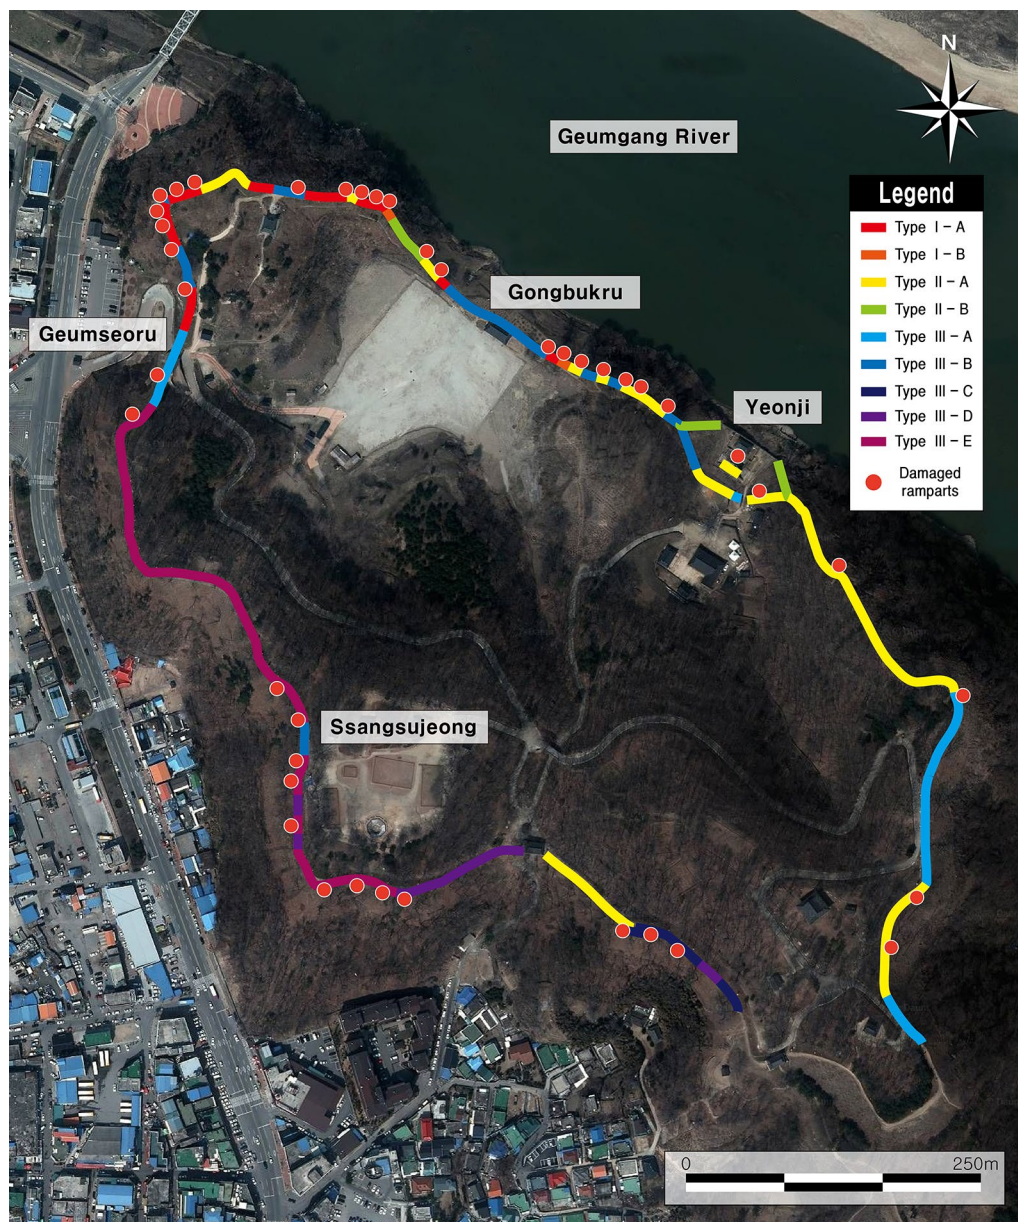
**Fig. 3** Distribution map showing the 41 sections of representative damaged ramparts and the classified construction types of the fortress

Results of inspections confirmed the 41 spots of the ramparts with damages and, in case several different types of damages are complexly observed in a single section, all of the types were recorded (Fig. 3). Looking at the types of damages that occurred on the fortress, damages on individual rocks are observed with any structural deformation on 7 spots. The 24 of the 34 sections where structural deformation spots occurred only displayed structural deformations without any damage on individual rocks and, at the remaining 10 spots, a variety of damage types were shown in a complex manner. Looking at the percentages of different damage types, inflating

Looking at the distribution of sections where damages occurred, we can see that 23 of the total 41 spots with damages are concentrated in the section between Geumseoru and Yeonji along the Geumgang River (Fig. 3). On the west and east sides, an extremely small number of sections have damages and, in contrast, damaged sections are shown to be concentrated on the ramparts near Ssangsujeong Pavilion on the south side. The root-cause investigation of the collapse of the ramparts reported that the incident was comprehensively affected by slopes of the surrounding topography, rampart construction techniques, surface water, underground water flows, conditions of the ground, and the distribution pattern of damages on the ramparts is also believed to have been influenced by such environmental factors [26, 27].

Looking at the locations for each type (Fig. 3), Type I is concentrated on the northwestern side of the Gongsanseong Fortress and shown to be distributed along the Geumgang River. Type II is observed on some parts of the northeastern and southern sides of the fortress and normally distributed along slopes. Type III has the

Also, the classified construction types and the locations on the ramparts where structural deformations have occurred were overlapped to examine the distribution pattern (Fig. 3). First, many of the damaged sections in the Gongsanseong Fortress are located on northern slopes whereas the distribution of damaged ramparts is shown to be reduced on southern slopes. Among the different construction types, the most distributed type is type II, and the highest share of damaged ramparts compared to the length is shown in type I (Table 3).

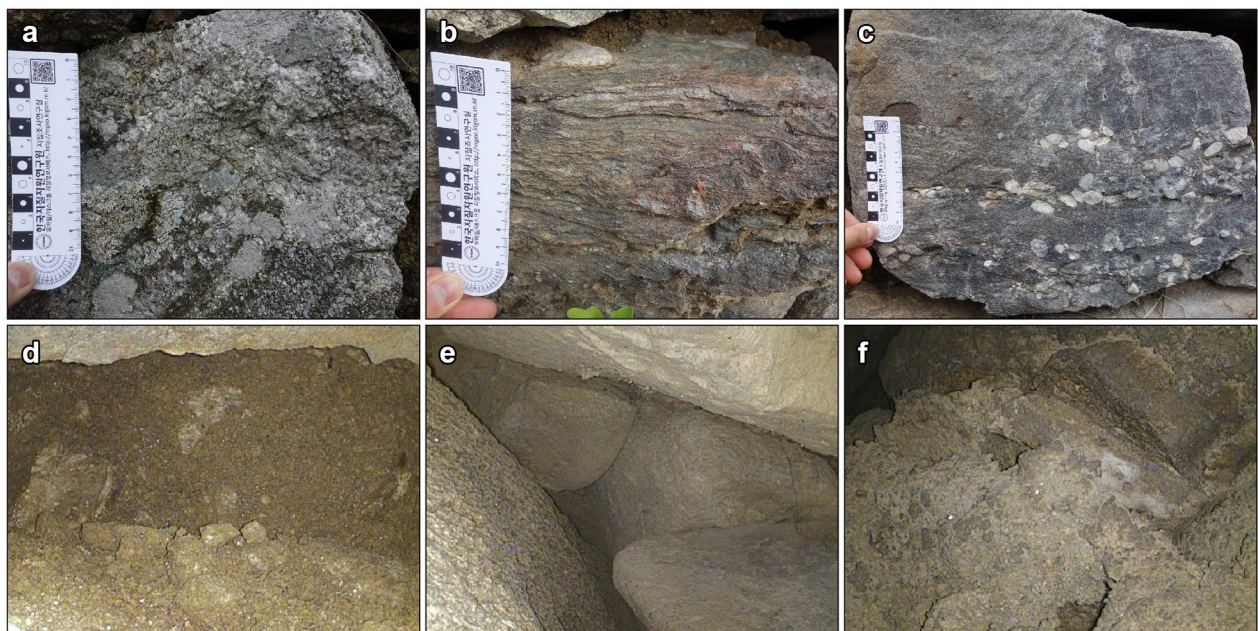
**Fig. 5** Construction materials of the fortress wall. Rock properties origin as igneous (A), metamorphic (B), sedimentary (C) process, and internal fillers of sand (D), gravel (E) and cement mortar (F)

Among them, gneiss and leucocratic granite are observed the most dominantly, and they show signs of quartzite and miscellaneous rock types mixed together (Fig. 5A–C). Leucocratic granite was dominantly used on most of the ramparts while a great amount of gneiss is observed on northwest ramparts of the Gongsanseong Fortress from Geumseoru to Gongbukru.

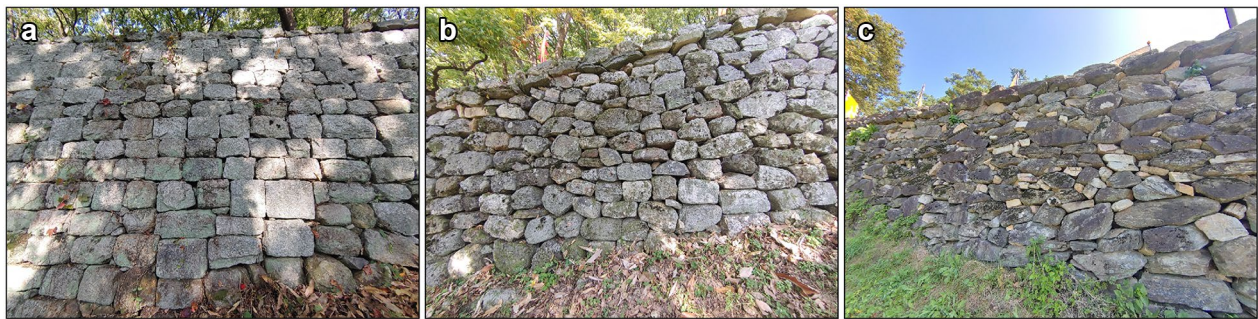
**Fig. 6** Classification of the fortress walls through morphological characteristics. **A** Type of straight rock piling. **B** Type of uneven rocks layer piling. **C** Type of uneven rock piling

Different construction techniques are applied depending on the curves of the ramparts, angles of outer ramparts, construction methods, and the Gongsanseong Fortress shows clear discrepancies from one section to the next because of different construction methods. A construction method is based on continuity of joints and standardization of stones, and three construction techniques, which are straight stones piling; uneven stones layer piling; and uneven stones piling, are applied to the Gongsanseong Fortress. Straight rock piling is a technique in which rocks that are standardized and, thus, nearly uniform in size are built to fit the joints (Fig. 6A)

whereas uneven stones layer piling is a technique of constructing stones of atypical shapes in line with the joints (Fig. 6B).

Uneven stones piling is found in the ramparts to which no particular construction technique is applied and refers to the form in which stones of atypical shapes are piled up by simply matching the external surfaces (Fig. 6C). After classifying the ramparts based on the shapes of the stones and construction techniques, we were able to see that most of the Gongsanseong Fortress is built by the uneven stones layer piling method. Straight stones piling is applied mainly in restored sections while the section restored in the 1970s on the northwestern side of the fortress is mostly built by the uneven stones piling method.

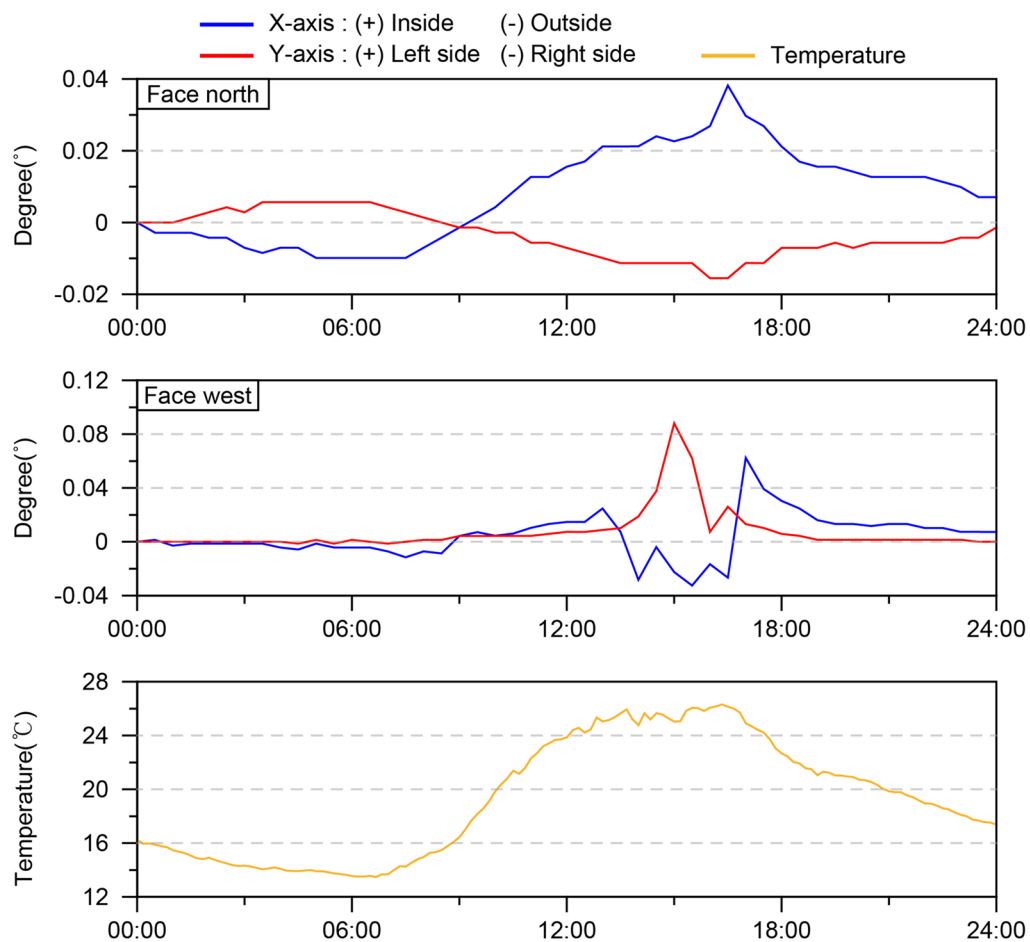
**Fig. 8** Diagram showing the daily behavior as time series on some sensors of north and west faces in the ramparts

Through the measuring sensors installed on the Gongsanseong Fortress, daily changes of the behavior were examined in comparison to the changes in temperature and, in order to minimize the effect of the amount of sunshine. We used measurement results from spring and fall, two seasons with identical lengths of day and night (Fig. 8) and (Table 2 and Fig. 9). Looking at the

temperature change first, the temperature begins to increase at about 6 a.m. when the sun rises and reaches the maximum around 2 p.m. The maximum temperature is maintained until about 4 p.m., from which the temperature starts to drop and continues to fall until sunrise on the following day.

Most of the sensors observed gradual movements as the temperature began to go up after sunrise and, after 4 p.m., showed a patterns in which they return to the state prior to the behavior change starts to occur. Although the temperature continued to drop until sunrise on the next day, the ramparts showed almost no movement after 8 p.m. and maintained a stable state.

However, the breadths of change and the main hours of movement slightly vary depending on the direction ramparts are facing. The monitoring sensors currently installed to face west, south and north, and those that face north and south demonstrate movements that are extremely similar to the temperature change. The ramparts that face west display stable behavior changes until the noon but, after this point until sunset, drastic behavior changes are observed. The fine movements detected by monitoring sensors attached on the ramparts can be interpreted to be mainly driven by expansion and contraction of the stones due to the thermoelastic coefficient depending on the temperature change and, subsequently, influenced by direct sunlight, which changes according to the sun's diurnal motion.

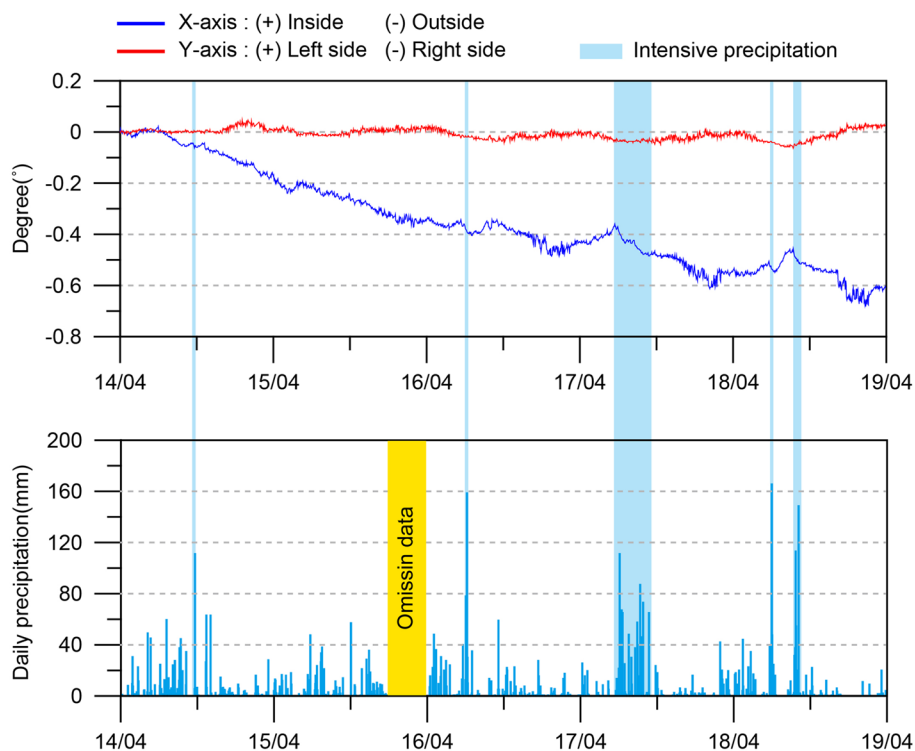
**Fig. 11** Diagram showing the representative environmental movement variation of the rampart

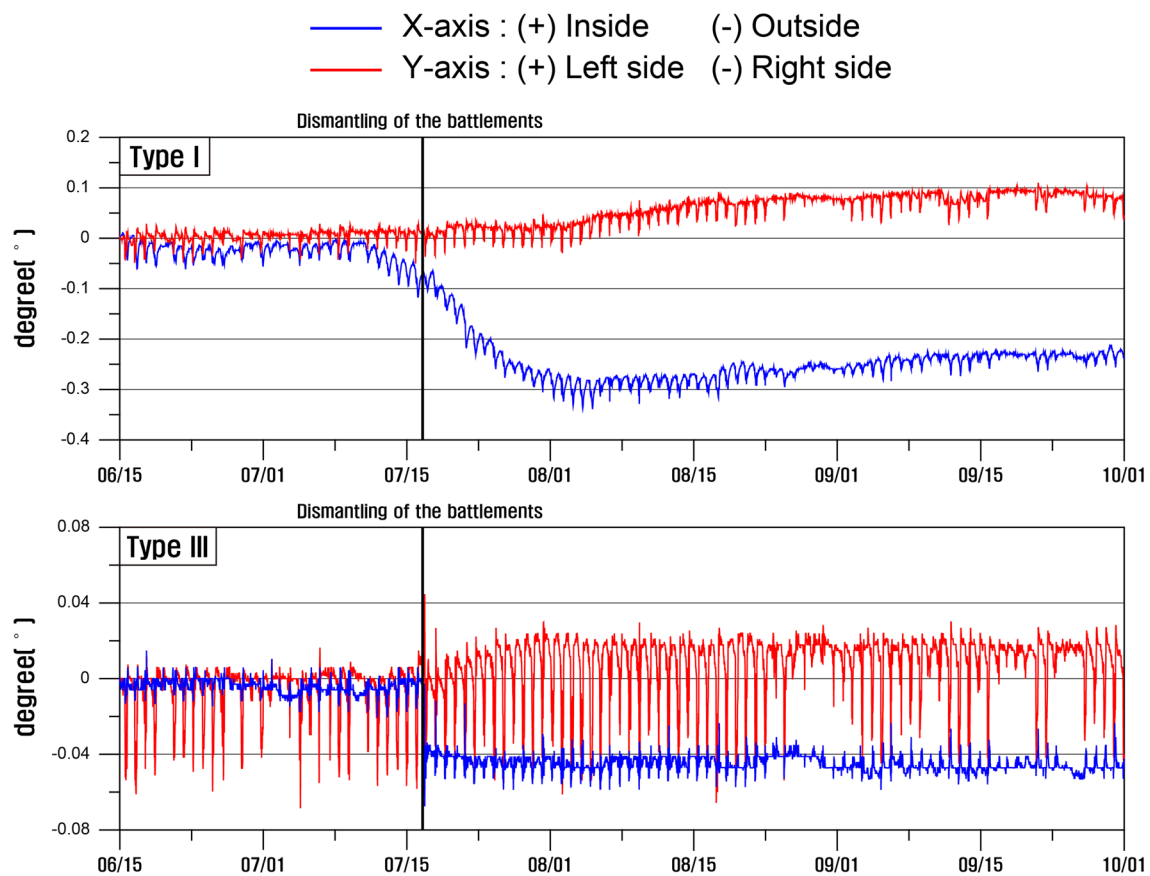
**Fig. 12** Diagram showing the representative behavior difference as construction types of the ramparts

A battlement was installed on the rampart near the entrance but, after the issue of structural stability of the rampart was raised due to the load of the battlement, it was dismantled in 2015. During the process of removing this load, behaviors were detected on the ramparts, and different forms of movements were observed depending on the construction type (Fig. 12).

brittle change instantaneously before reaching stabilization. So, even in the same environment, different forms of behavior changes may be manifested depending on the construction type, and the effect of different behavior changes may occur as structural instability on the boundary between different construction types.
