Dynamic characteristics of built heritage using ambient noise recordings

Sayed Hemeda^{1,2*}

Keywords: SHA, PGA, Microtremor analysis, Natural frequency, Abu serga church-Cairo, Resonance, Geophysical campaign

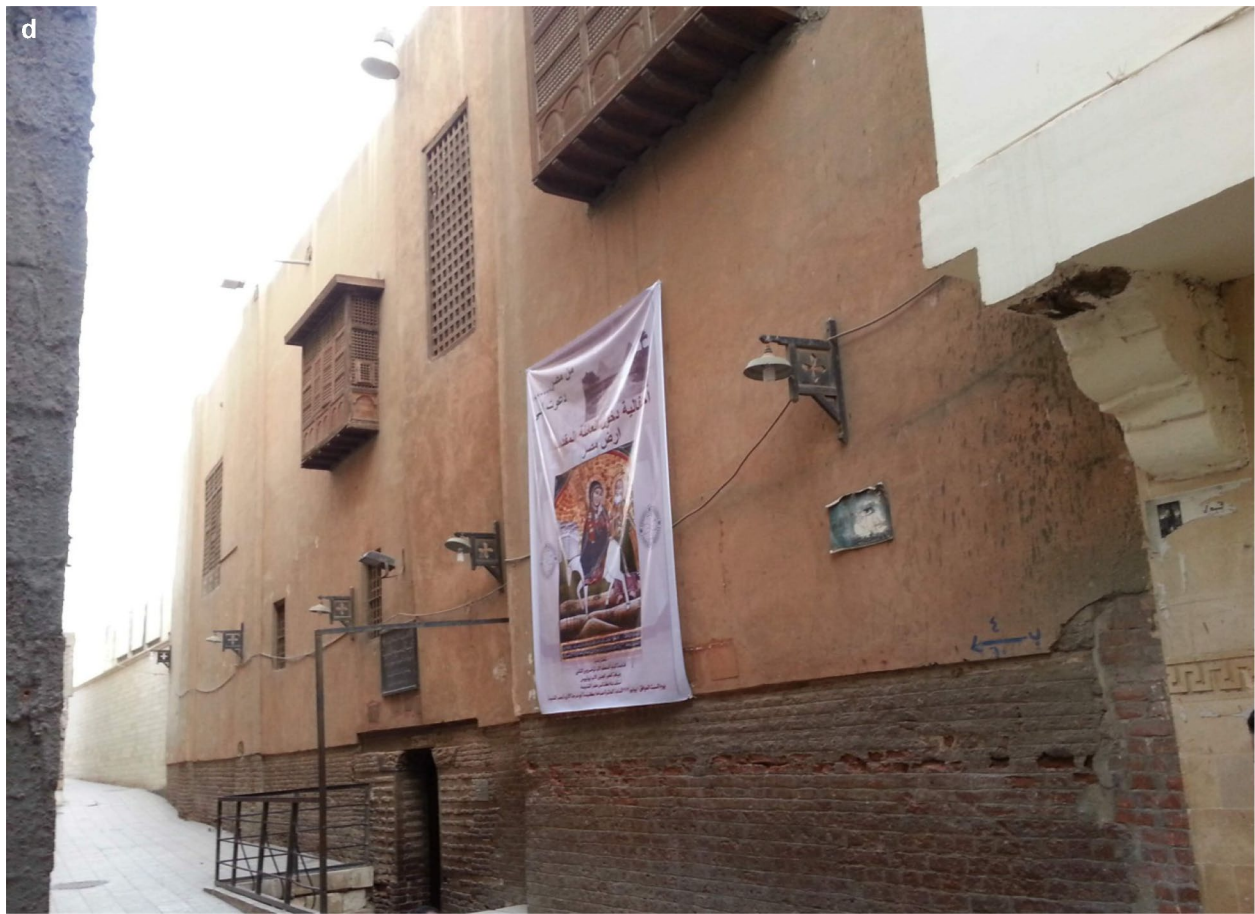
It was burned during the fire of Fustat during the reign of Marwan II around 750. It was then restored during the eighth century, and has been rebuilt and restored constantly since medieval times; however, it is still considered to be a model of the early Coptic churches. Again, the most precious and ancient of the icons are on the southern wall. A vast central hall is divided into three naves by two rows of pilasters, as shown in (Fig. 1a, b and c).

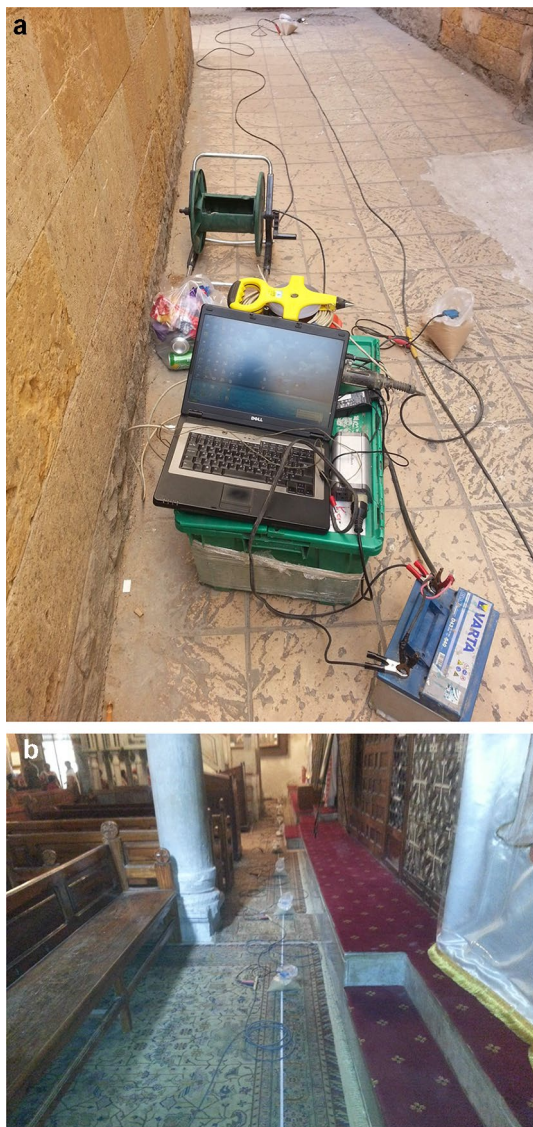
Fig. 5 **a** A sample of ReMi profile conducted out side Abu Serga Church. **b** A sample of ReMi profile conducted inside Abu Serga Church

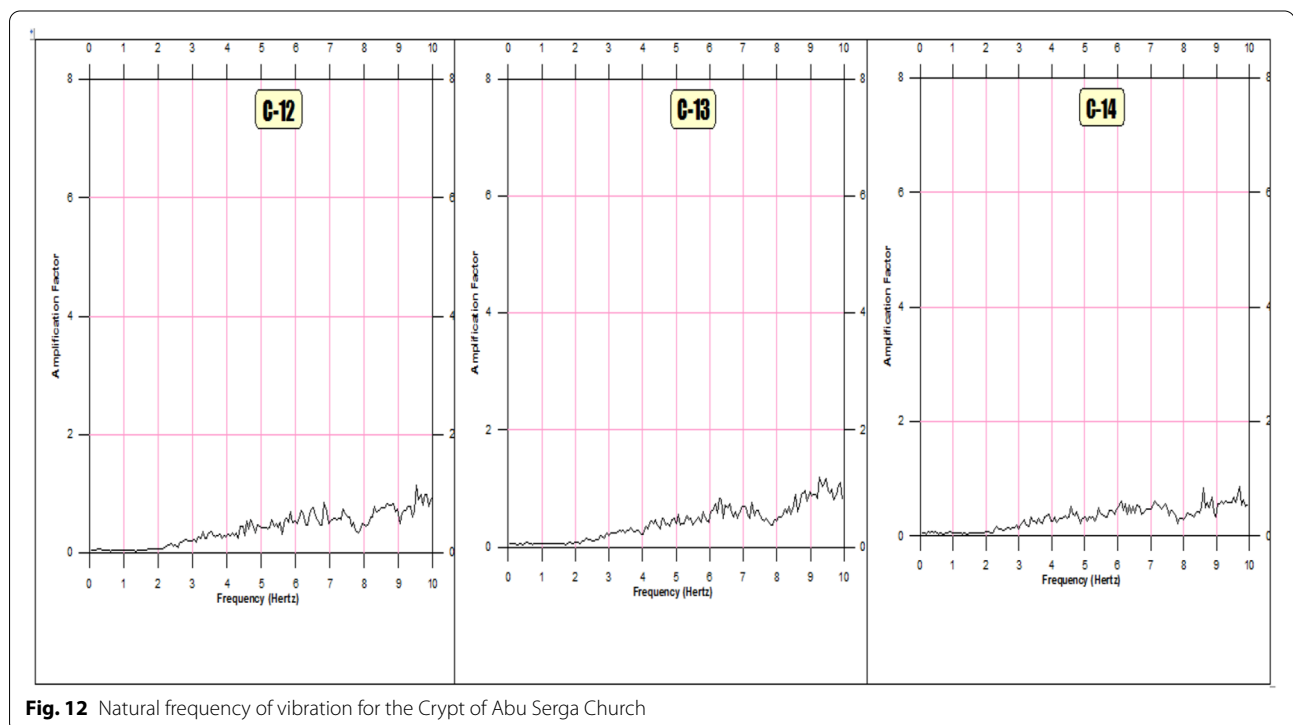
**Fig. 12** Natural frequency of vibration for the Crypt of Abu Serga Church

Serga church. The Underground Crypt shows no fundamental peak of neither vibration nor amplification factors as shown in (Fig. 12).
