Study on the causes of secondary cracks of the eave wall mural of Daxiong Hall at Fengguo Temple in Yixian, Liaoning, China

Cheng Liu¹, Yuan He^{1*}

Keywords: Fengguo Temple, Mural, Eave wall structure, Secondary disease, Crack

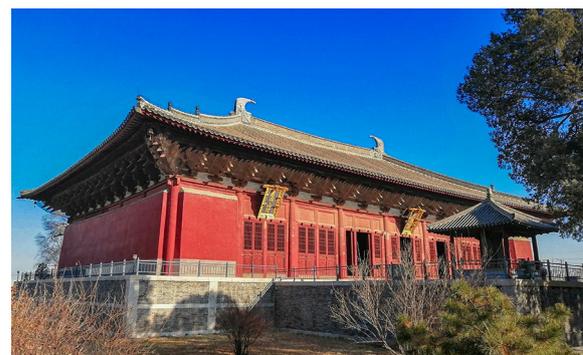
Fig. 1 Daxiong Hall in Fengguo Temple

Daxiong Hall is a single-eave, hip-roofed, south-facing building (Fig. 1). It is nine units wide and five units deep ("unit" here refers to the section between two adjacent eave columns). After the maintenance and restoration project, the building's enclosing structure consists of partition doors and eave walls—the former includes seven units in the middle of the front facade and a central unit in the back facade, and the latter includes the remaining units. The mural depicting the Yuan Dynasty was painted on the entire inner surface of the eave wall, and the content of each unit is independent. There are five Buddhas painted on the each of the east and west walls (E1–5, W1–5), four Bodhisattvas each on the east and west sections of the north wall (N1–8), and an 11-faced Avalokitesvara painted on each of the east and west ends of the south wall (S1–2) [15]. This distribution is shown in Fig. 2.
