Typology, current state and non-destructive testing of timber roof trusses of historic churches in the West Vistula Delta, Poland

Tomasz Zybała^{1*}, Monika Zielińska¹, Magdalena Rucka^{2,3}, Jarosław Przewłócki¹ and Karol Grębowski¹

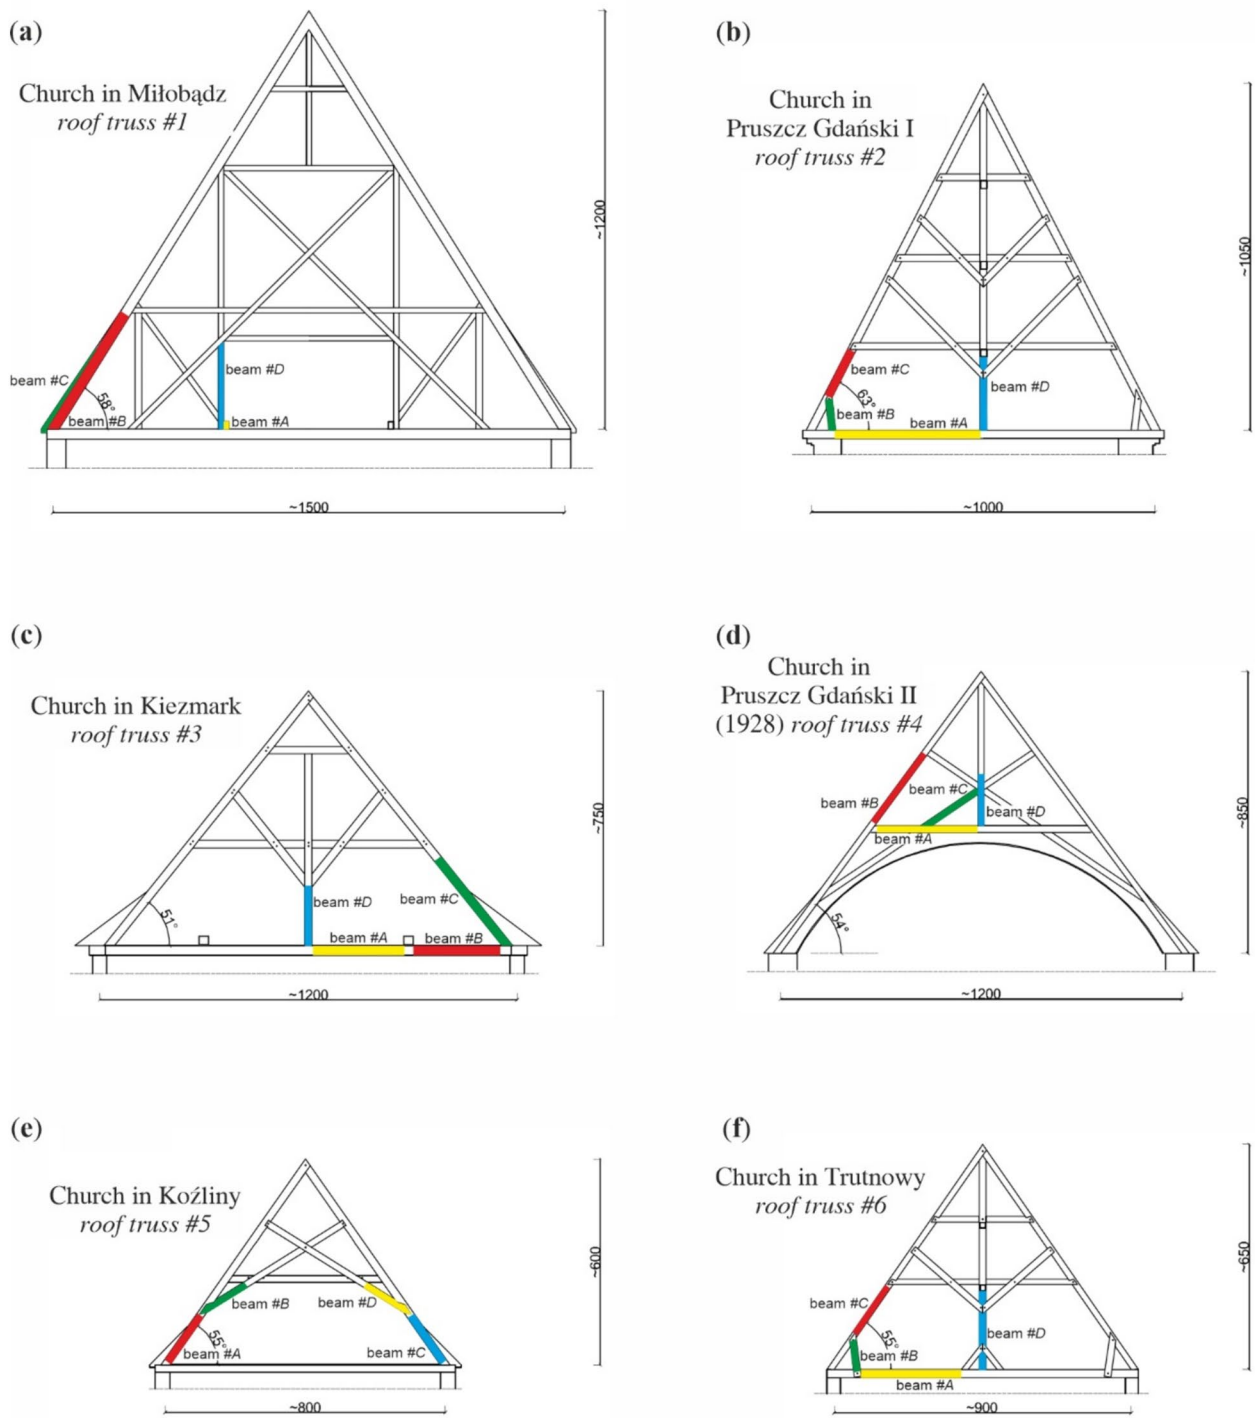
results. Depending on the type of roof truss and accessibility, these were floor beams, struts, rafters, and poles. Figure 4 shows the elements for which the measurements were made.

Fig. 4 Geometry and girders of the roof trusses with the indication of the measured timber elements, churches in: **a** Miłobądz (#1) **b** Pruszcz Gdański I (#2) **c** Kiezmark (#3) **d** Pruszcz Gdański II (#4) **e** Koźliny (#5) **f** Trutnowy (#6)

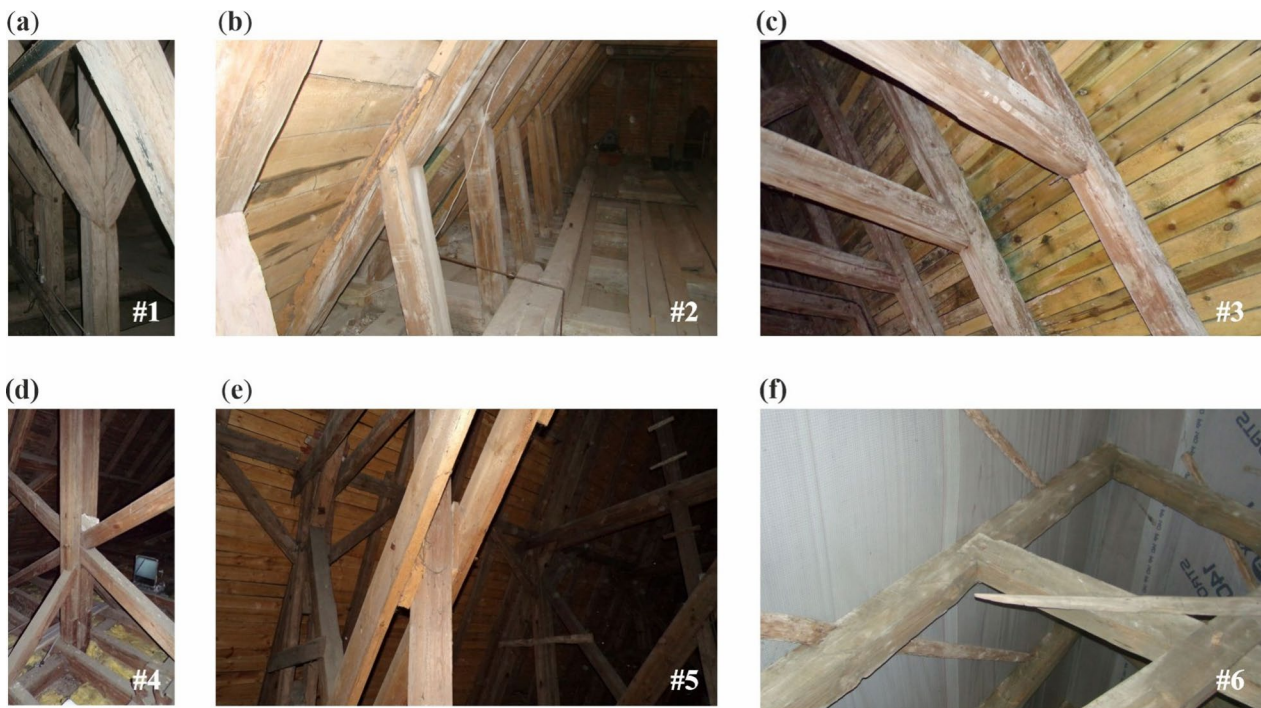
The rafters in the ridge of churches #2, 3, 5, 6 are connected with a bridle joint (Fig. 6f). The connections of rafters with collar beams are more varied. In churches #3 and #5 they are the same: mortise and tenon (Fig. 6c), in church #6 it is the dovetail log. The king post with struts is connected with a dovetail log (Fig. 6a) in church #2. The rafters and angle ties are connected with a lap joint in church #6 (Fig. 6b). In the roof trusses constructed in the twentieth century (churches #1 and #4), the carpentry joints are pinned and bolted (Fig. 6d, e) (Tables 1 and 2).

Fig. 6 Carpentry joints in church roof trusses: **a** Mitobądz (#1), **b** Pruszcz Gdański I (#2), **c** Kiezmark (#3), **d** Pruszcz Gdański II (#4), **e** Koźliny (#5), **f** Trutnowy (#6)

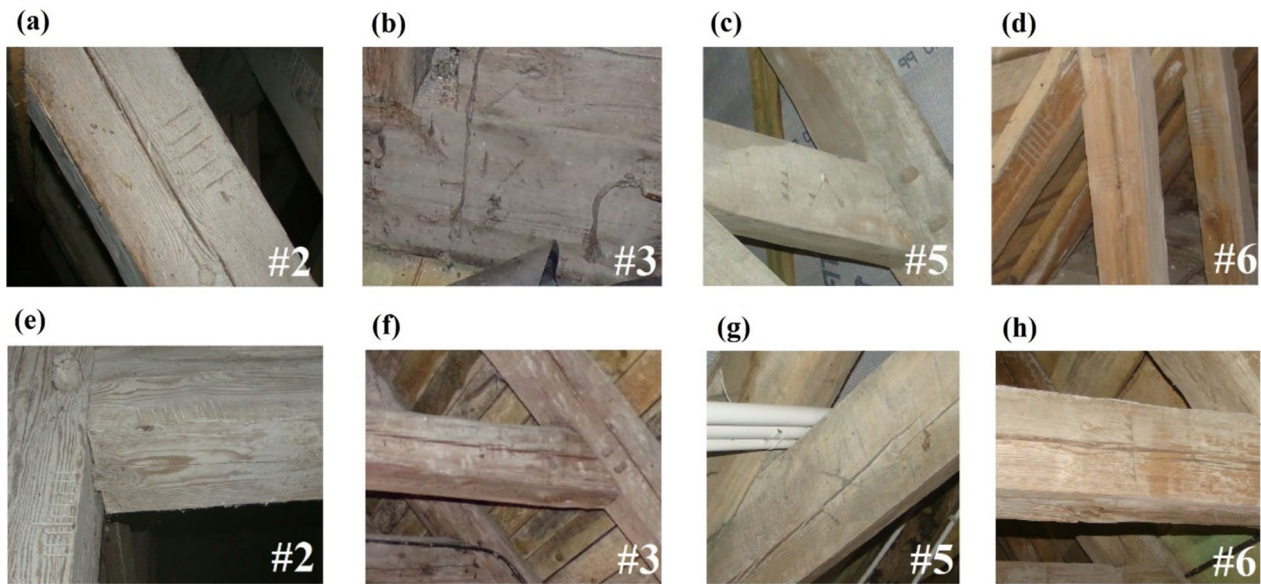
(Fig. 2). The state of conservation of the trusses is good, the roofing is waterproof and the gravity ventilation of the attics is intact (Table 1). Only the roof trusses built before the twentieth century (churches #2, #3, #5, #6) have carpentry marks (Fig. 7).

Fig. 7 Carpenters' marks on roof trusses: **a** and **e** Pruszcz Gdański I (#2), **b** and **f** Kiezmark (#3), **c** and **g** Koźliny (#5), **d** and **h** Trutnowy (#6)
