Conservation issues and chemical study of the causes of alteration of a part of the Stave Church in Hopperstad (Norway)

Marit Lehne^{1*}, Sara Mantellato², Asel Maria Aguilar Sanchez² and Francesco Caruso^{1,3}

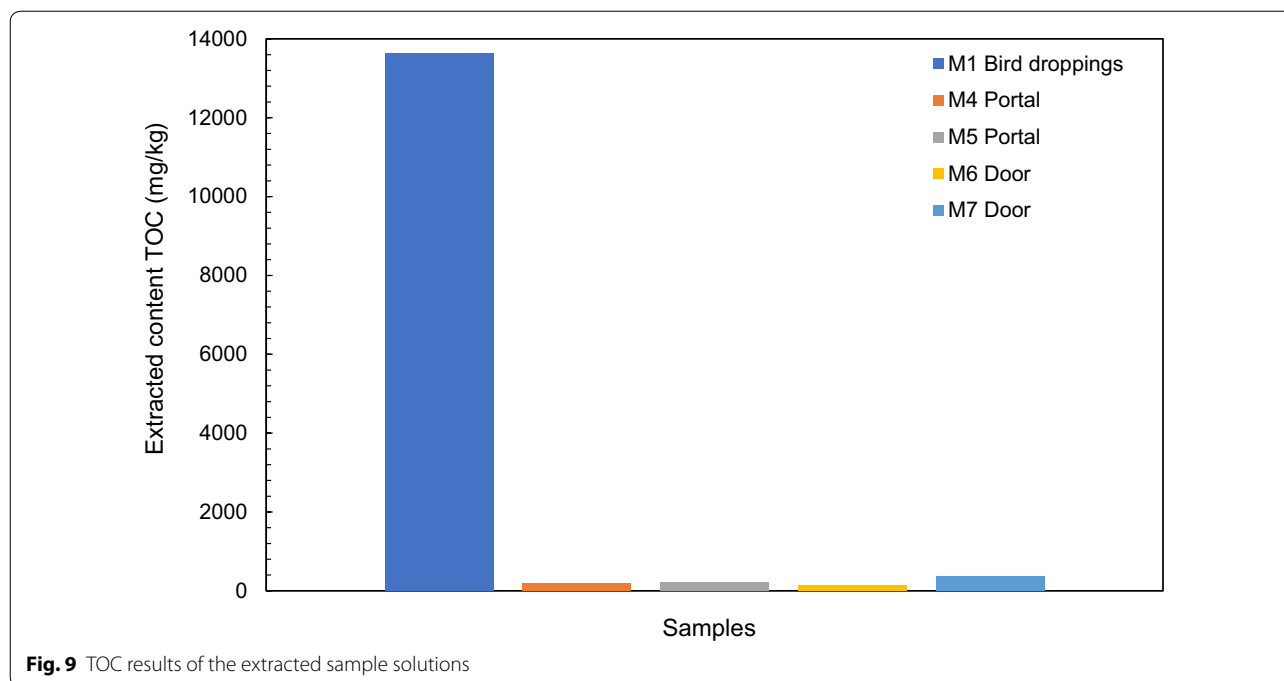
The TOC analysis was a complementary test to the other analytical methods. The results are shown in Fig. 9. Only samples of the exterior were analysed with the TOC (the same sample solution used for the ICP-OES analysis). The results confirmed that the bird droppings have animal origin by having a high amount of organic carbon. All the samples with white layer had a low amount of organic carbon compared to the bird dropping sample. This evidence indicates that the content in these solutions was mainly inorganic. This supports the results of the other conducted analyses: the crystalline structures observed with SEM and the high presence of calcium detected by XRF and ICP-OES analyses. The TOC result proves that bird droppings is not the origin of the white substance.

Fig. 9 TOC results of the extracted sample solutions

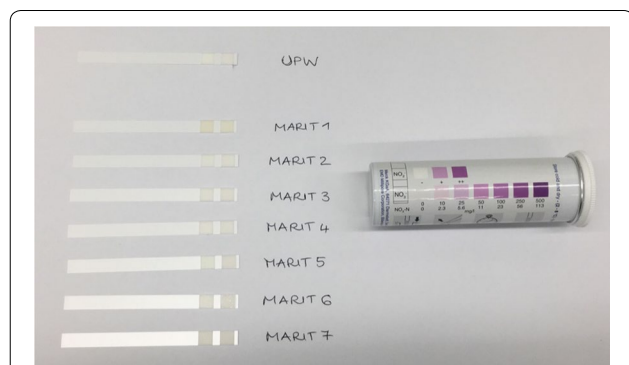
The results related to nitrate and nitrite strip tests are shown in Fig. 10.

The amount of both nitrate and nitrite ions in the sample solutions is below the LOD of the strips (10 mg/L). Nitrate is an important contaminant in surface soils,

Fig. 10 Results from the nitrate and nitrite test of the extracted and filtered sample solutions. The presence of the ions is indicated by a purple tone on the strips. UPW was used as a reference

originating from the use of fertilizers, animal waste, and the oxidation of organic nitrogen [12]. According to Arnold and Zehnder [33], soils in proximity of human housings and settlements are especially enriched in nitrate and chloride, compared to the normal soils, as nitrate being produced by microorganisms from organic wastes, and chlorides being supplied by the consumption of sodium chloride. Since none of the ions were detected by the strips, it means that the origin of the white layer
