The *Samuel F. B. Morse* statue in Central Park: scientific study and laser cleaning of a 19th-century American outdoor bronze monument

Abstract

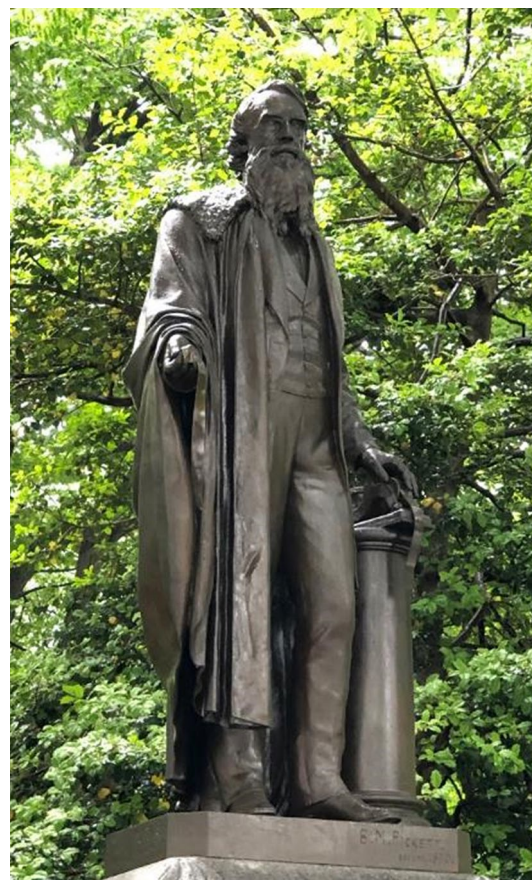
Over time, the statue's surface has suffered from severe degradation. Exposed areas are deeply pitted, and sculptural detail has been lost as a consequence of decades of unprotected exposure to corrosive atmospheric agents such as salts and acid rain. Furthermore, blisters of active corrosion and associated localized coating failure have long been noted in the deep recesses of the figure's long coat. These observations prompted conservation staff at the Central Park Conservancy (CPC) to undertake a research project aimed to investigate the ongoing issues and formulate an adequate treatment. The Morse statue was thus removed from its granite base and relocated to a controlled workshop space to aid in the manipulation

Fig. 1 Statue of *Samuel F. B. Morse*. The statue of *Samuel F. B. Morse* in its current Central Park location at East 72nd Street, where it was moved in 1988

of the large figure and in devising a cleaning and recoating plan. The need of a precise, quick, and safe approach for the object, conservators, and the environment guided the choice of treatment towards laser cleaning. This treatment uses specific, tunable laser parameters such as wavelength, as well as pulse frequency and duration, to preferentially excite and safely remove undesired coatings or contaminants from a surface through photomechanical, photothermal, and photochemical reactions [3]. Among its successful applications, laser cleaning has proven highly effective for removing corrosion products from bronze sculptures [3–9] and archaeological objects [10–13]. One of the main advantages of this cleaning methodology is the possibility to select suitable settings for achieving the expected results, preventing the operator from damaging the artwork [14].
