Studying a 2 millennia old bronze kettle using easily accessible characterization techniques

Marta Kotlar¹, Nives Matijaković Mlinarić², Vladan Desnica³ and Katarina Marušić^{4*}

Abstract

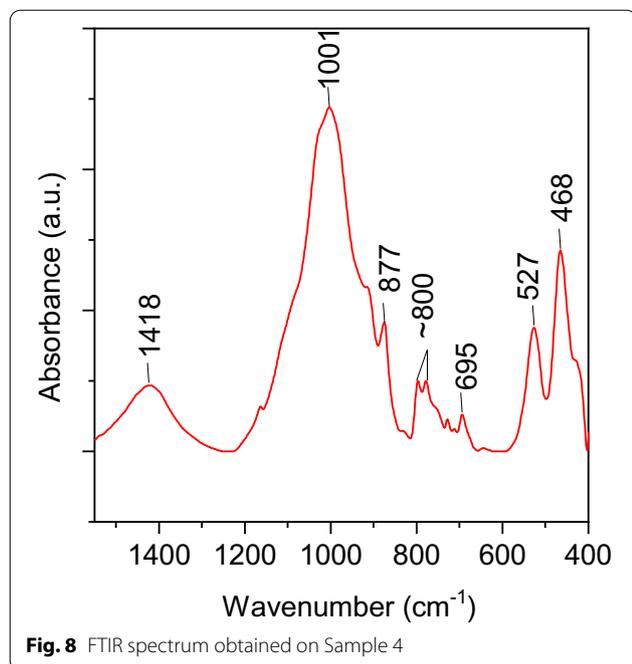
Sample 4 has a blackish colour, as can be seen in Fig. 2. The main colour is not green/blue pigmented, so it is expected that this sample is not a sample where copper corrosion products prevail. The SEM image obtained on Sample 4 is presented in Fig. 7. It shows presence of two different structures pointed by numbers 1 and 2. The structure in Point 1 has a rougher structure, while the structure in Point 2 is smoother. EDS analysis were performed in these two points and the results are also

presented in Fig. 7. It is clear that in Point 1 iron is a dominant element, while in point 2 silicon is.

Fig. 7 SEM image of Sample 4 and elemental composition in atomic-% obtained by EDS analysis on the two points marked on the SEM image
