Strategy for developing a future support system for the *Vasa* warship and evaluating its mechanical properties

Thomas Lechner^{1*}, Ingela Bjurhager² and Robert I Kliger¹

Abstract

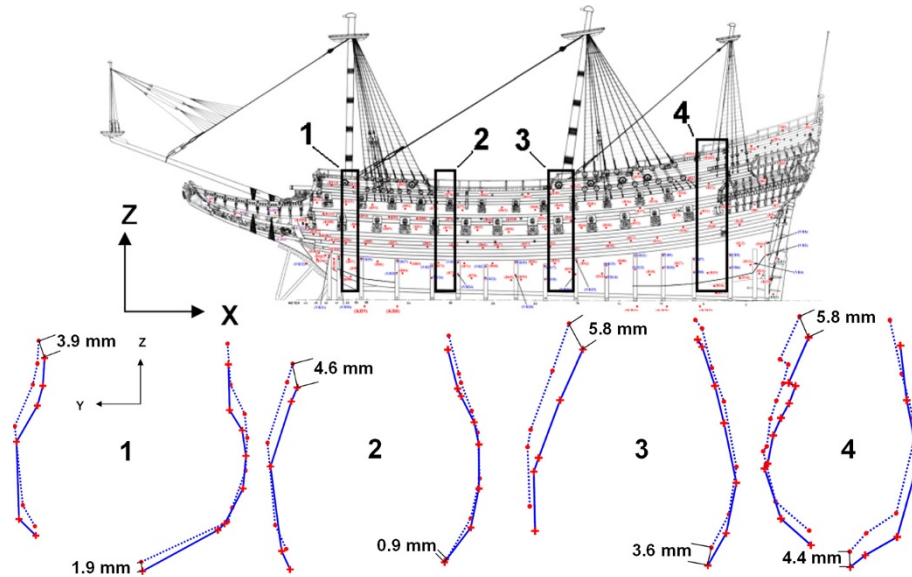
Figure 1 This figure shows the deformation pattern of the *Vasa* warship between 2000 and 2003, on both the starboard and the port side in four different sections. Figure adapted from [9].

However, despite all the efforts that have been made, the problems associated with local and global deformation still remain and the warship is slowly deforming at a more or less constant speed. Manual measurements performed between 1987 and 1999 registered deformation as large as 50 millimetres at the bow [10]. Measurements made later showed that the deformation increased by as much as 0.5 mm per year, see Figure 1 [9]. The most likely contributory factors to the relatively high deformation rate are the low stiffness in the wood and the connections, in combination with large forces applied to the hull. A certain small seasonal shrinkage/swelling of the wood also needs to be considered. The deformation is of both a translational and a rotational character [11]. The latter at least is believed to be caused by asymmetrically distributed weight, e.g. the heavy bow mast, which, due to its inclination, is likely to induce lengthwise torsion in the warship.

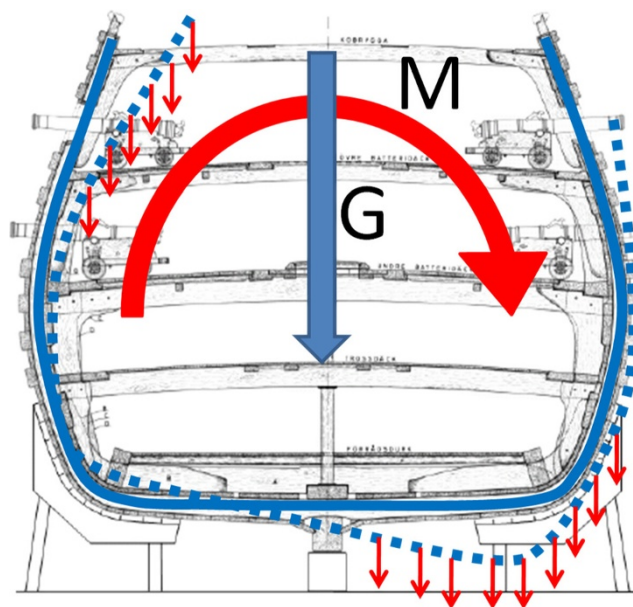
Figure 2 Cross-section of the *Vasa* warship. The deformation and translation are expected to be caused by deck structures that are not sufficiently stiff, weak connections between decks and the hull and asymmetrically distributed weight, e.g. the warship's inclined mast.

been stated that the load transfer to the support structure is insufficient, leading to local indentations [7]. Different simplified finite element (FE) models of sections of the ship have since been established for cross-sections of the hull to predict the deformation [9,10]. In line with the actual measurements on the ship, the first sectional FE model (based on recent European oak MOE properties) showed that the main deflection and deformation is a translation of the side structure, deflection of the deck

beams [10] and also deformation of the bilge, see Figure 2. The model and the material parameters were subsequently updated by Ljungdahl [9]. The updated model suggested that improved support, especially the strengthening of the main frames supporting the gun decks, would increase the stiffness of the ship's structure and probably reduce the speed of the time-dependent deformation. This FE model used material parameters from only a few *Vasa* oak samples as input. So, in order

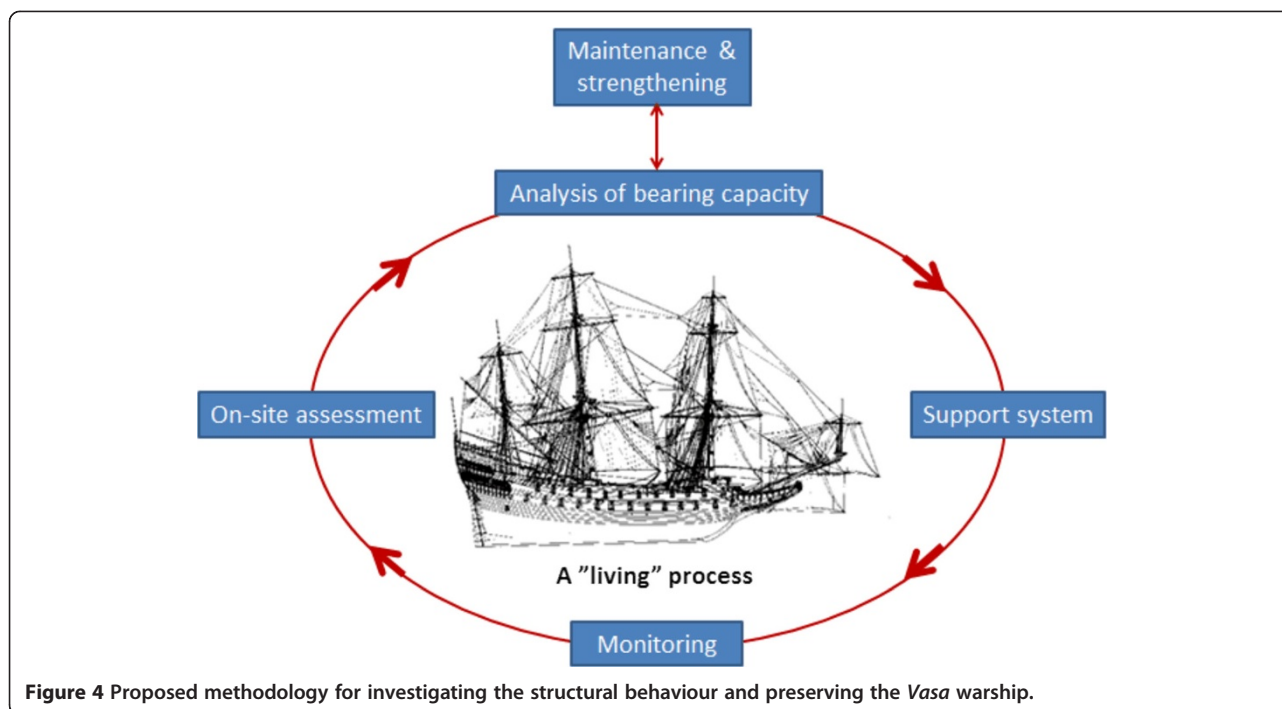
Figure 4 Proposed methodology for investigating the structural behaviour and preserving the *Vasa* warship.

A complete three-dimensional model of the warship would be of great help when it comes to creating a new support system using advanced technology in order to protect the national treasure, the *Vasa*, for the future and prevent the ship's structure deforming still further. The proposed overall methodology is illustrated in Figure 4 and consists of four steps in a "living process" with the aim of maintaining the ship in its present shape, i.e. minimising (time-dependent) deformation. These steps are:

- (1) On-site assessment of mechanical properties of the wood and description of the connections between elements
- (2) Analysis of bearing capacity by computer modelling of the ship

- (3) Choice of a new and improved support system based on the two previous steps and verification of the computer model
- (4) Monitoring the ship after installing the system

In this section, we propose a detailed methodology for the on-site assessment (Step 1, cf. Figure 4) in the

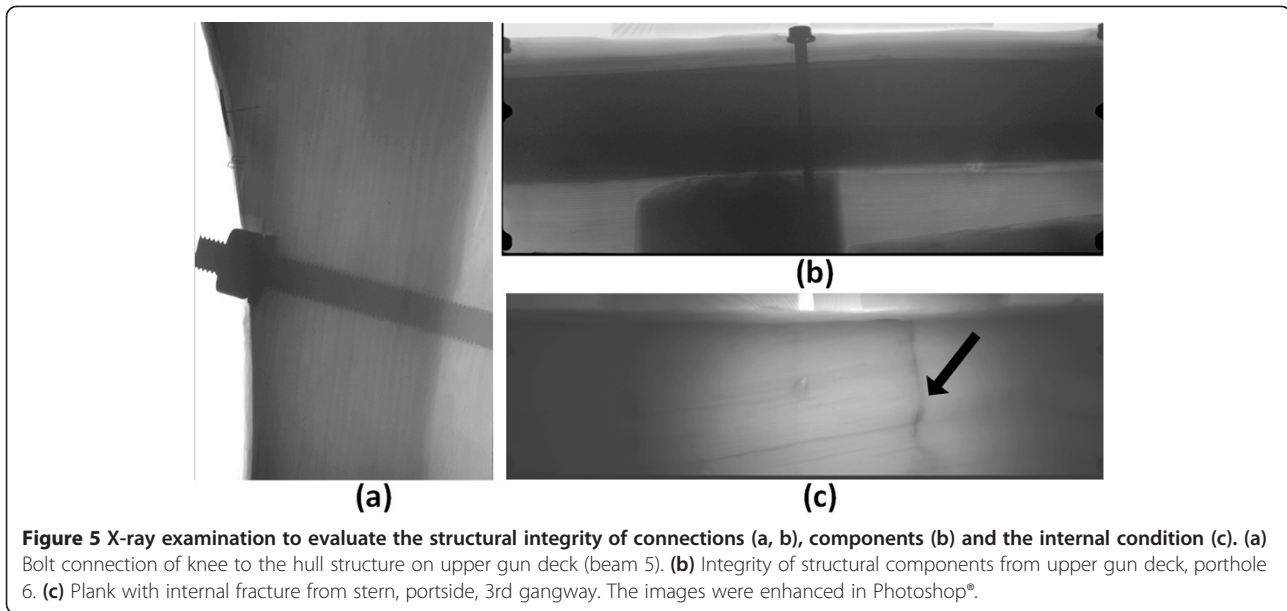
Figure 5 X-ray examination to evaluate the structural integrity of connections (a, b), components (b) and the internal condition (c). (a) Bolt connection of knee to the hull structure on upper gun deck (beam 5). (b) Integrity of structural components from upper gun deck, porthole 6. (c) Plank with internal fracture from stern, portside, 3rd gangway. The images were enhanced in Photoshop®.

In addition to the determination of density, the X-ray technique is well established as a powerful tool for investigating the internal condition of the structure [14], especially the examination of connections and the integrity and condition of the structural components, such as those in the *Vasa* warship, see Figure 5. The investigation of connections in the *Vasa* warship is decisive for the load transfer within the hull and the load transfer from the hull to the existing support cradle and needs to be made in detail. This will also make it possible to measure and make visible geometry and joint configurations, as well as contact between hidden elements. Information of this kind is crucial for the accuracy of the FE model and supports the decision-making when it comes to ways of transferring the forces between the elements in the model.
