Design and validation of tailored colour reference charts for monitoring cultural heritage degradation

Abstract

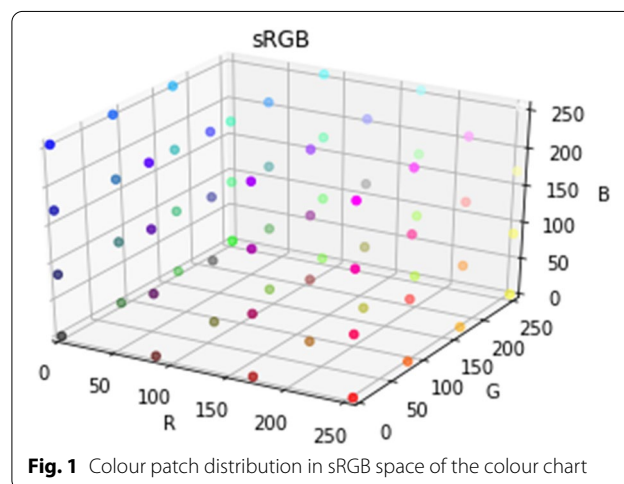
Fig. 1 Colour patch distribution in sRGB space of the colour chart

phones, which follow Rec. ITU-R BT.709 [22]. The uniform distribution is selected because, unlike other checkboards, the aim of this chart is to help to automate the calibration over the whole colour space, so the colours are not restricted to certain common skin and landscape tones, as others commonly do. Due to physical restrictions (size of the printed colour chart and size of each colour patch in the chart, needed to have a minimum resolution and avoid edge misleading measurement errors) the colour charts have been designed with 64 colour patches. The distribution in the sRGB space of these colours is shown in Fig. 1.

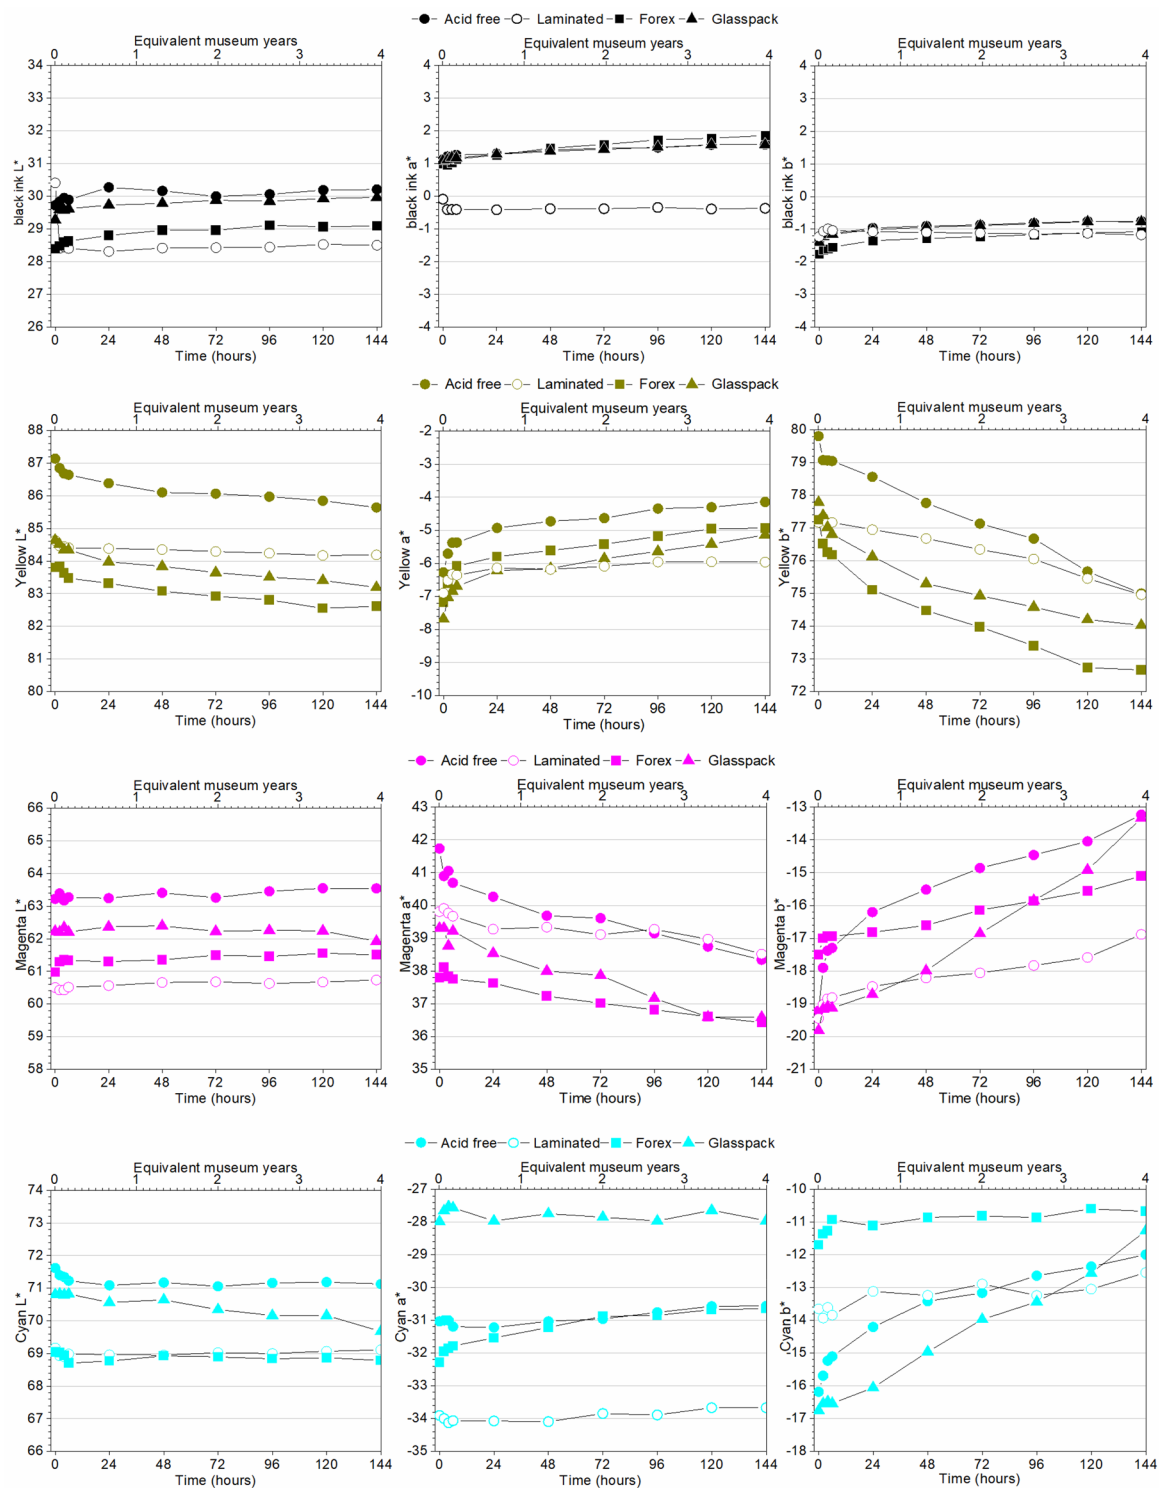
Fig. 3 Variation of L*a*b* chromatic coordinates for black, yellow, magenta and cyan inks over the four base materials employed: acid free paper, laminated acid free paper, Forex Smart and Glasspack

Considering the colour of inks printed on the different substrates (Fig. 3), it can be observed that the L^* parameter is almost invariable, a^* experiences minor variations while b^* is the most affected parameter, depending on the colour and support. Black can be considered stable in all cases; probably inks protect the base material from light, being this effect more appreciable for black ink. Both magenta and cyan increase their b^* value, i.e. turn yellower, while the yellow ink changes in the opposite direction.

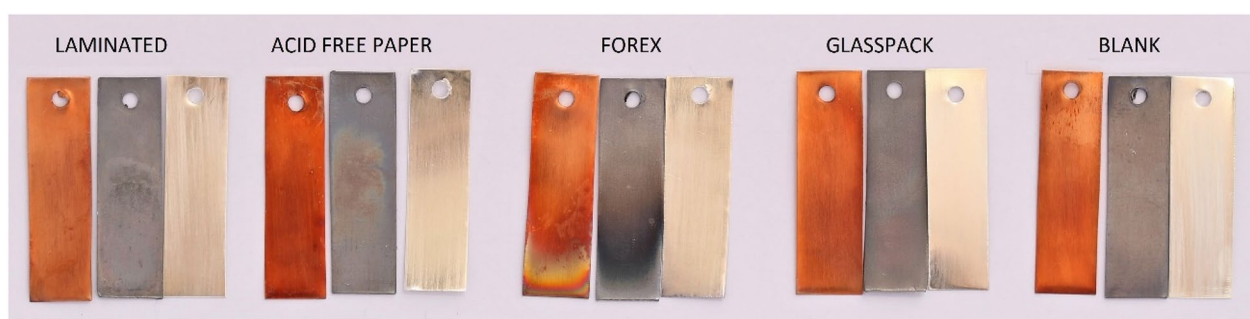
Fig. 4 Results from Oddy test on copper, lead and silver coupons exposed to laminated acid free paper, acid free paper, Forex Smart and Glasspack

As a general result, the Oddy test gave optimum results for Glasspack, acceptable results for acid free paper and failed for Forex (Fig. 4). Silver was not affected by any material, and can be rated as P (suitable for permanent use) according to [21], indicating that no sulphur compounds are emitted from any of the tested materials. These pollutants can be emitted by some papers or the inks, whose composition is complex and unknown, and might include sulphur-containing compounds. Copper got some reddish areas in all cases, attributable to the natural formation of native cuprous oxide layer (cuprite). Forex produced the higher degradation, showing marked iridescence in the lower area, rating this material as U

(unsuitable for use); followed by acid free paper (rated T, for temporary use). Forex, and with less severity acid free paper, darkened the lead coupon (U), that was unaffected by Glasspack (P). Laminated paper yielded an intermediate behaviour, and slightly tarnished the lead (rated T).
